City of Milpitas Sewer Master Plan

Sewer Master Plan

Prepared by HydroScience Engineers, Inc.

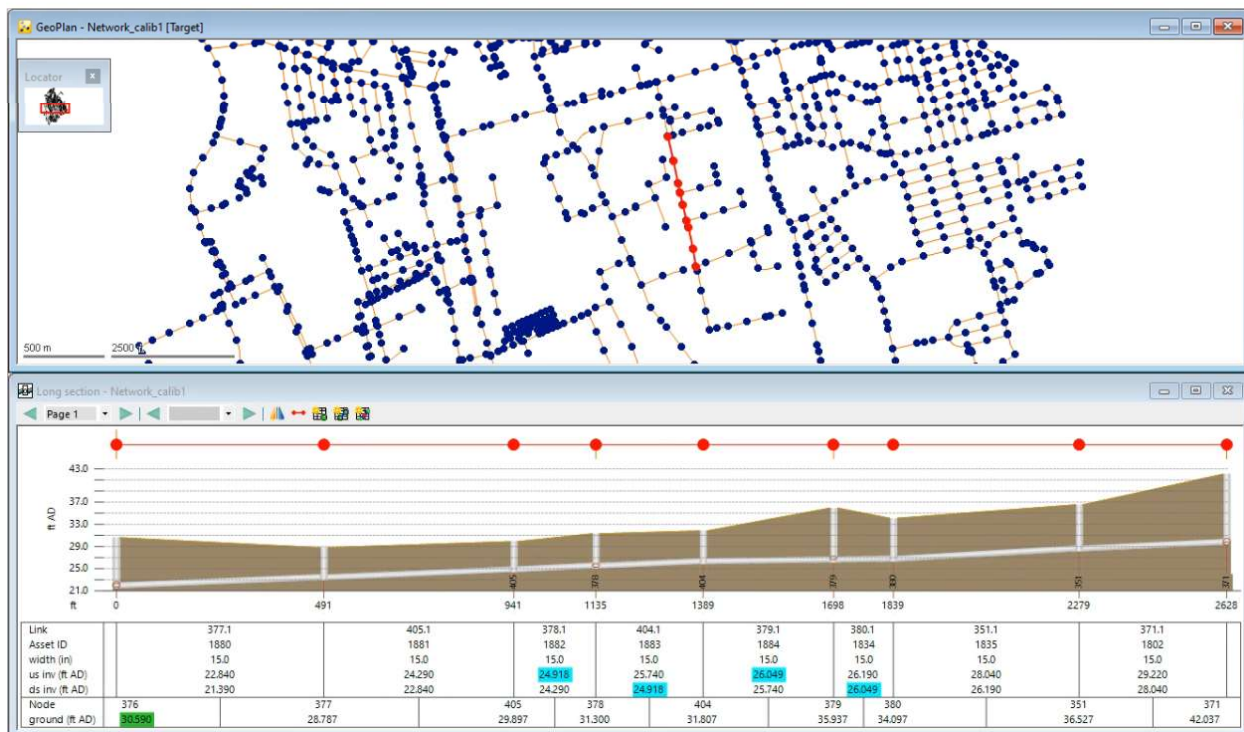
Figure 6-3: InfoWorks Profile View

Once all validation errors were reconciled, the system was analyzed using the pipeline *Profile View* (see **Figure 6-3**). If additional analysis was required, record drawings or CCTV were reviewed, where available. Significant adjustments were made based on differing datums referenced in the record drawings. Each update to the model data was marked with a data flag and different flags were created to represent the varying reasons for the updates. **Figure 6-4** shows the various data flags that were developed and used during the model network review process.

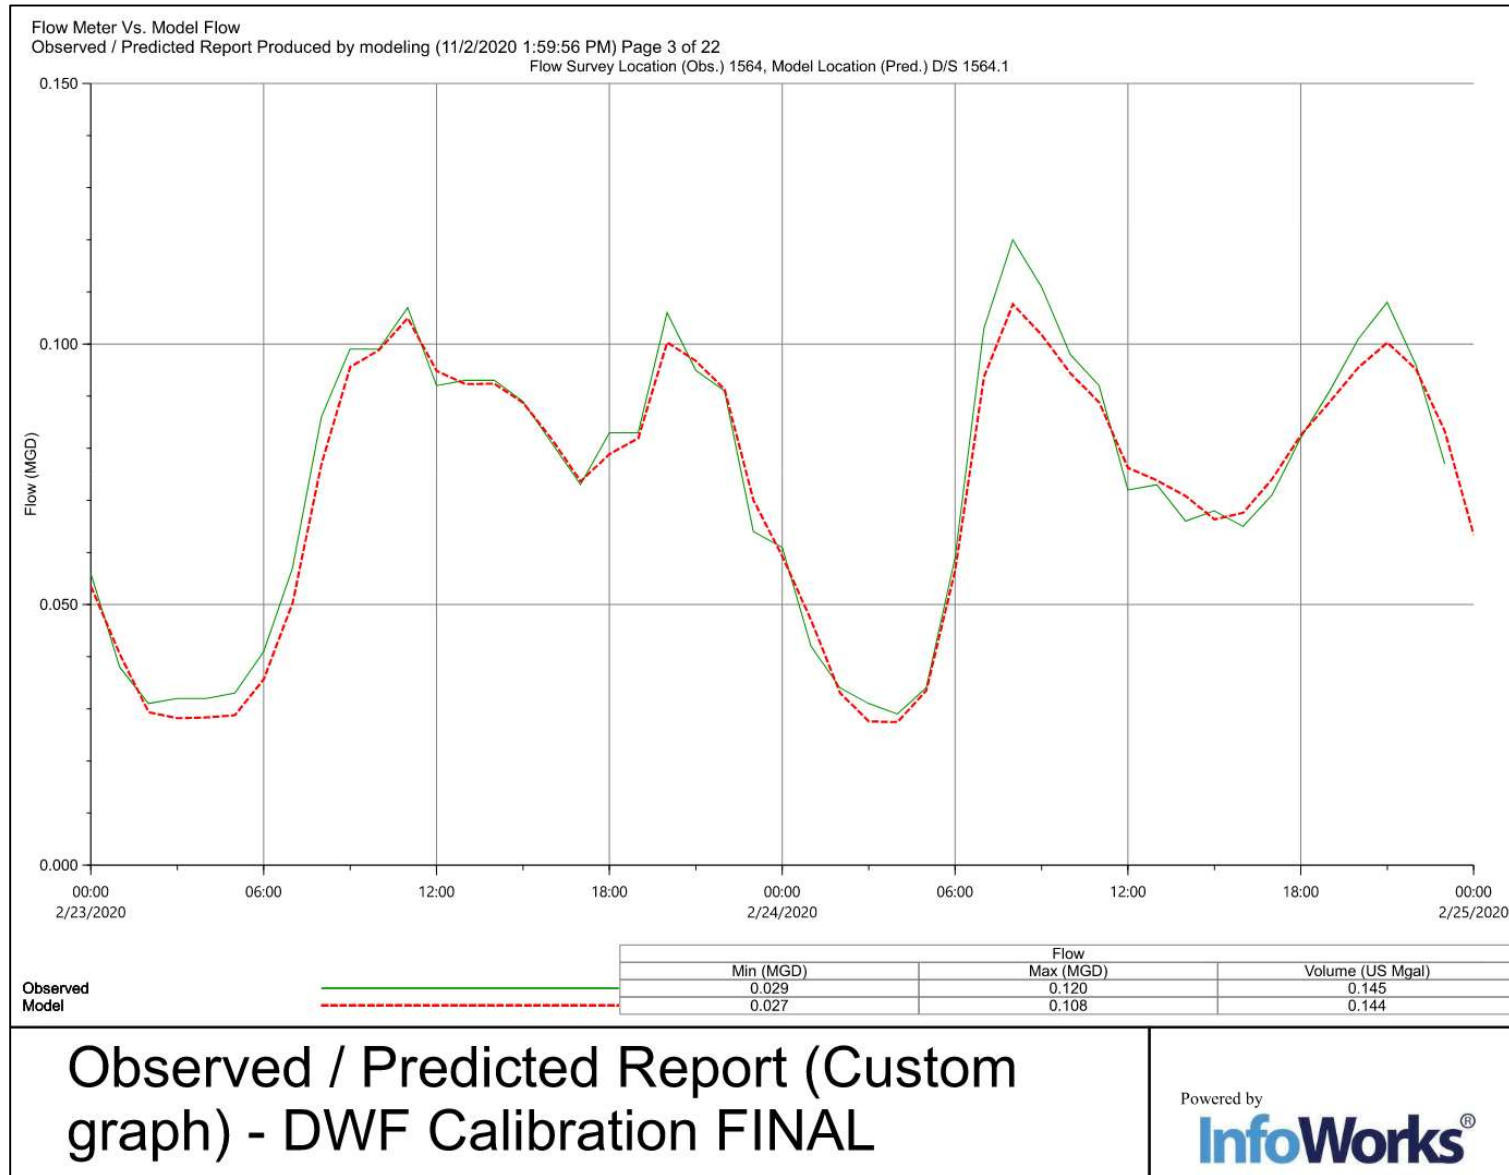
Figure 7-10: Example of Dry Weather Model Calibration Charts

Figure 7-10 presents a comparison between modeled and observed dry weather weekday flows. For the overall system, modeled flows are 3.4% higher than the observed flows on an average dry weekday and are within 10% (higher) of the measured flows on the average dry weekend. A calibration within 5% is considered a good representation of actual conditions and having modeled flows higher than measured flows assures that the model is conservative in its representation of the collection system.

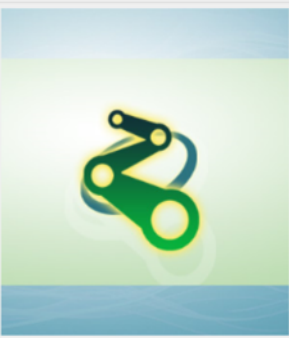
Figure 3-6: IAP LOF/COF Setup Example - Diameter (1 of 2)

Consequence of Failure Wizard (Gravity Main - "Diameter")

produces a holistic risk score for each pipe GIS asset. Screenshots of IAP modules can be found in Figures 3-6 to 3-8.

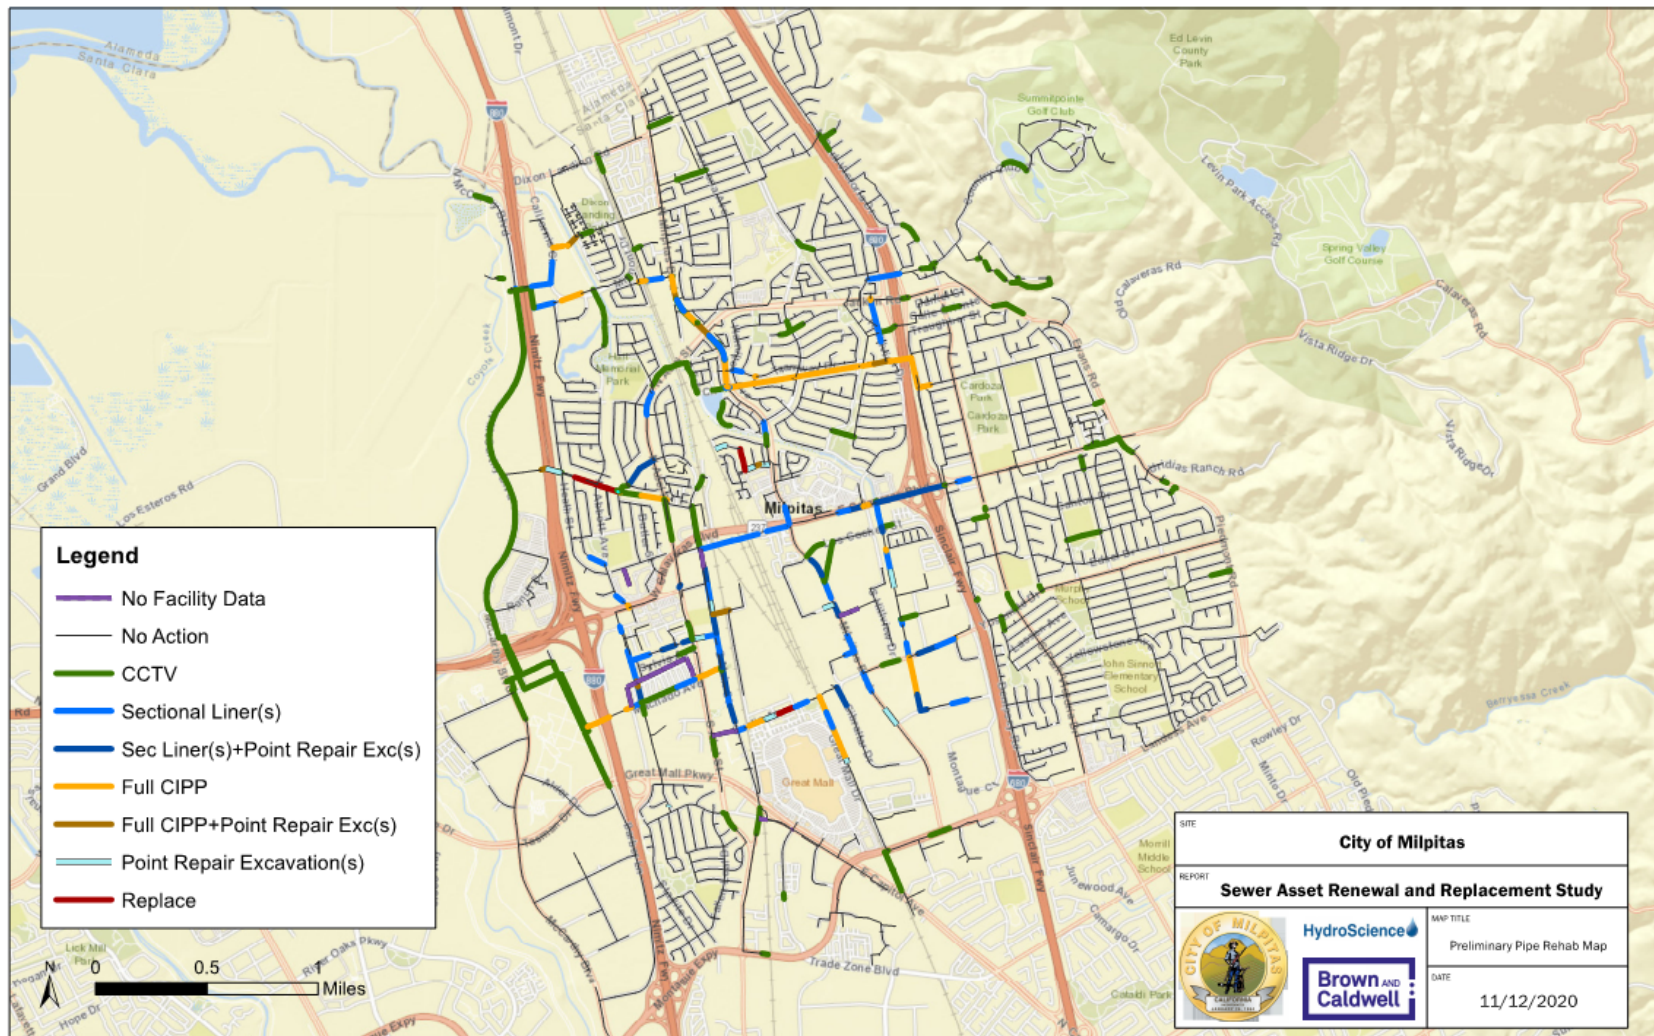
Figure 4-4: Preliminary Pipe Rehabilitation Recommendations Map

Figure 4-4 provides the sewer main pipeline rehabilitation recommendations. The capital improvement program (CIP) recommendations for each asset is also included in GIS and tabular format in Appendix A. Note that these recommendations are subject to change depending on future discussions with operational staff prefers to determine rehabilitation preferences of the various levels and types of defects. The Class 5 cost estimates are high level (1-2% planning level) and will be refined as project scopes are further defined. Detailed cost estimates are recommended when further CIP budgeting and planning takes place.

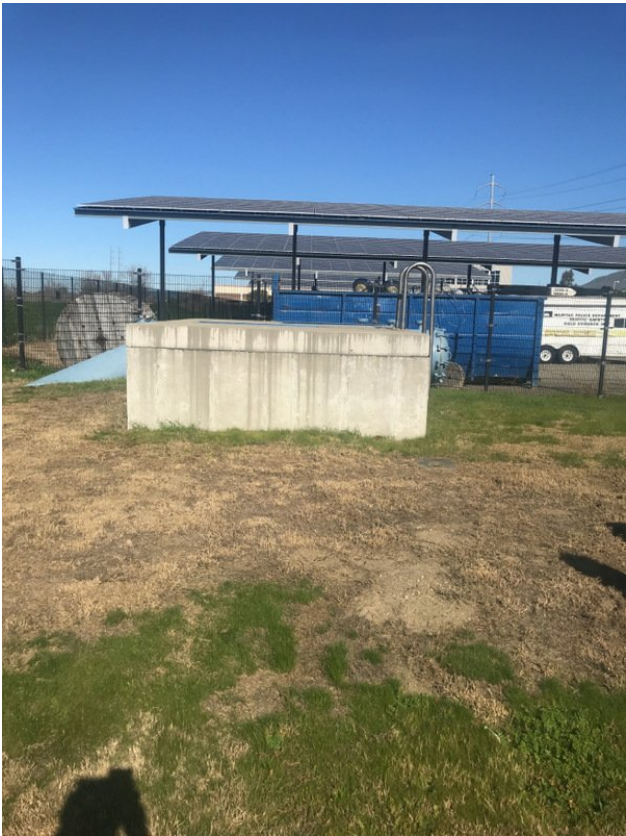
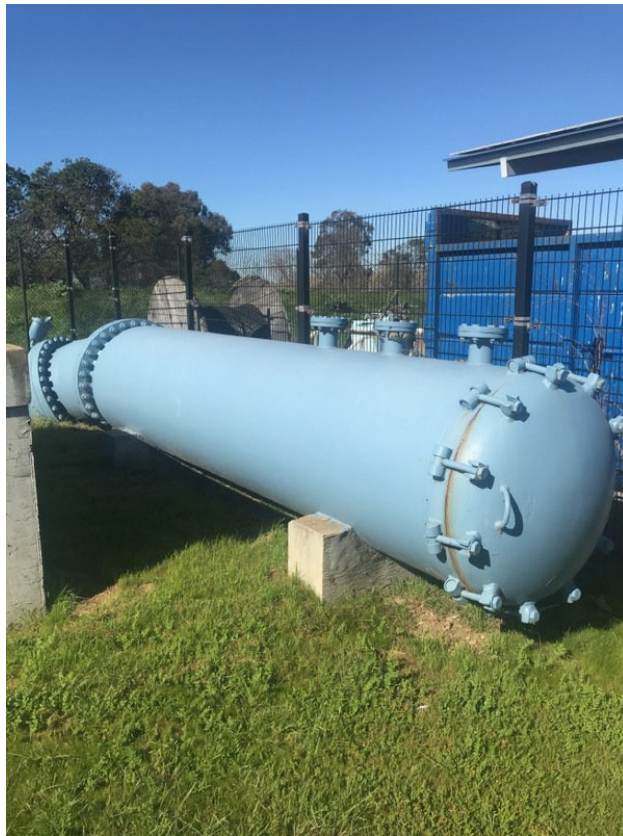
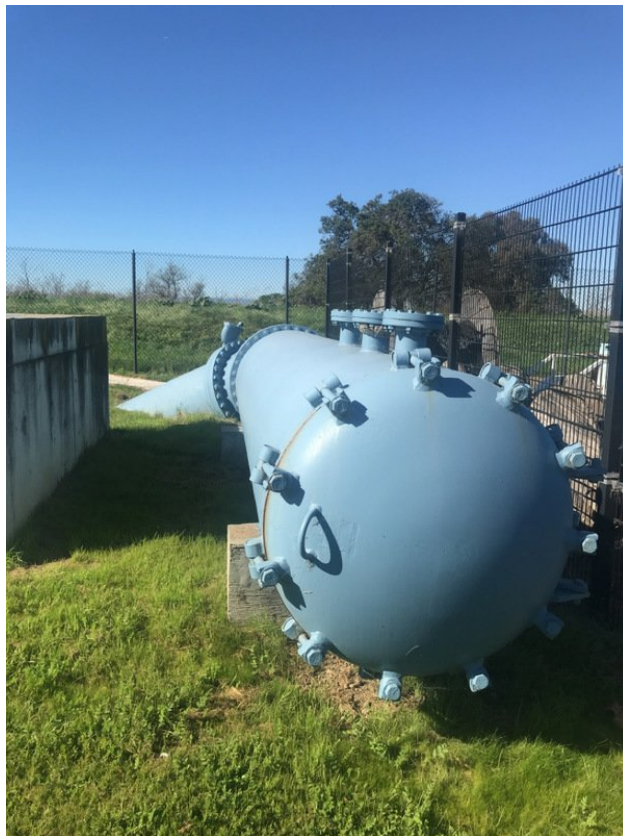
Mechanical Observation Comments

Has never been used

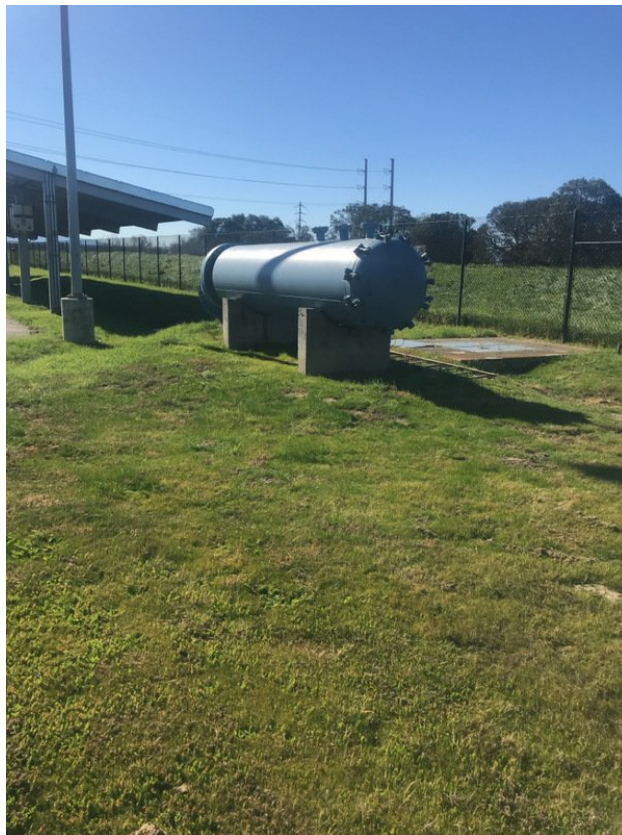
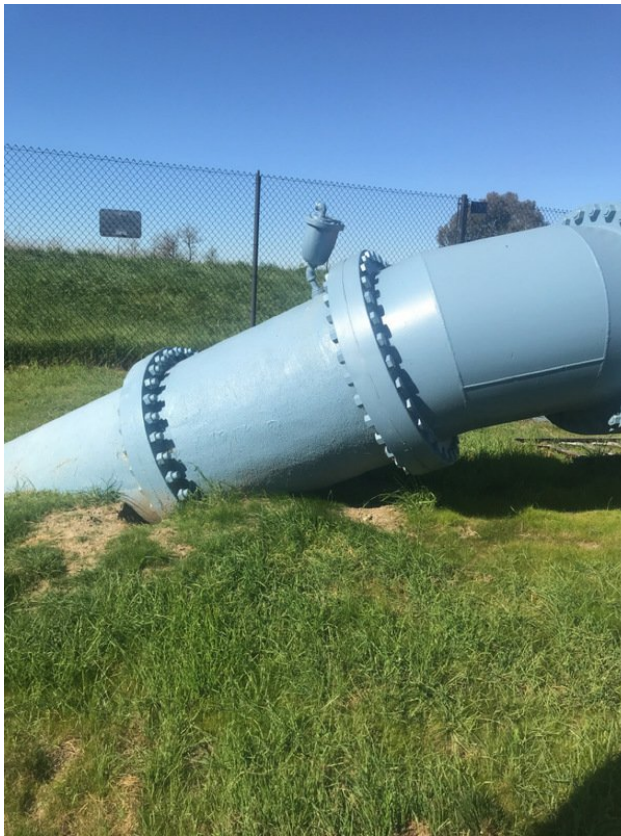
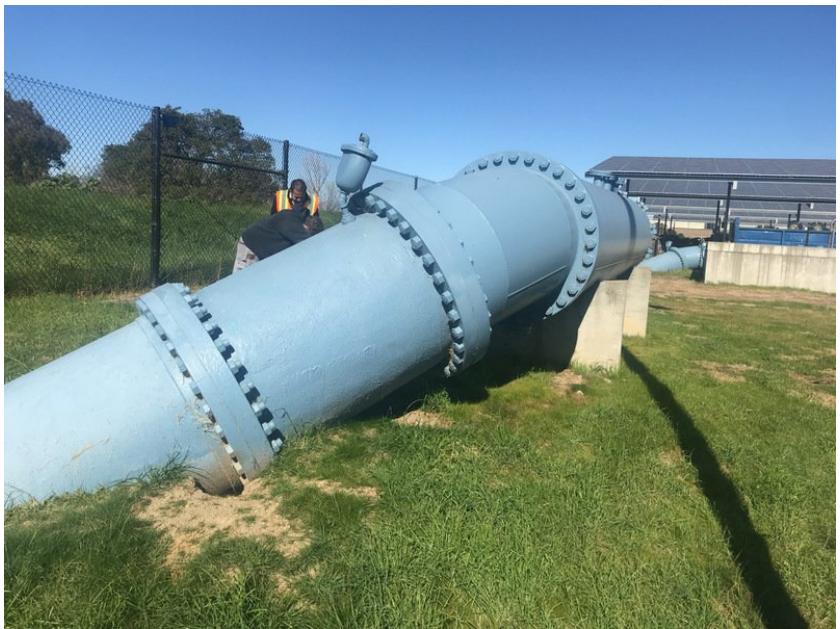
| Mechanical Observation Comments | Never been used |

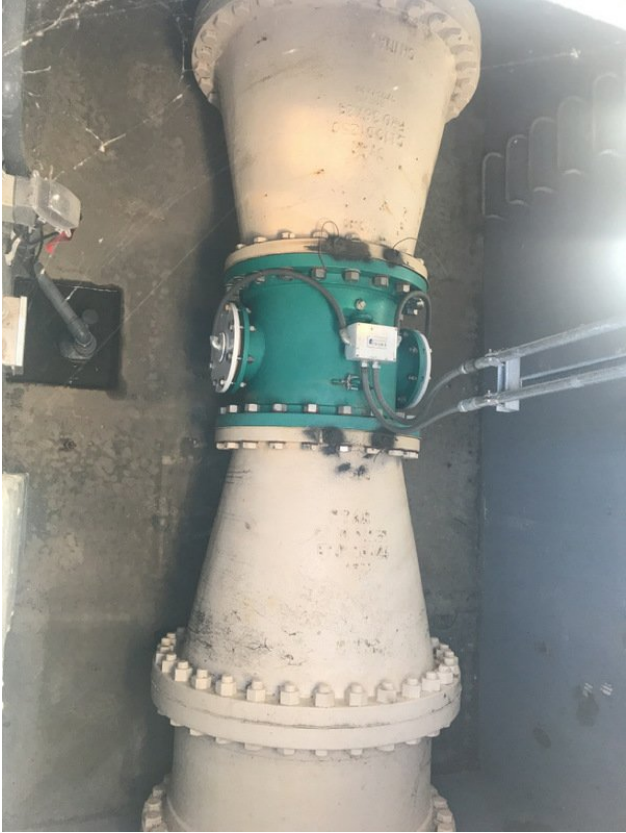
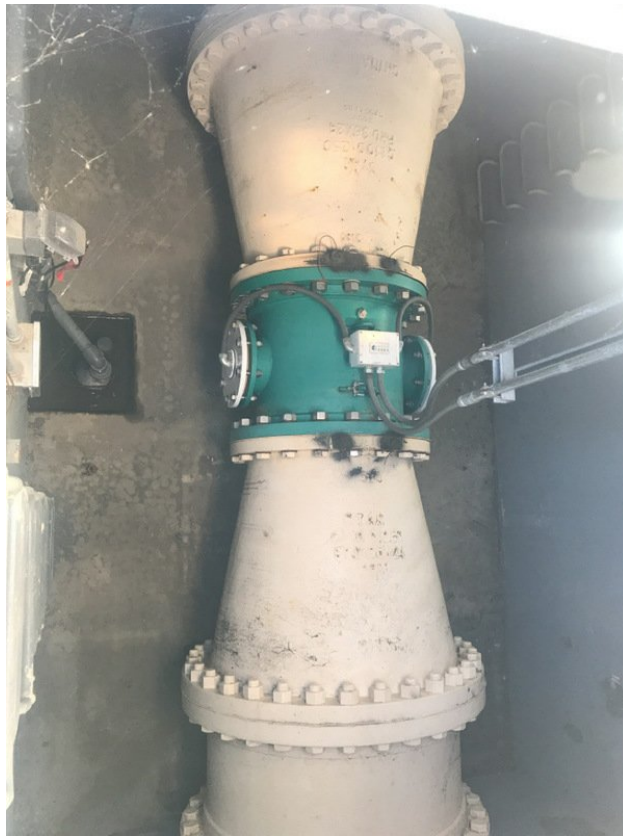
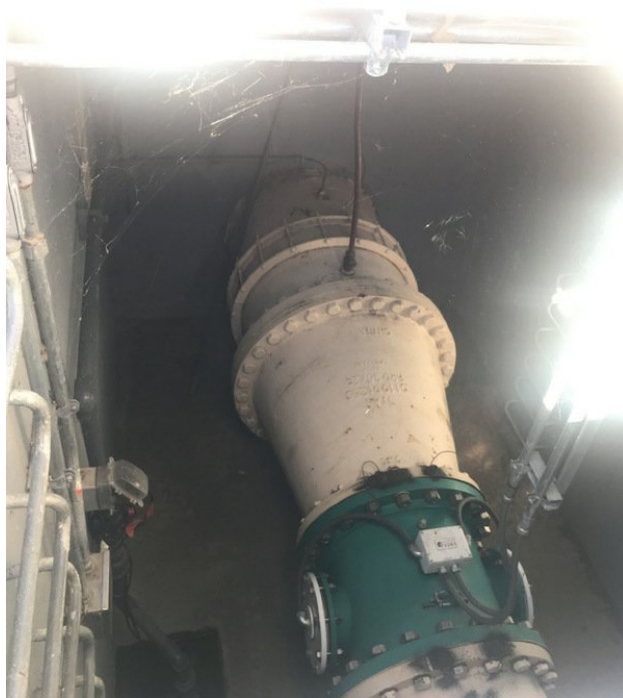
| Mechanical Field Assessment | Not in Operation |

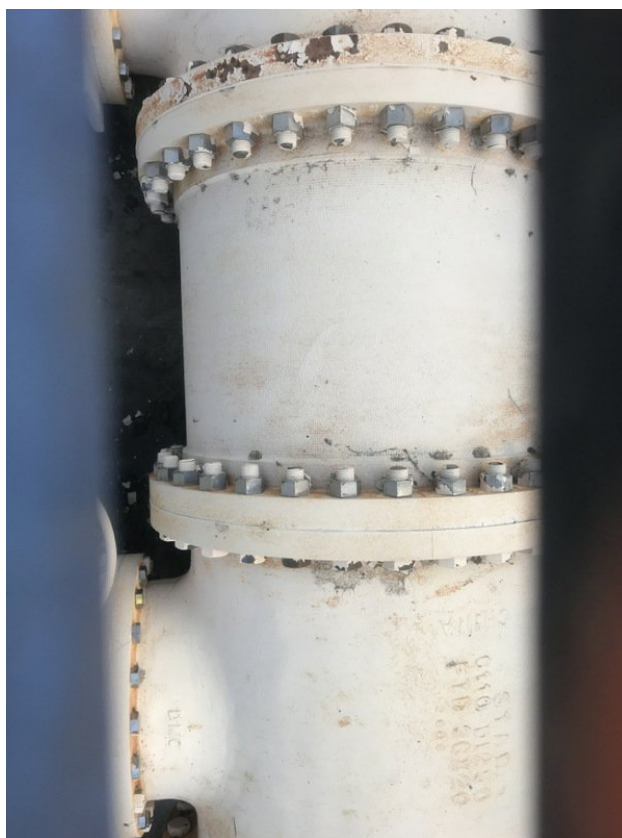
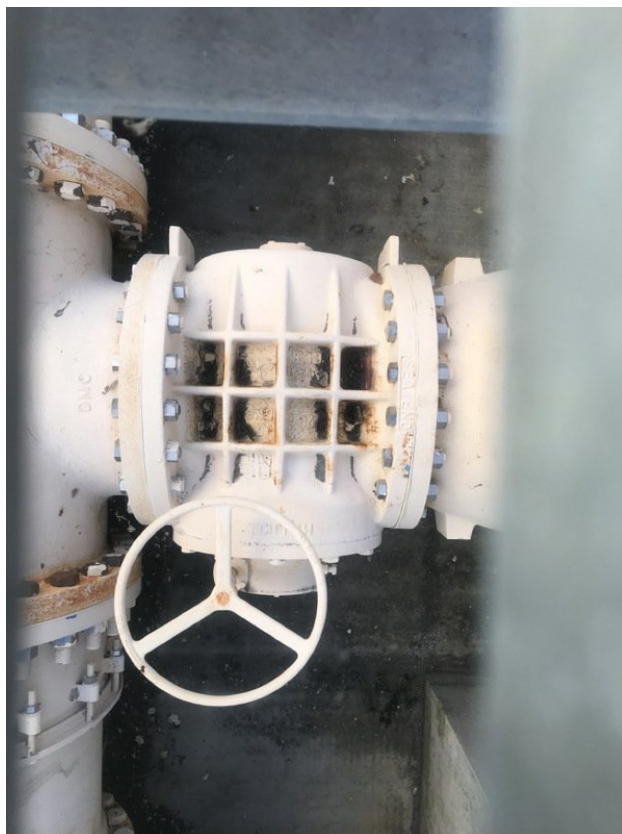
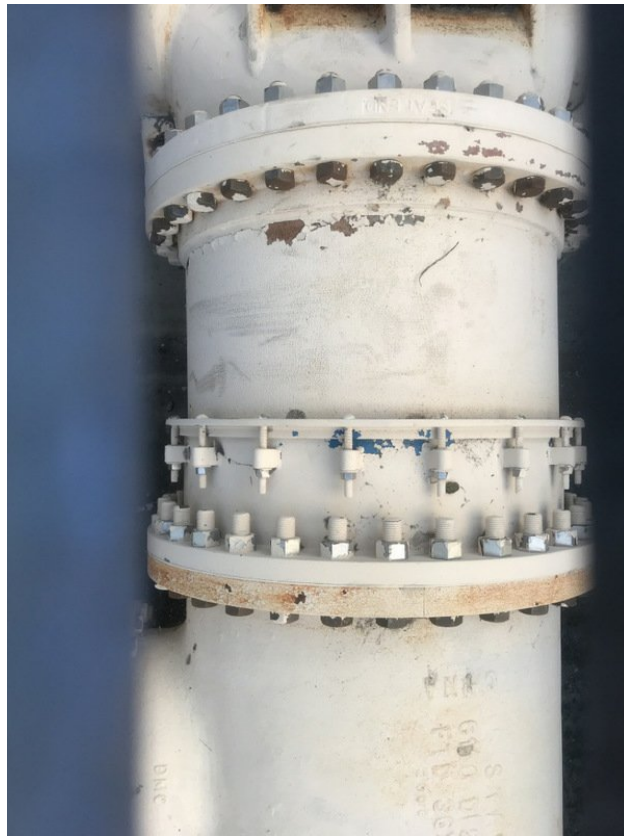
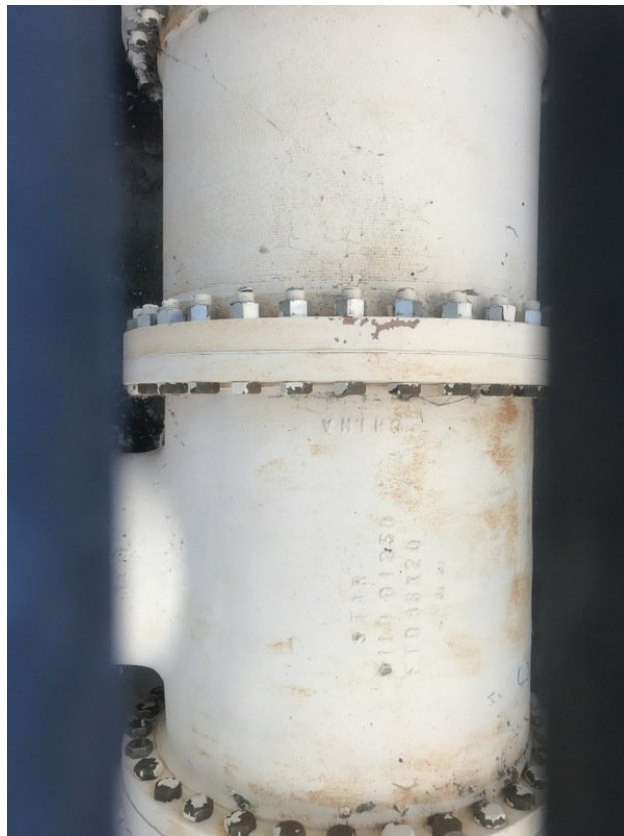
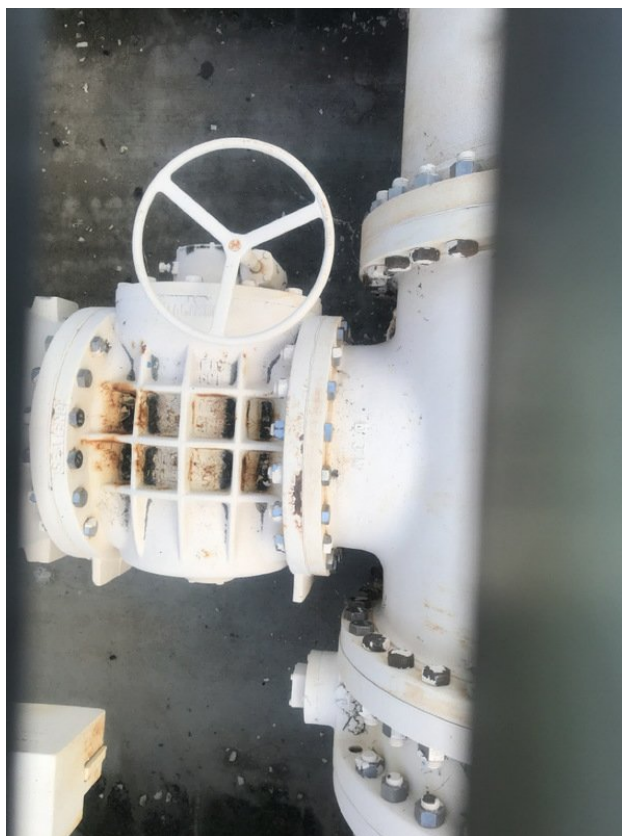
Blistered

| Mechanical Observation Comments | According to staff, the pipes operate well. |

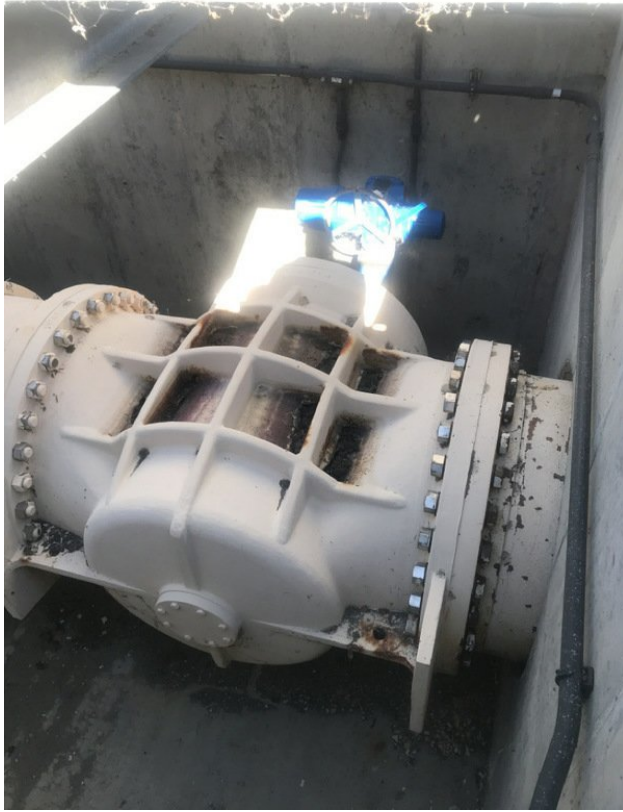
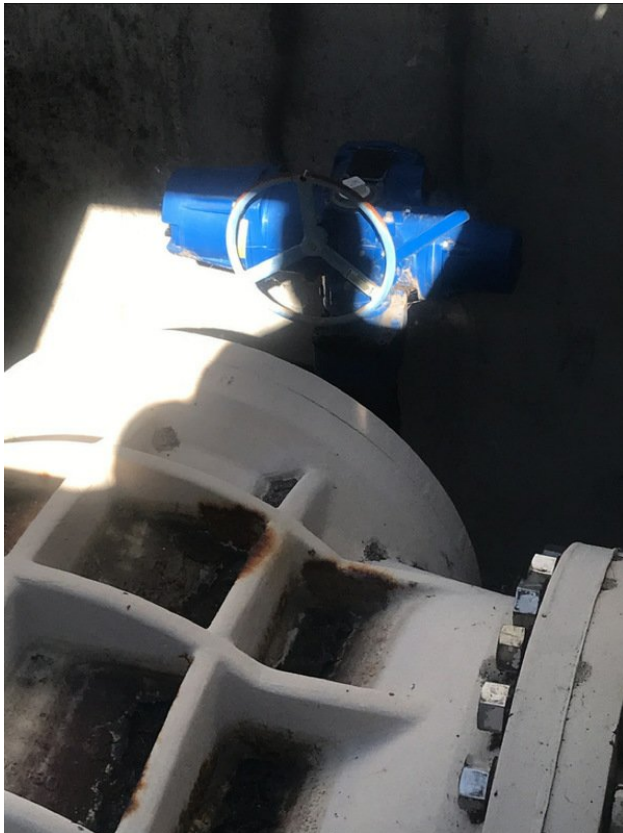
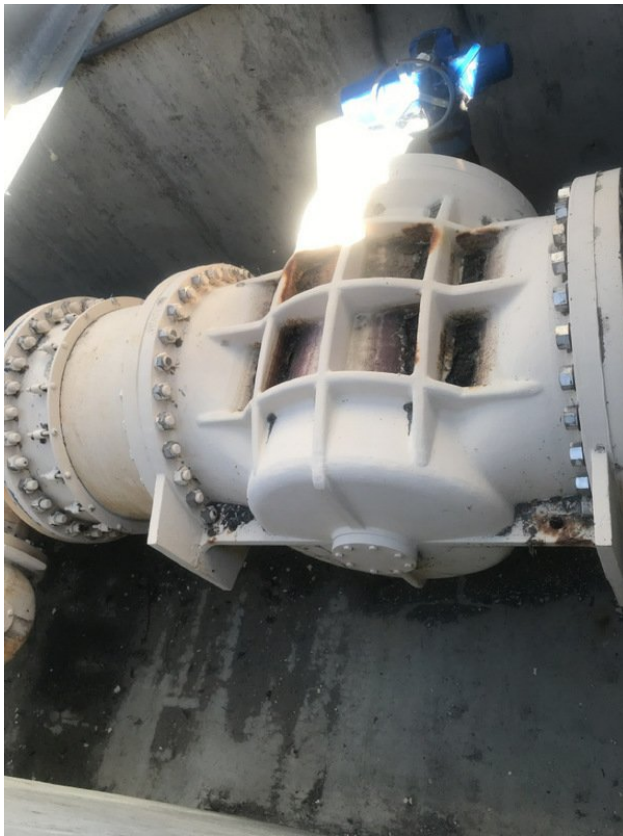
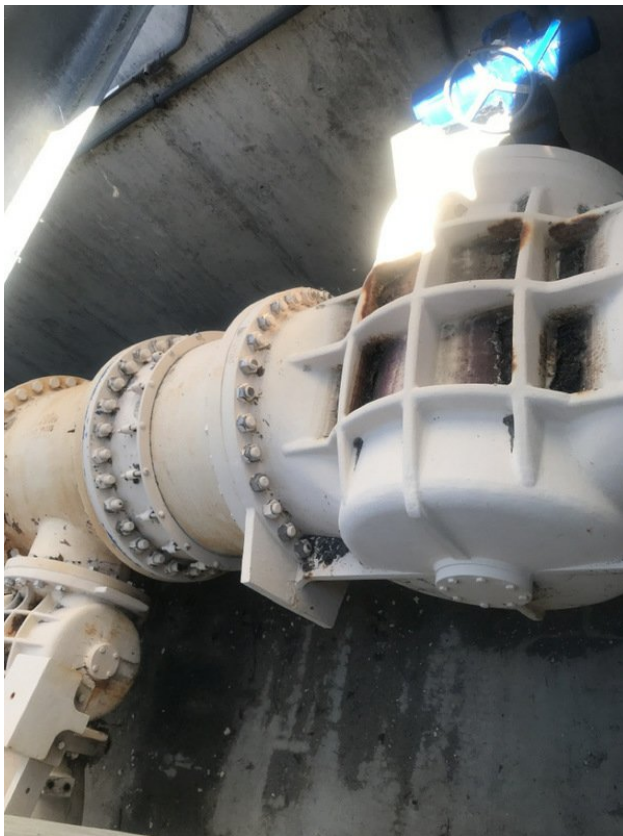
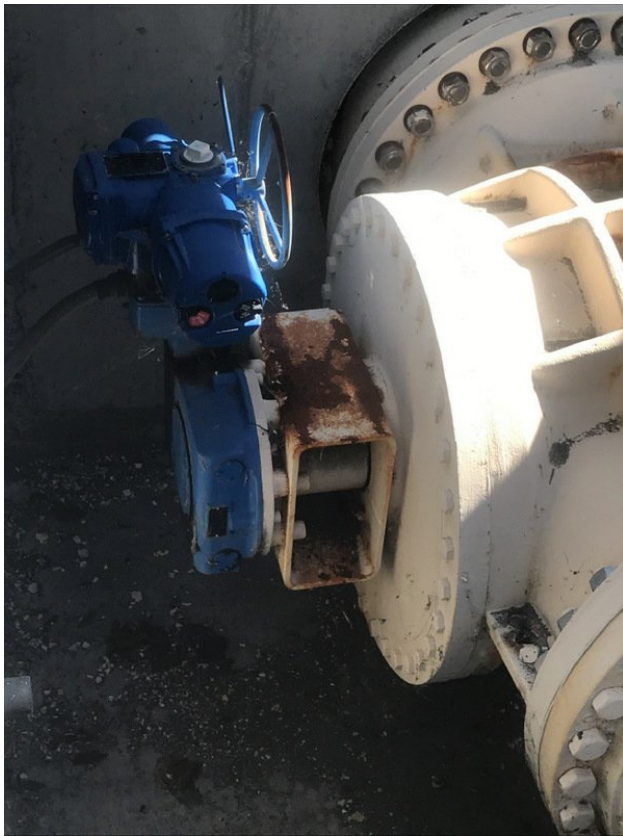
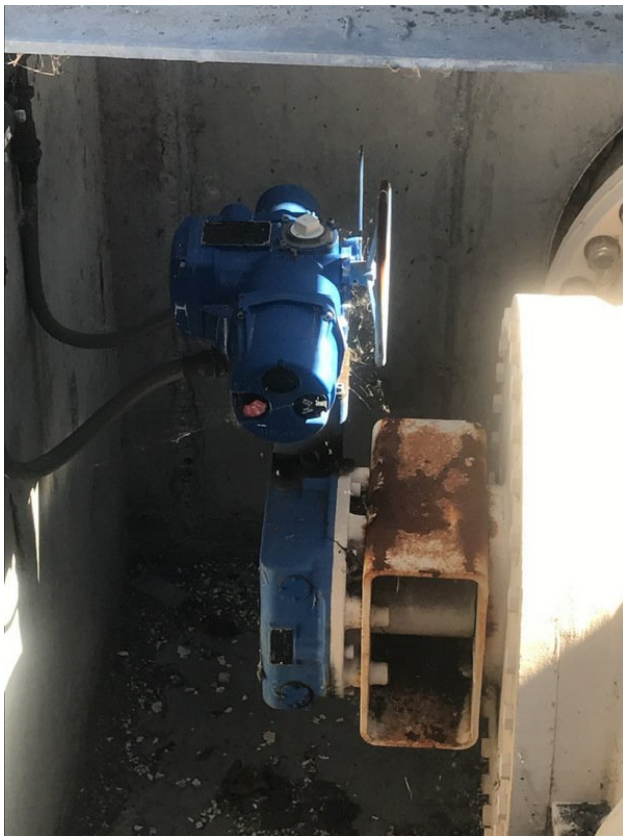
| Mechanical Observation Comments | operator has never used this. The operator dont know if the actuator works. |

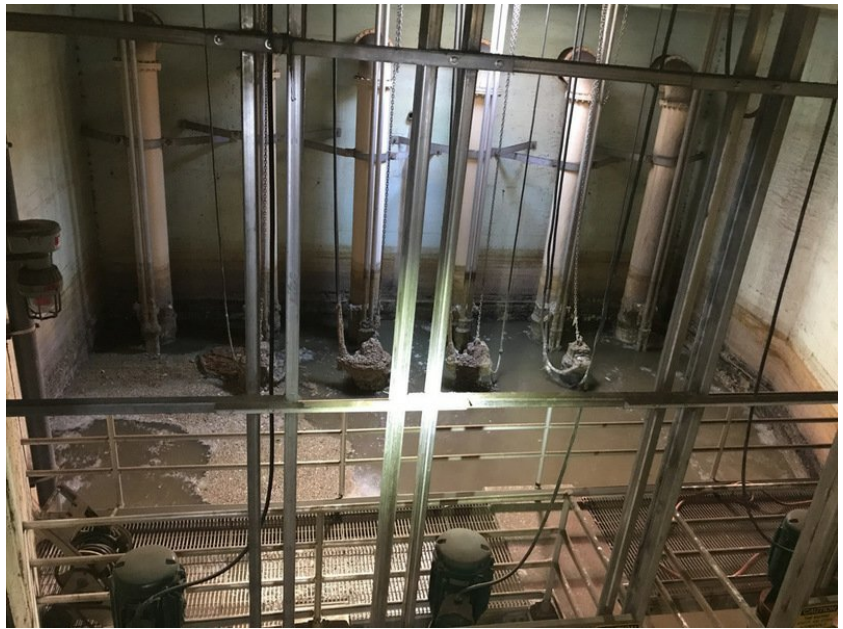
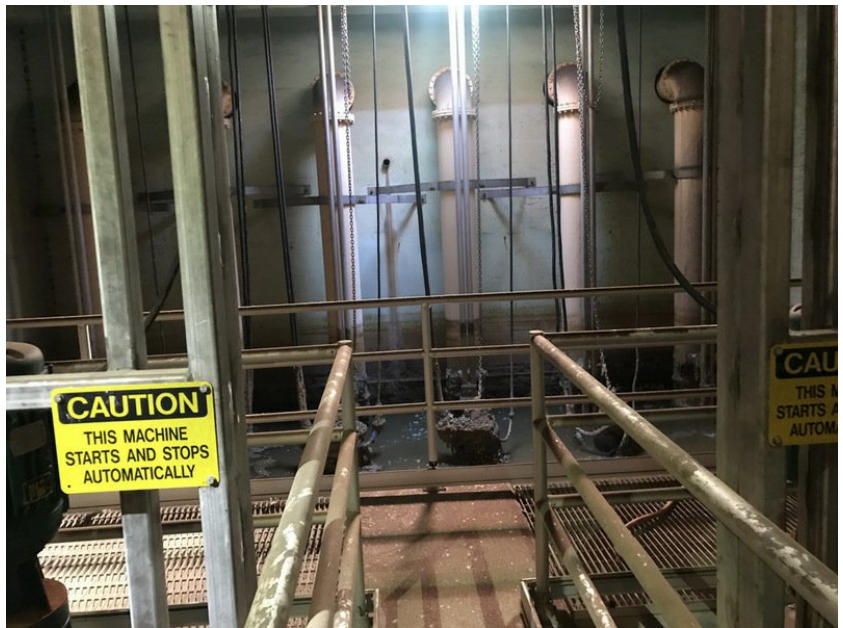
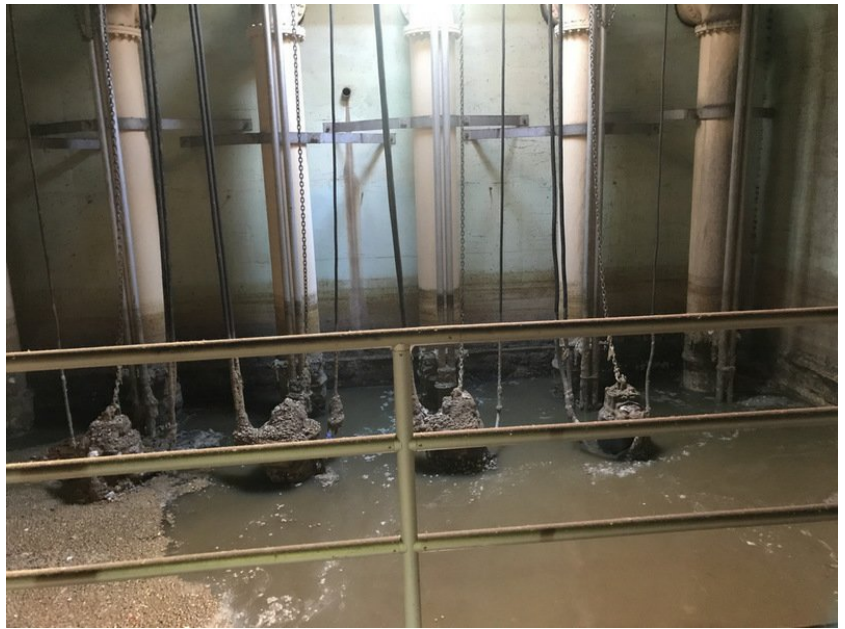
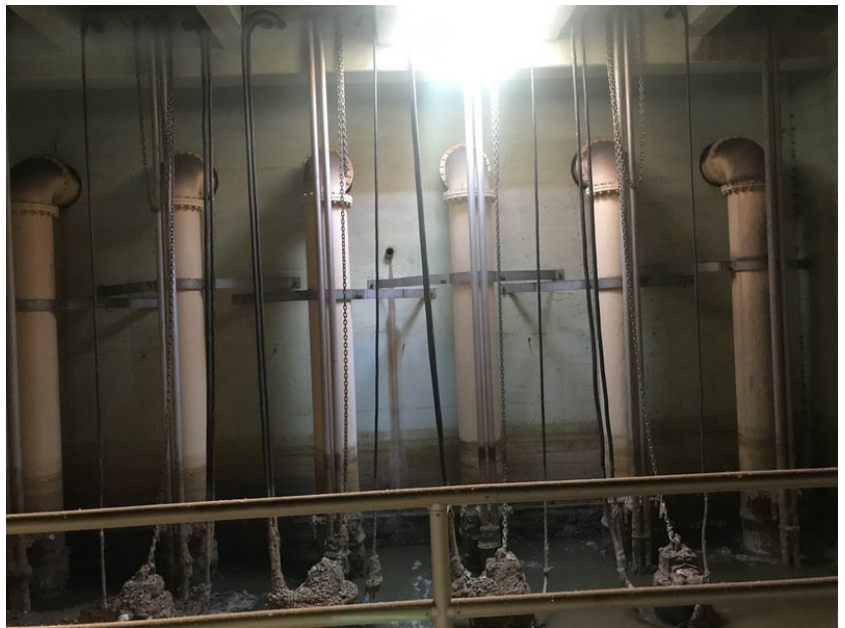
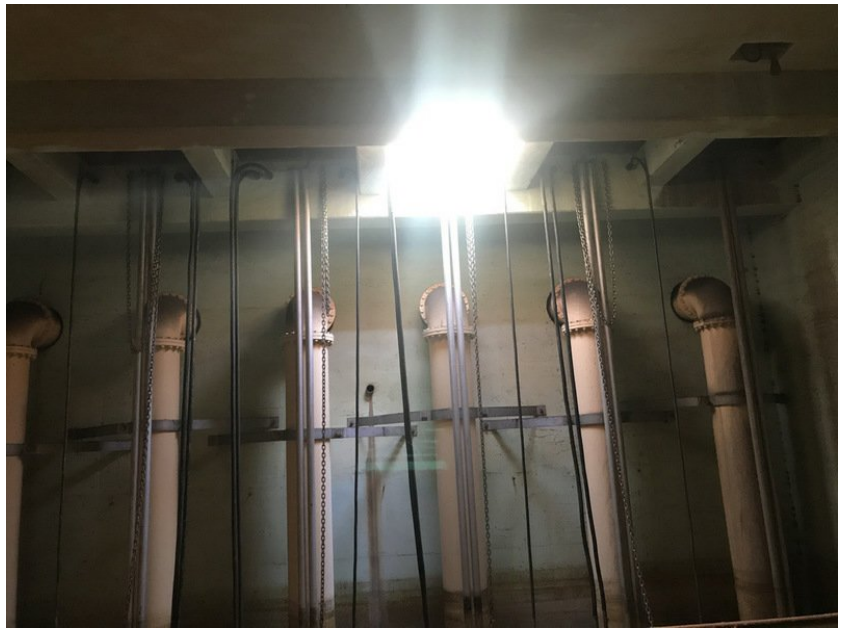
| Mechanical Observation Comments | Rebuilt 1.5 years ago |

| Mechanical Condition Score | 1 - Good – No defects observed. |

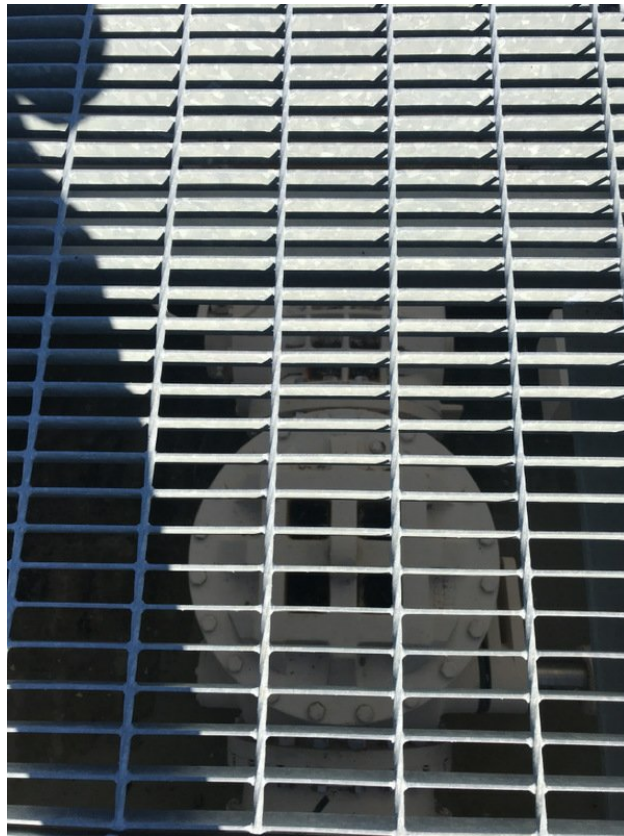
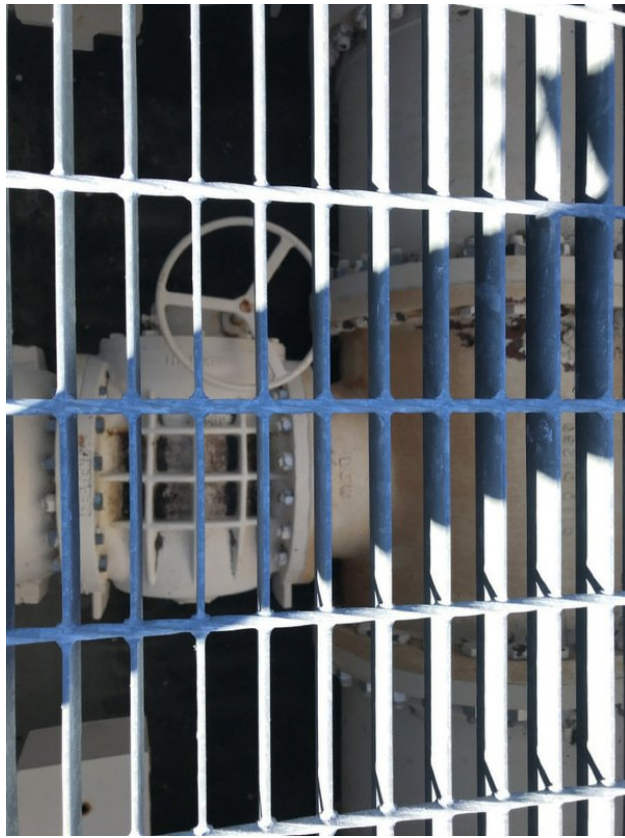
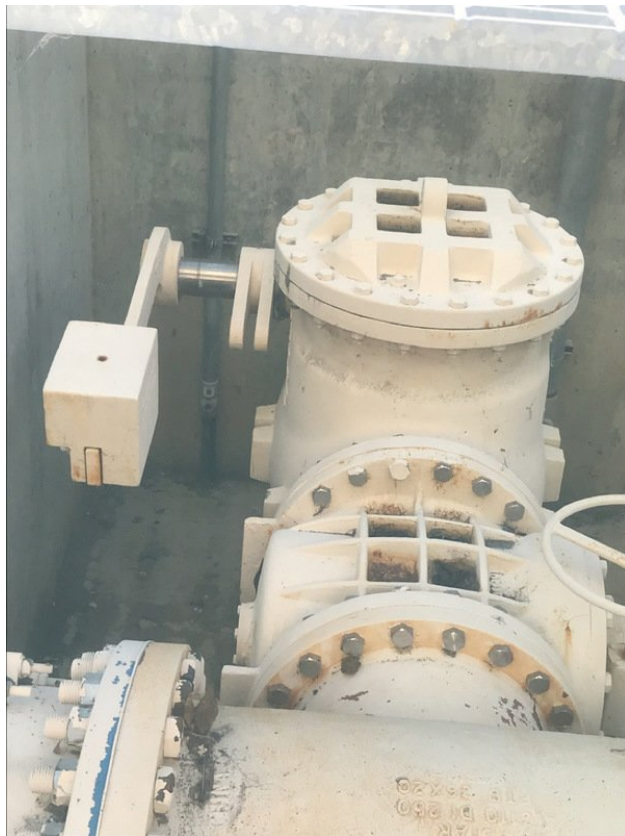
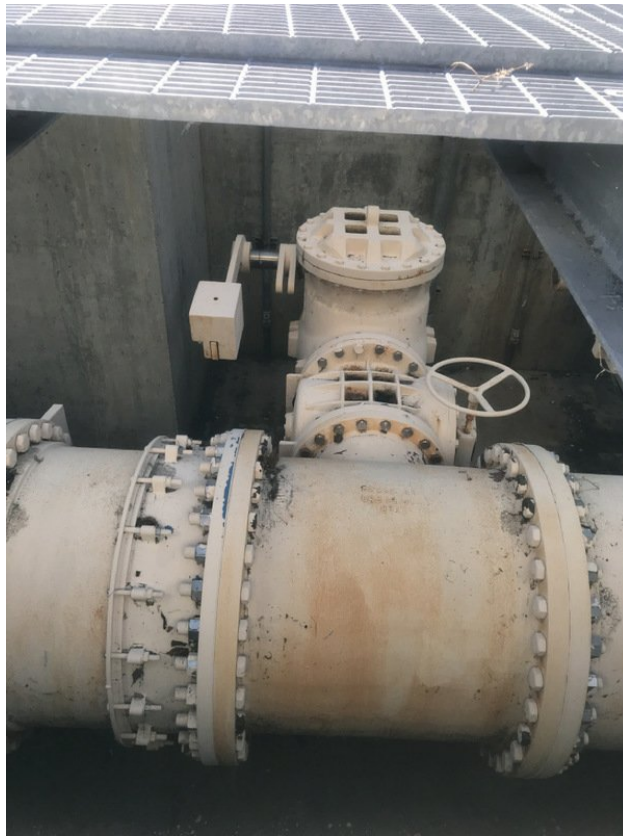
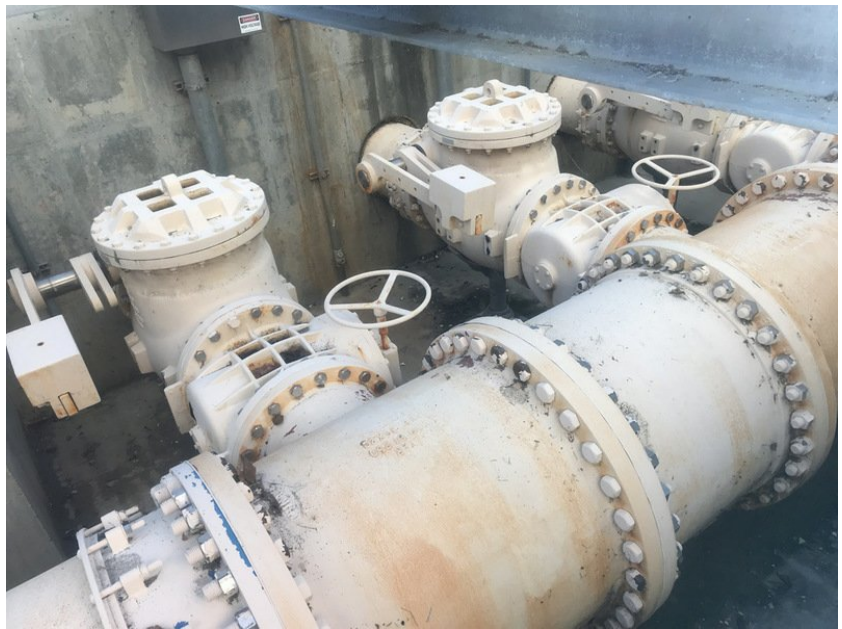
Mechanical Equipment Photos

| Mechanical Observation Comments | None |

| Mechanical Condition Score | 2 - Fair – Only minor defects observed. |

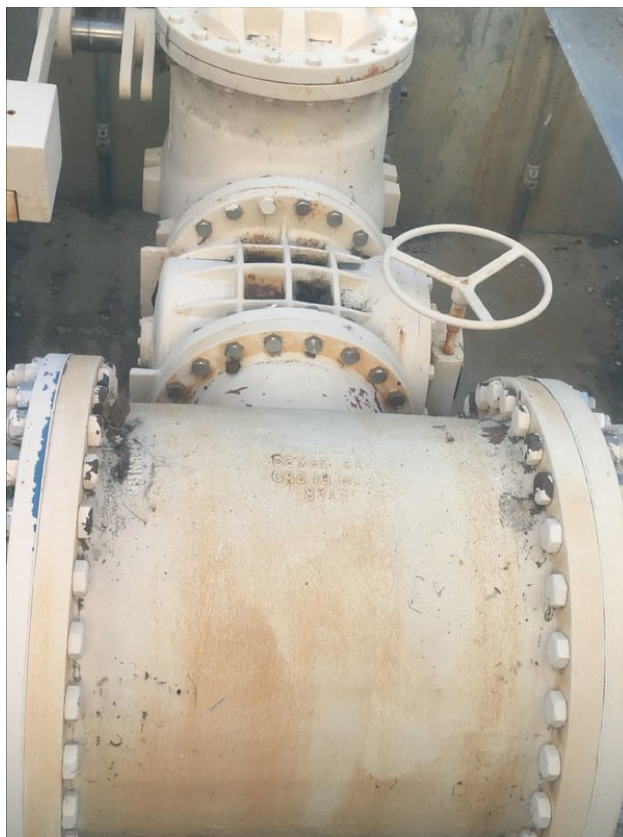
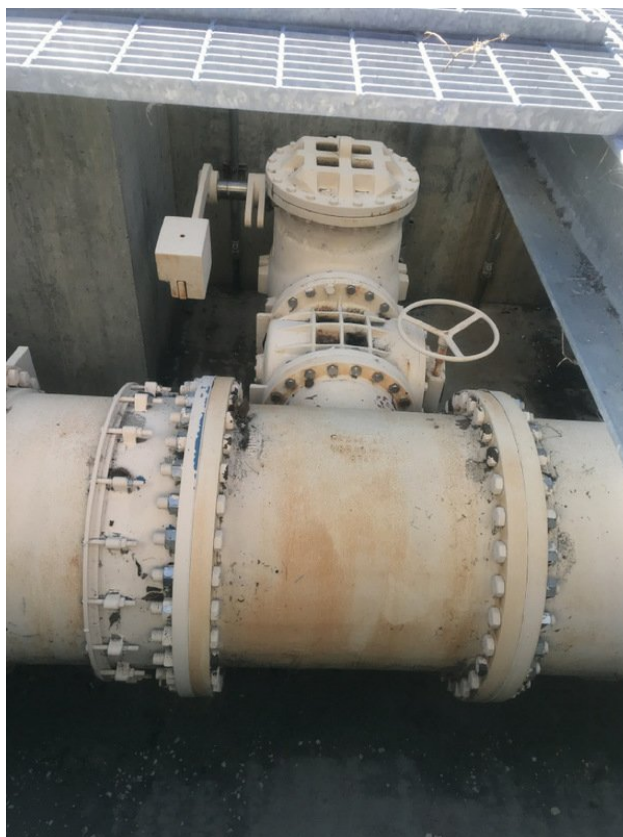
Mechanical Equipment Photos

Mechanical Observation Comments

None

| Mechanical Condition Score | 1 - Good – No defects observed. |

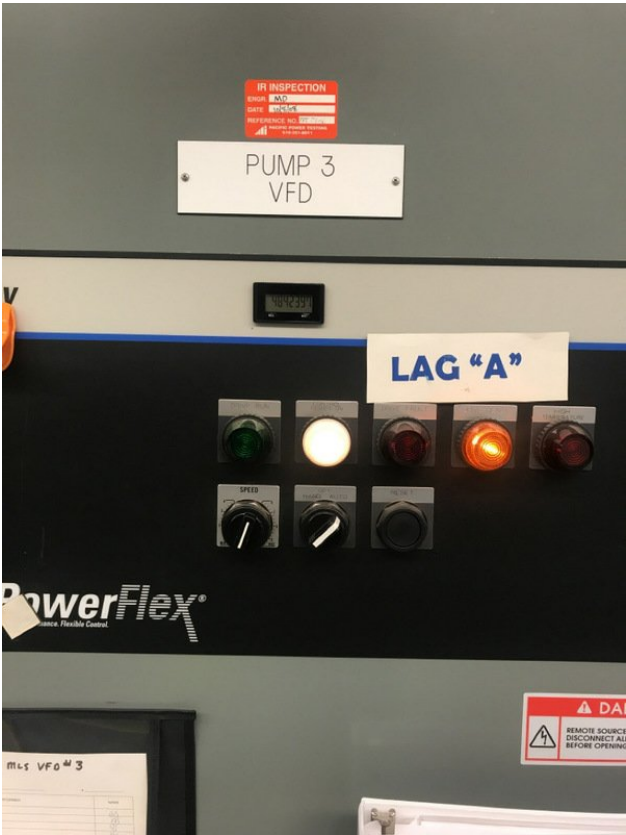
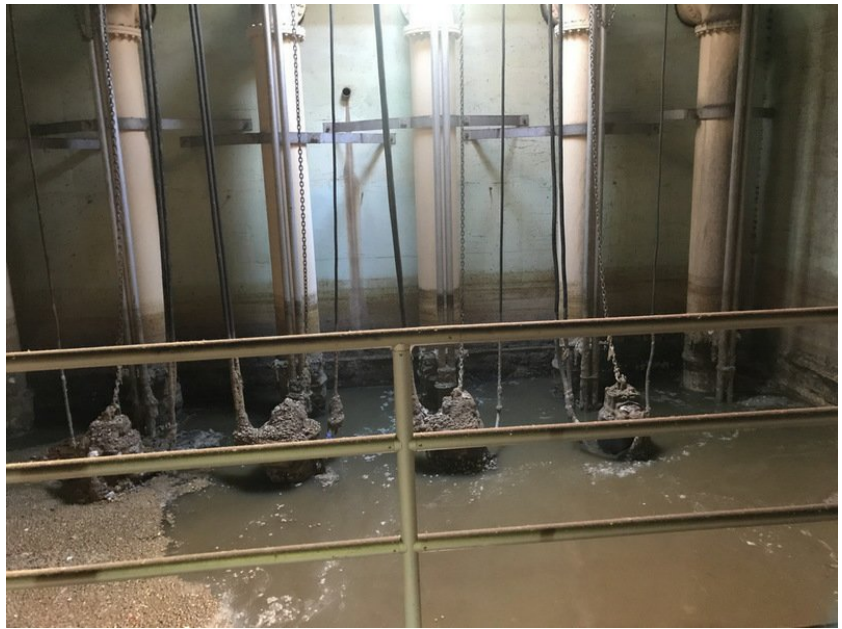
Mechanical Equipment Photos

| Mechanical Field Assessment | passed life limit |

Mechanical Observation Comments

It has 50,000 hours on it. Should be replaced.

Mechanical Condition Score

4 - Poor – Major defects observed. Asset integrity may be compromised.
