City of Milpitas Sewer Master Plan

Sewer Master Plan

Prepared by HydroScience Engineers, Inc.

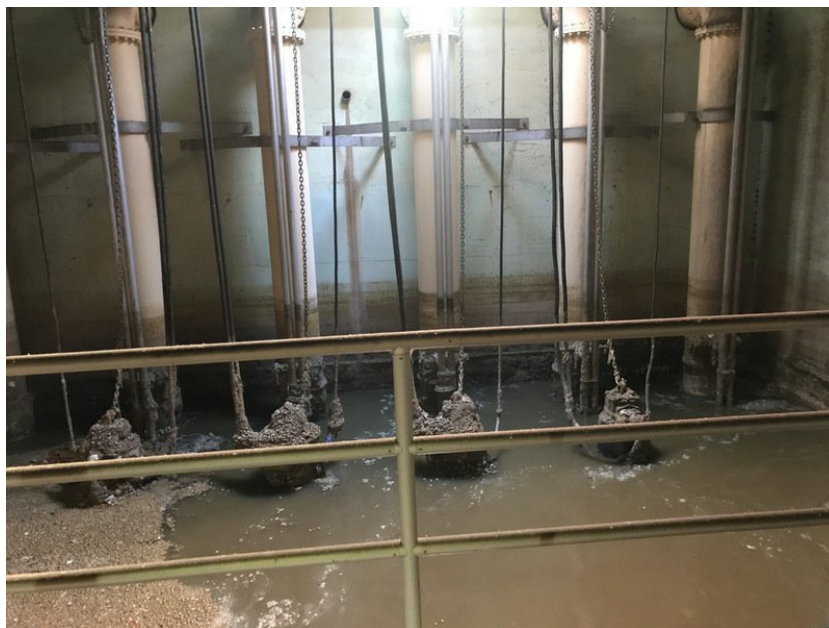
Mechanical Equipment Photos

Mechanical Observation Comments

None

Mechanical Condition Score

2 - Fair – Only minor defects observed.

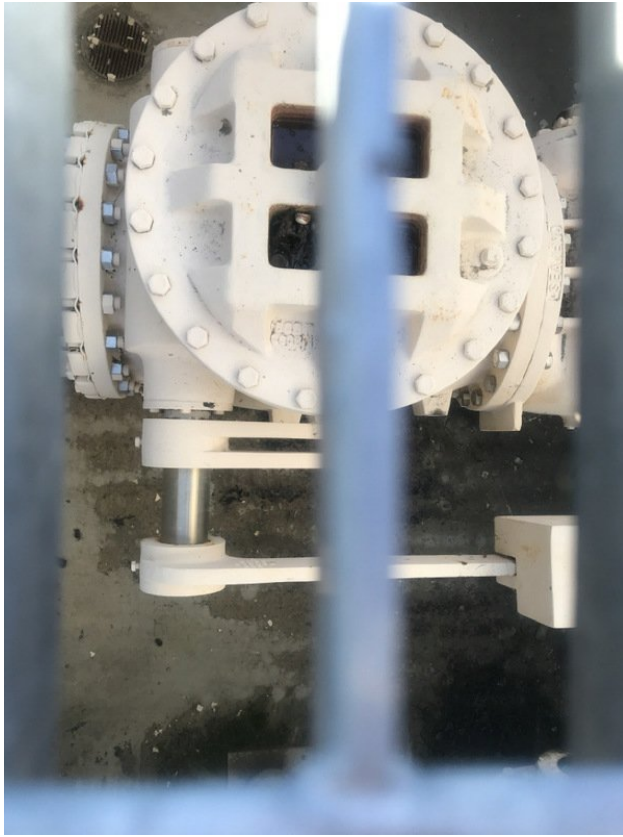
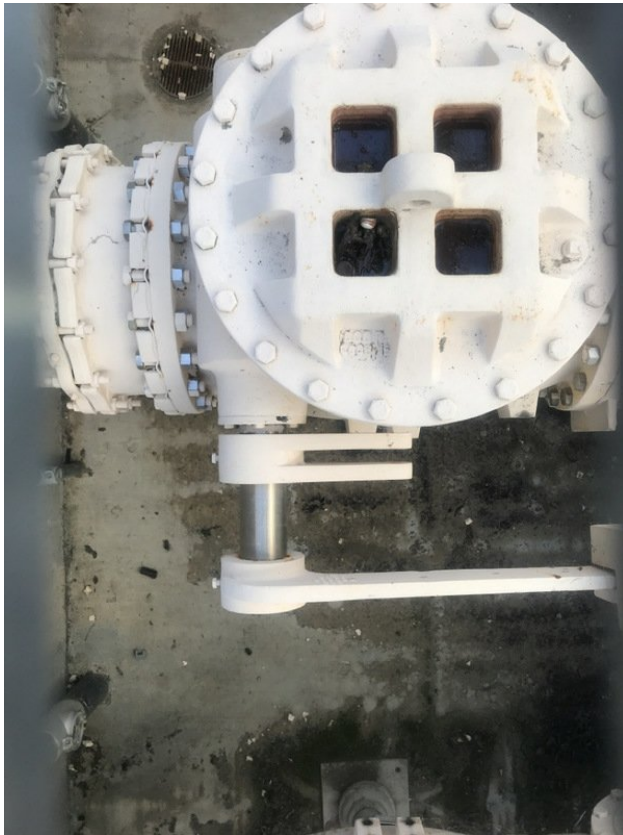
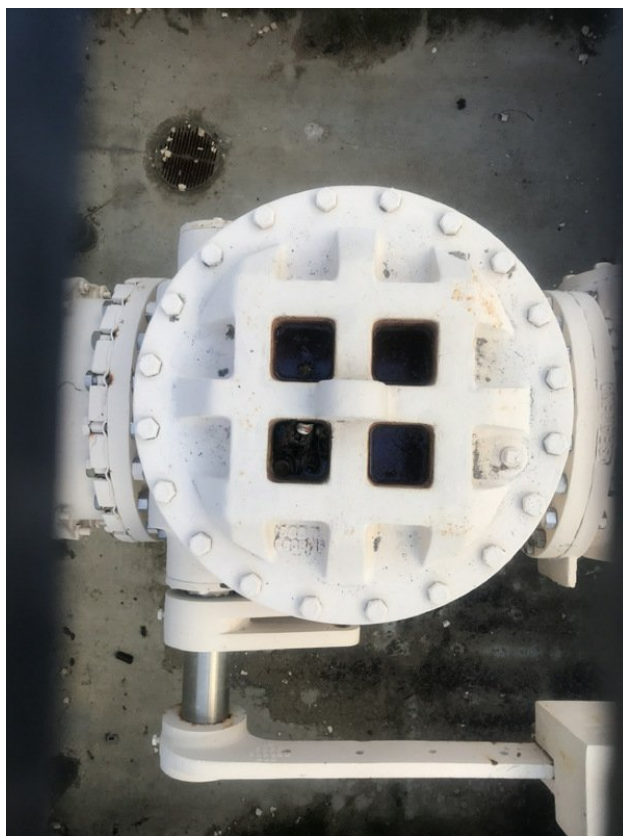
Mechanical Equipment Photos

| Mechanical Observation Comments | None |

| Mechanical Condition Score | 2 - Fair – Only minor defects observed. |

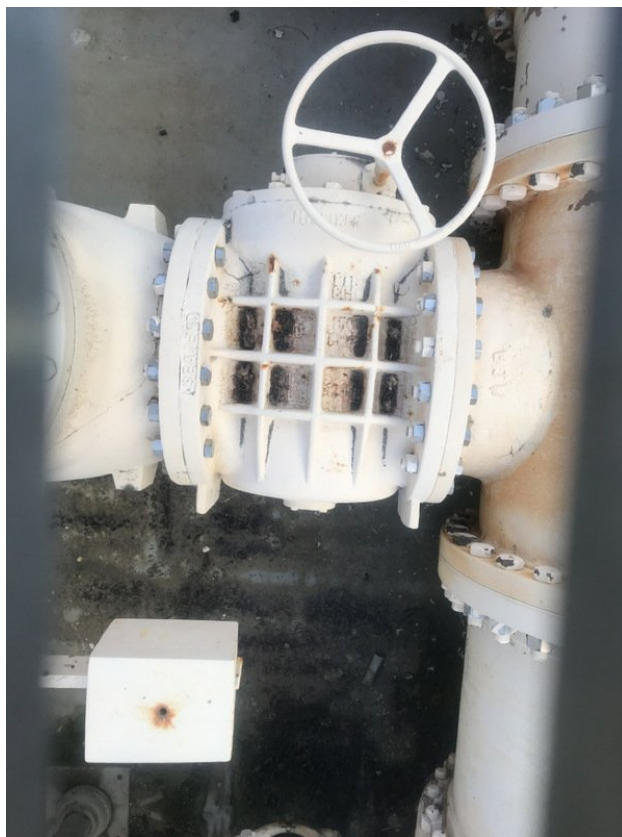
Mechanical Equipment Photos

| Mechanical Observation Comments | None |

| Mechanical Condition Score | 2 - Fair – Only minor defects observed. |

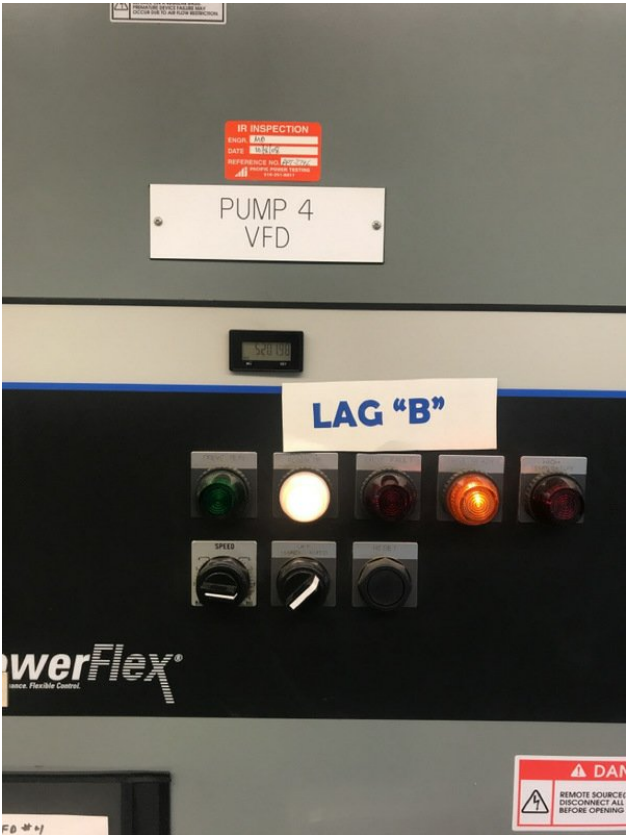
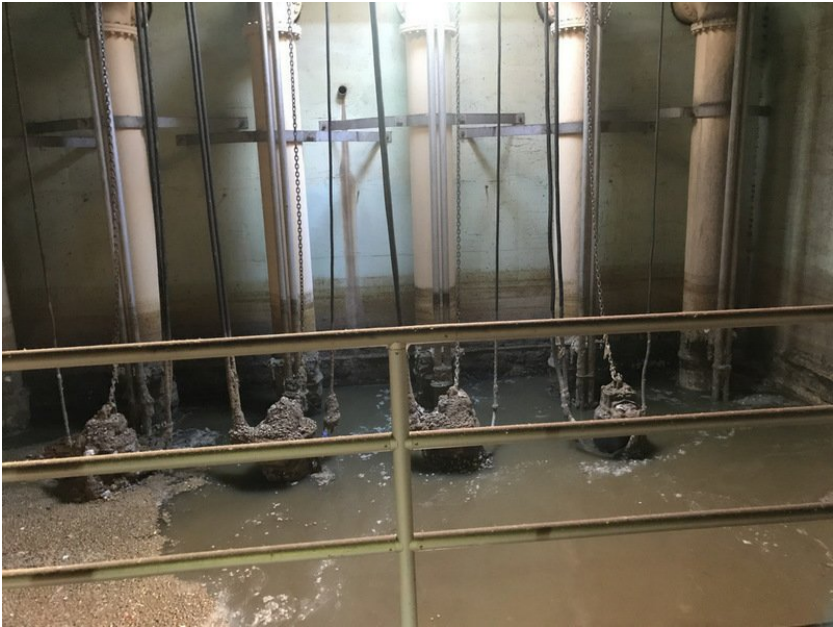
Mechanical Equipment Photos

| Mechanical Observation Comments | None |
| Mechanical Condition Score | 1 - Good – No defects observed. |

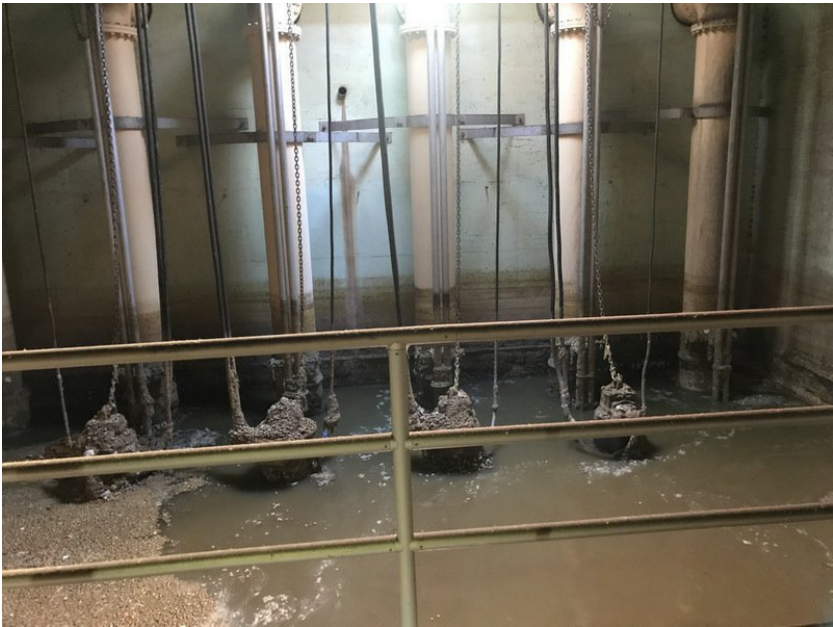
| Mechanical Equipment Photos | |

| Mechanical Observation Comments | None |

| Mechanical Condition Score | 2 - Fair – Only minor defects observed. |

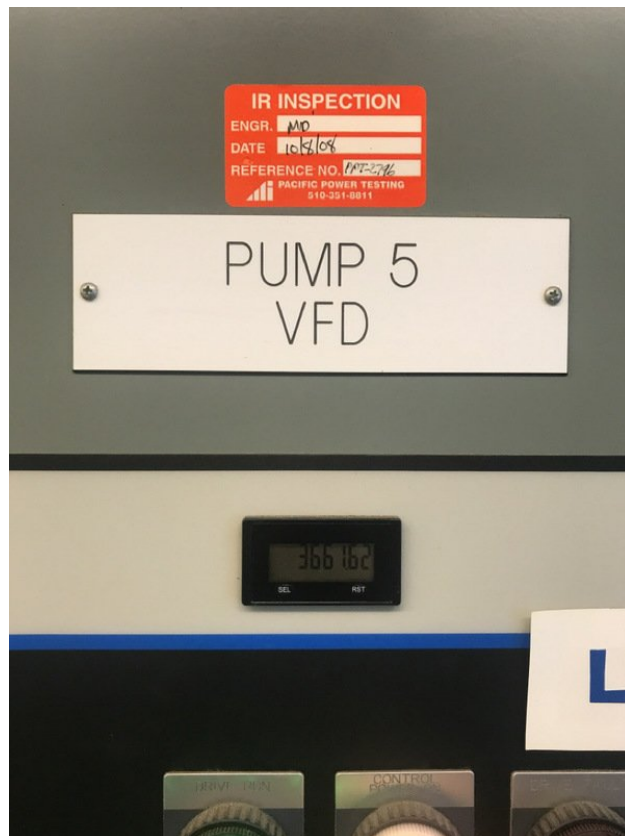
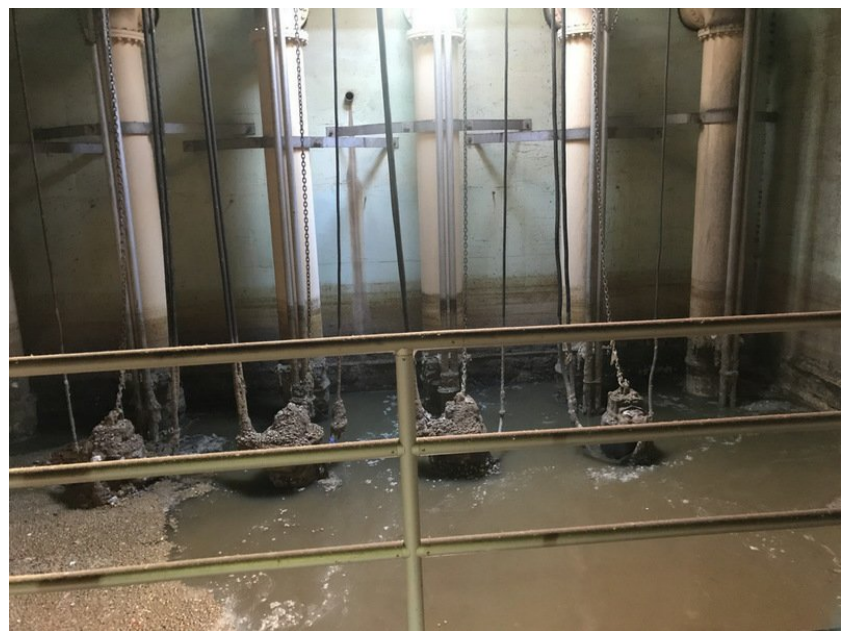
| Mechanical Equipment Photos | |

Mechanical Observation Comments

None

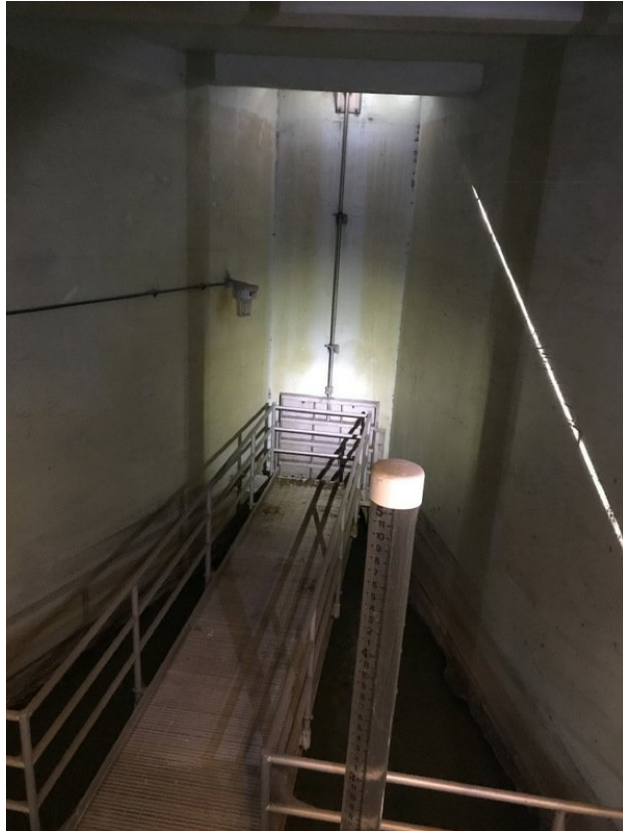
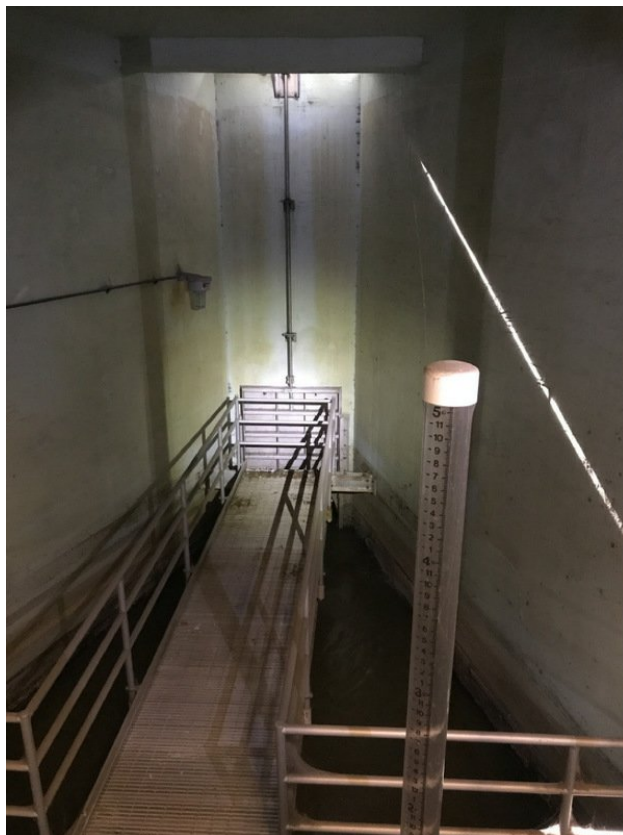
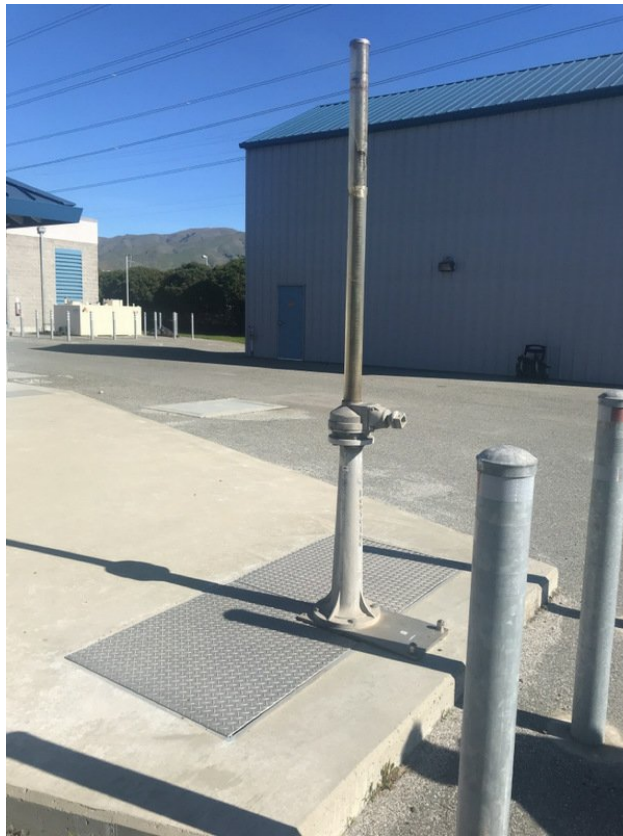
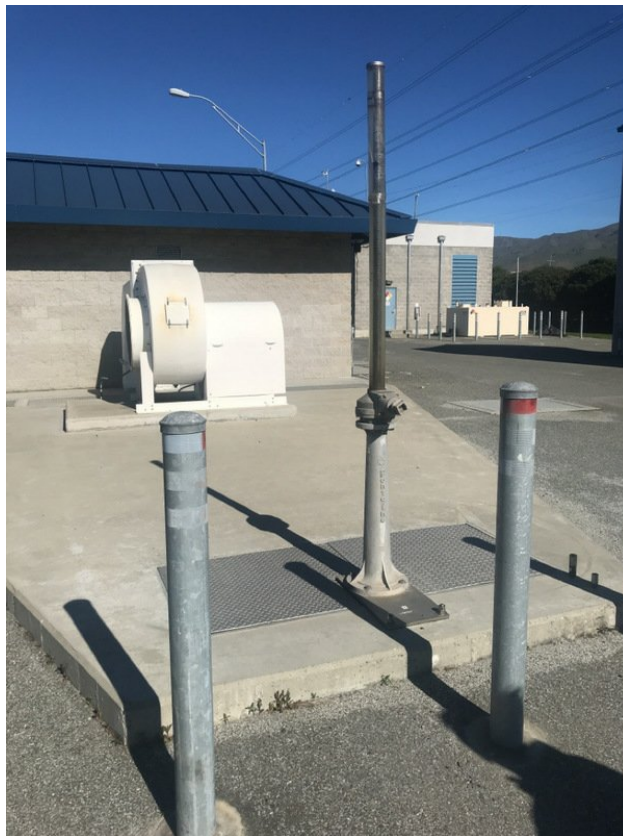
| Mechanical Equipment Photos | |

Mechanical Observation Comments

None

| Mechanical Condition Score | 1 - Good – No defects observed. |

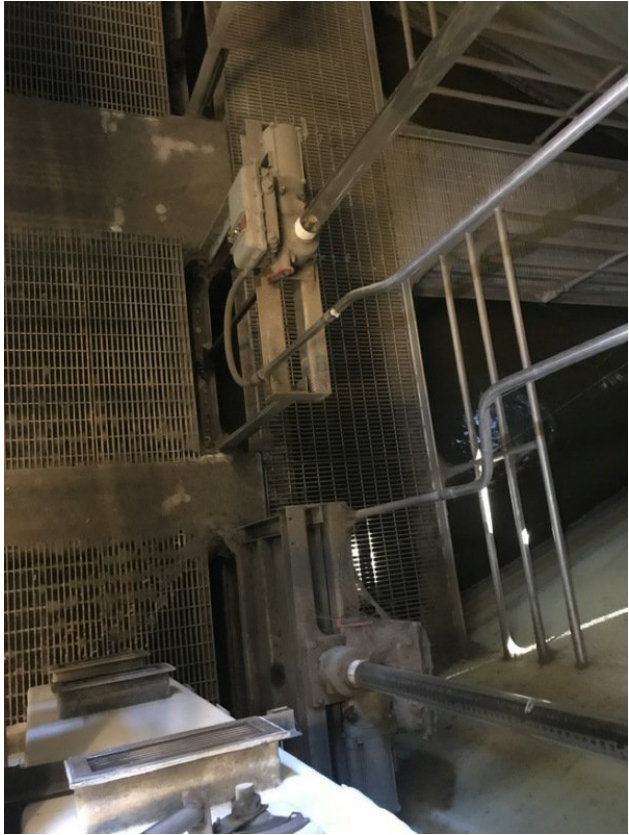
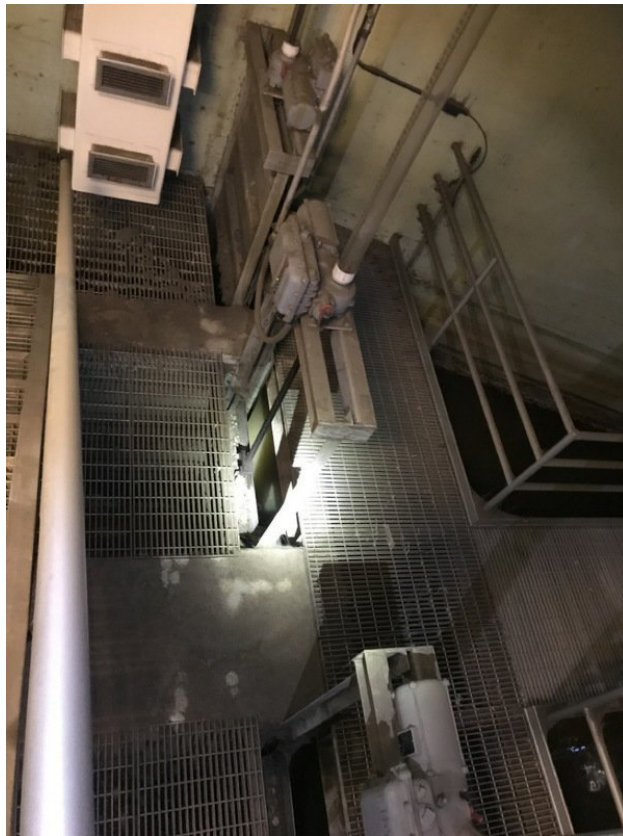
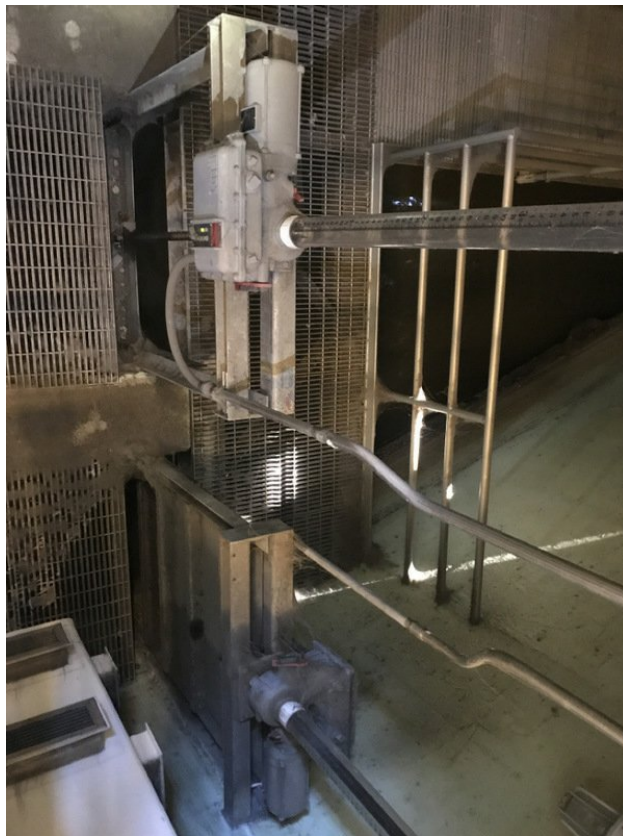
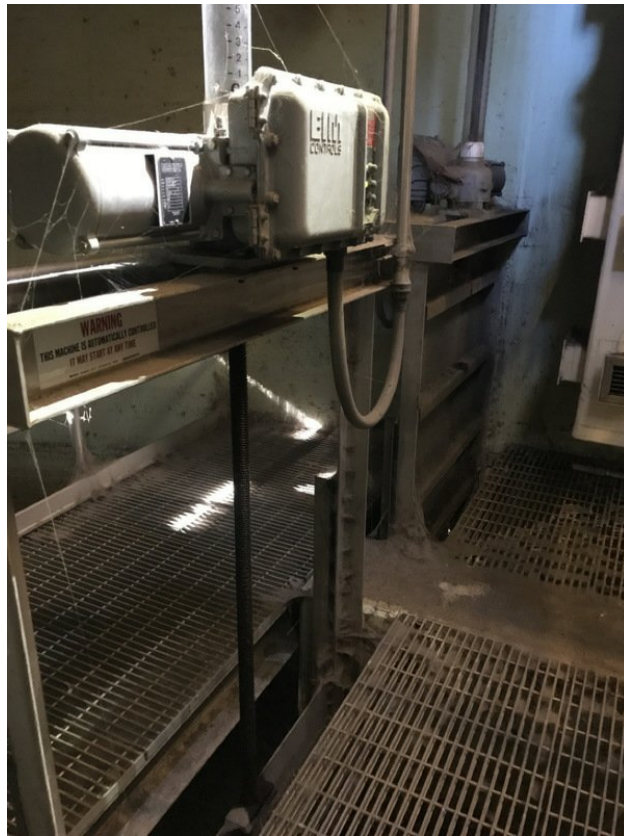
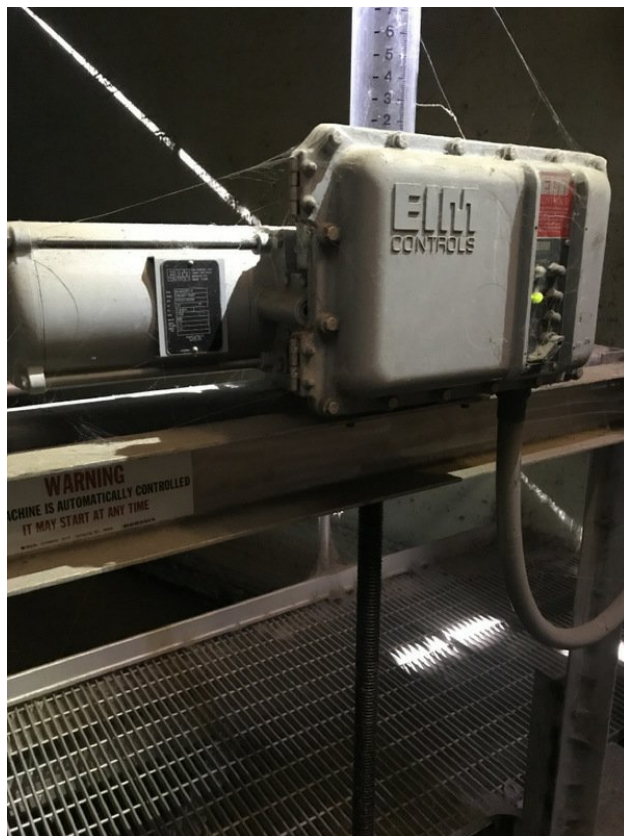
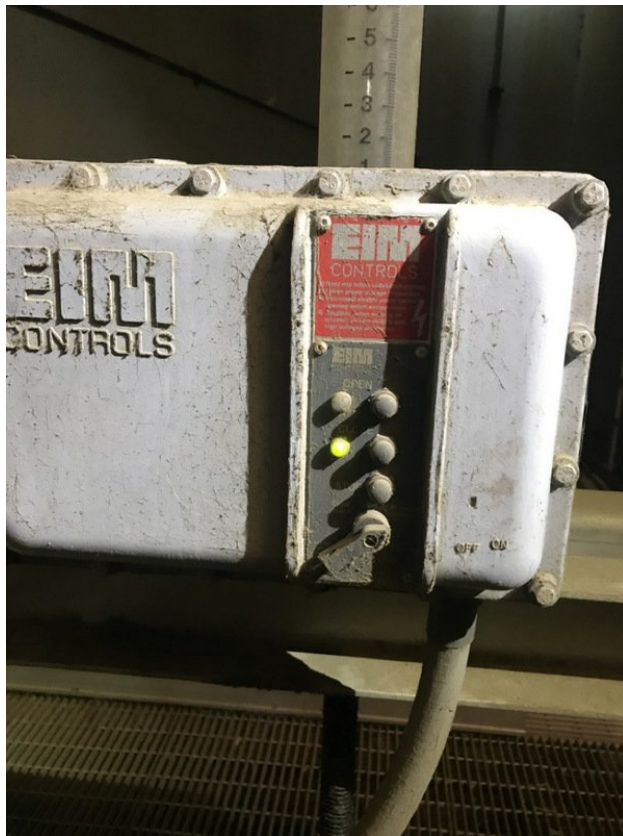
| Mechanical Equipment Photos | |

Mechanical Observation Comments

None

| Mechanical Condition Score | 1 - Good – No defects observed. |

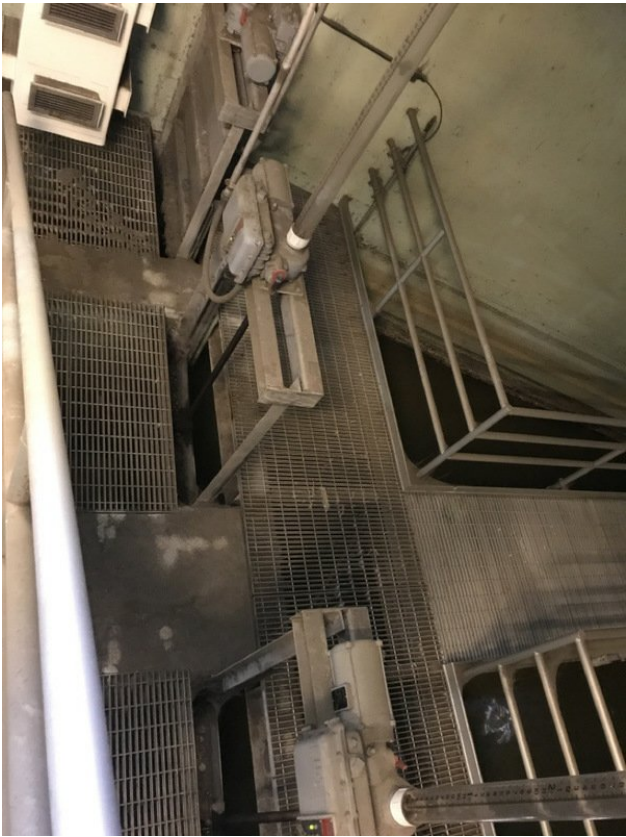
| Mechanical Equipment Photos | |

| Mechanical Observation Comments | None |

| Mechanical Condition Score | 1 - Good – No defects observed. |

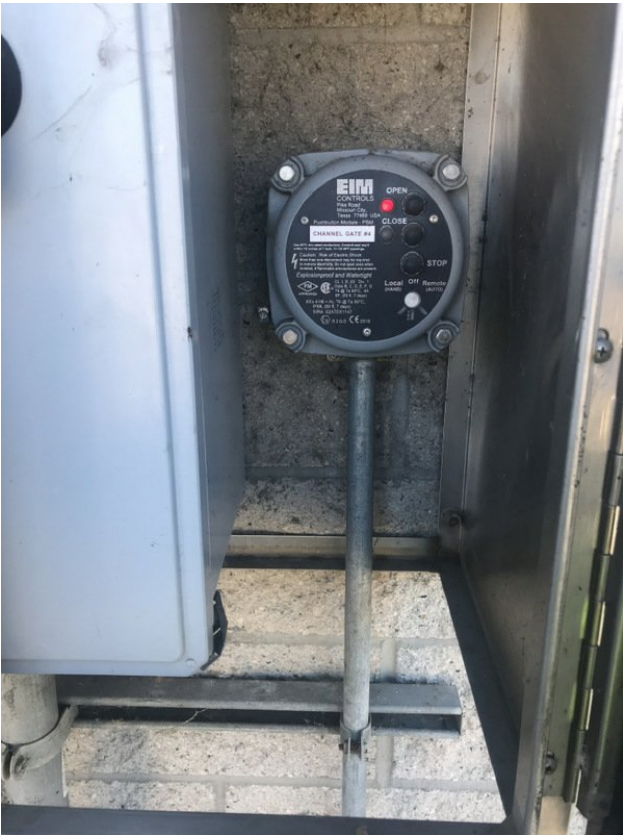
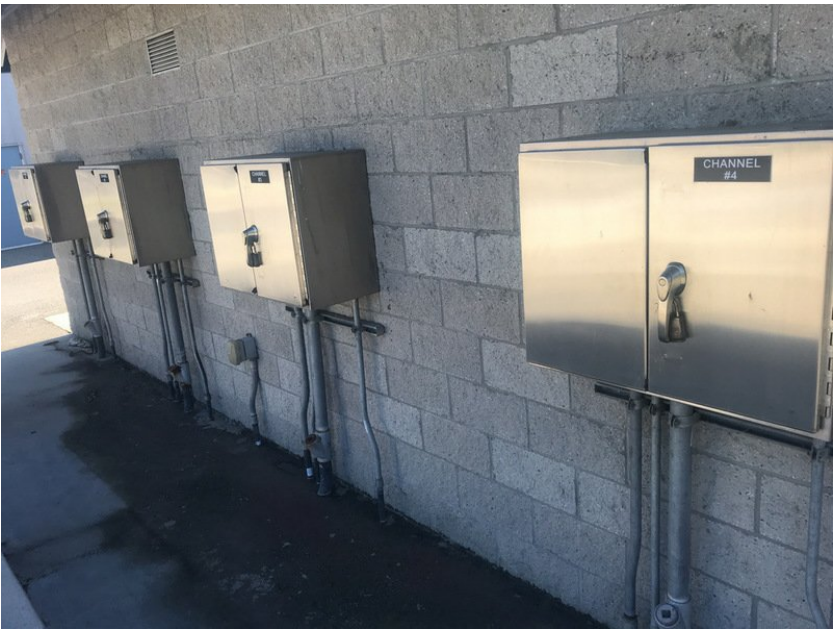
Mechanical Equipment Photos

| Mechanical Observation Comments | None |
| Mechanical Condition Score | 1 - Good – No defects observed. |

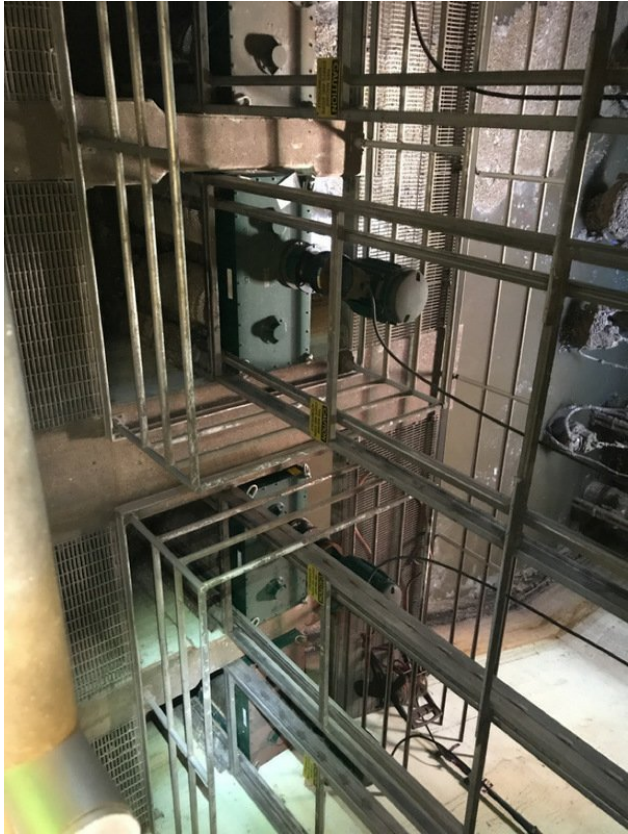
| Mechanical Equipment Photos | |

| Mechanical Field Assessment | Excessive Vibration, Inadequate Supports |

| Mechanical Condition Score | 5 - Failing or Failed – Asset integrity is compromised. Asset may be out of service. |

| Mechanical Performance Score | 5 - Failing or Failed – Asset is not functioning as intended or is out of service. |

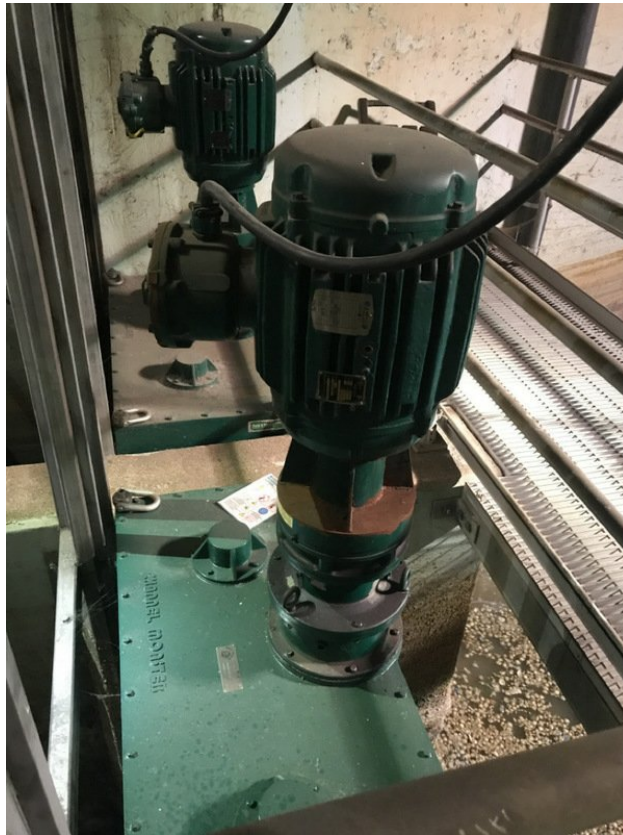
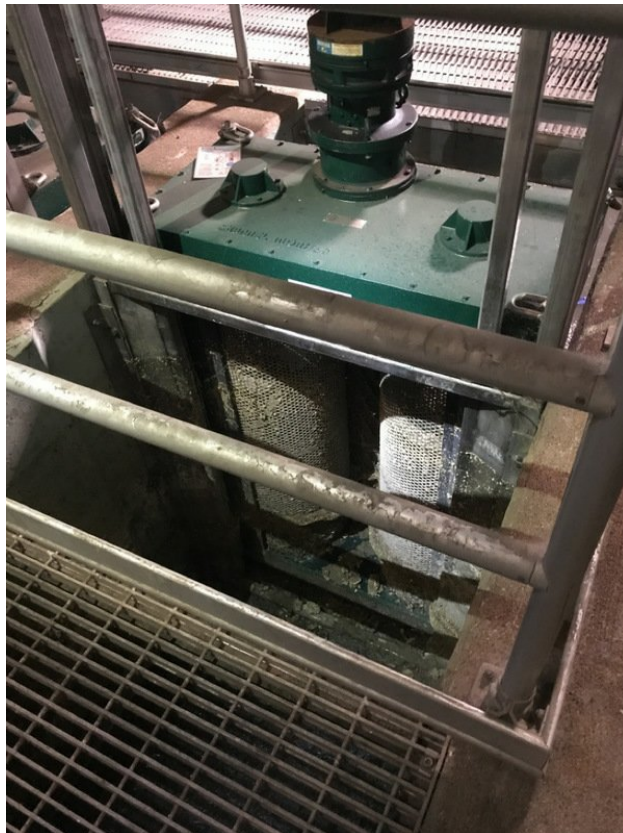
| Mechanical Field Assessment | None |

None

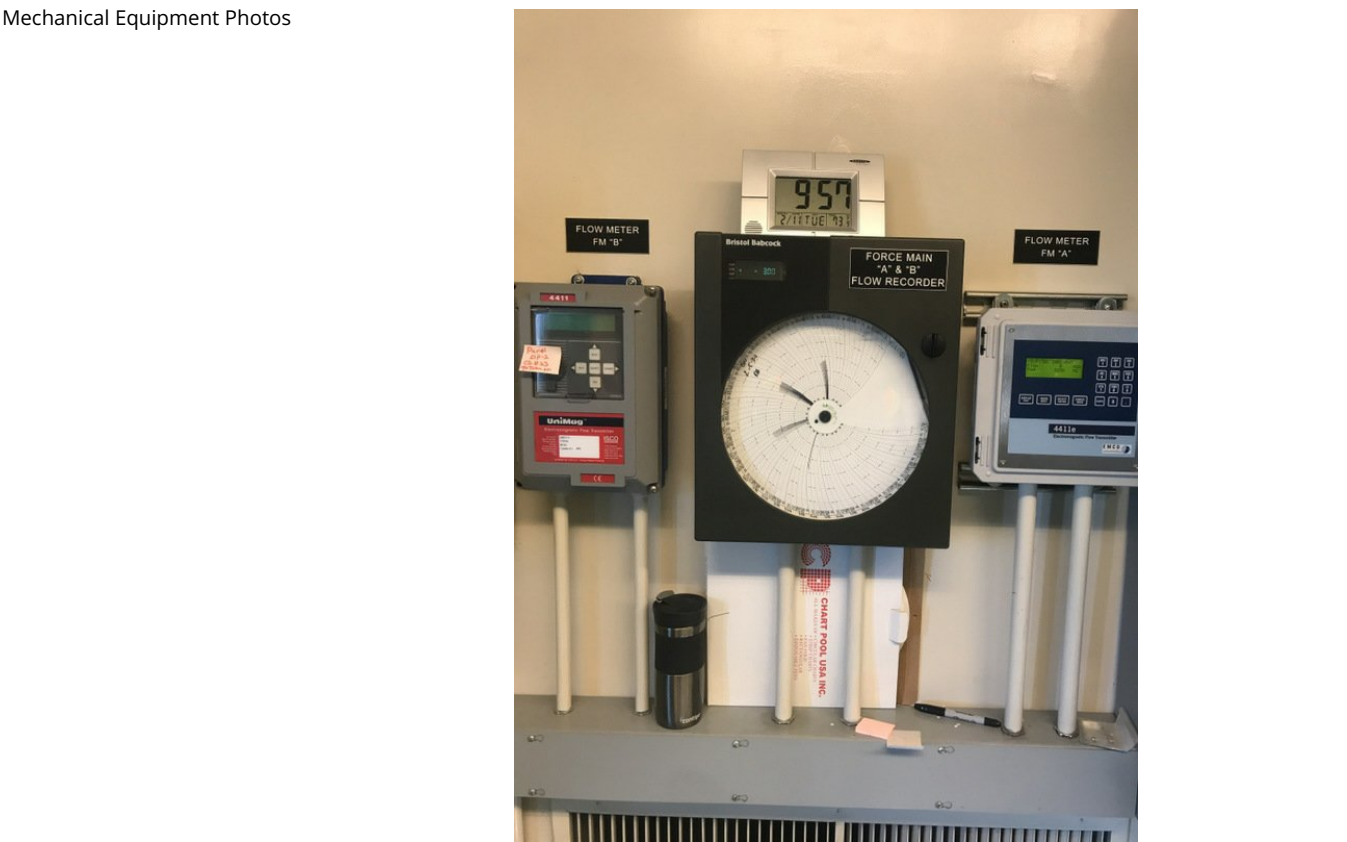
| Mechanical Asset Name | Force Main A B Flow Recorder |

| Mechanical Observation Comments | None |

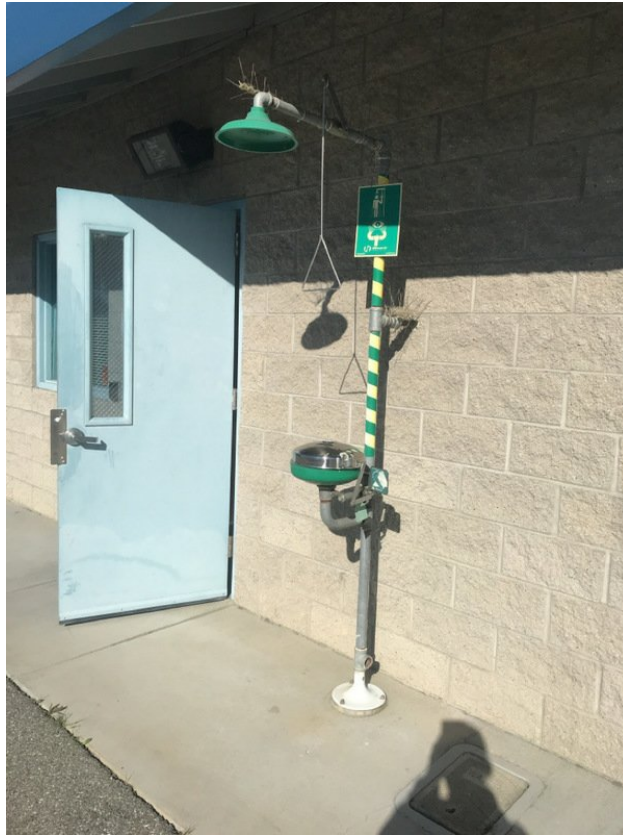
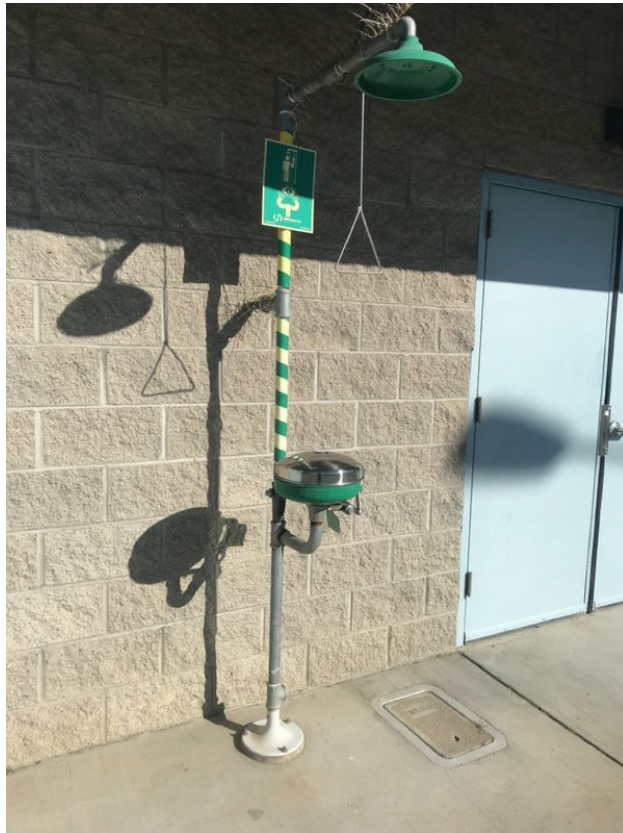
| Mechanical Asset Name | Eye wash |

None

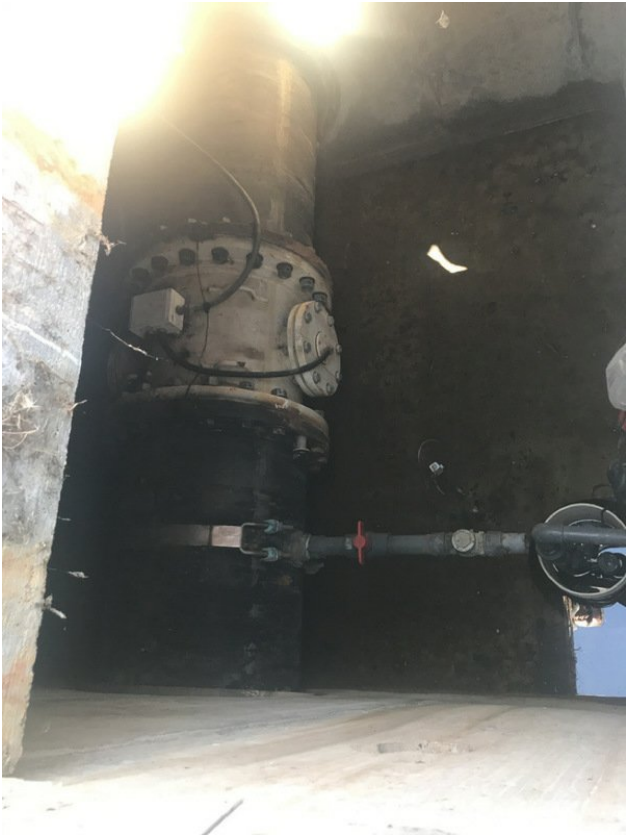
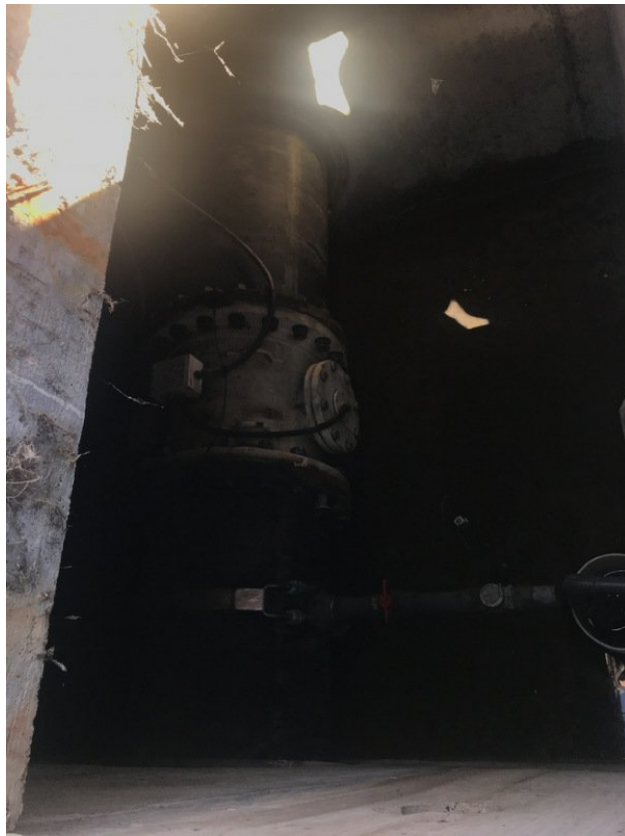
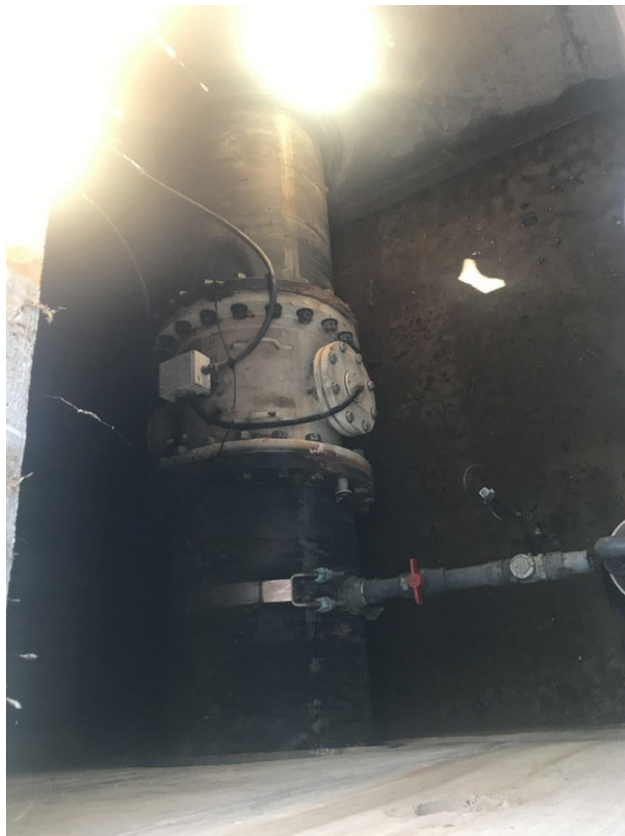
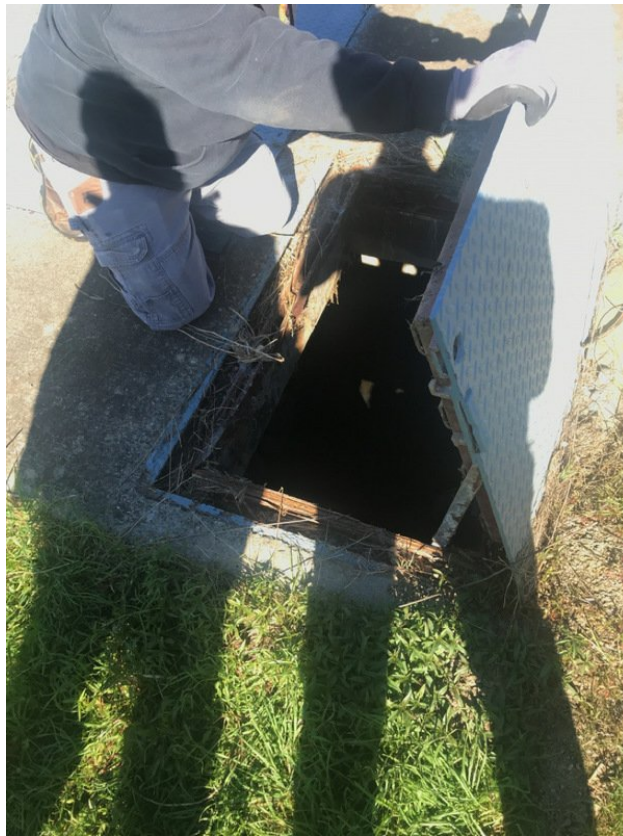
| Mechanical Asset Description | This is for force main B |
| Mechanical Field Assessment | It works but the operation is not accurate. |

4 - Poor – Major defects observed. Asset integrity may be compromised.

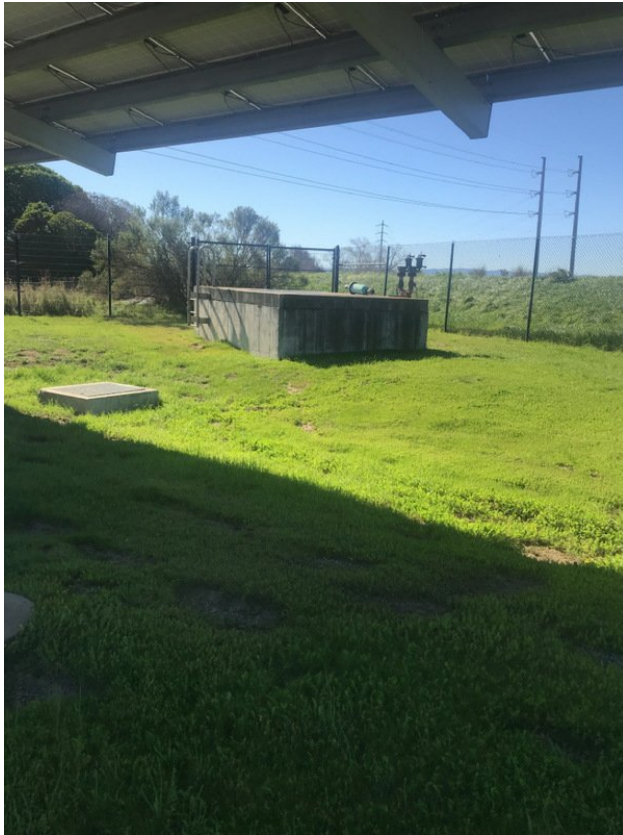
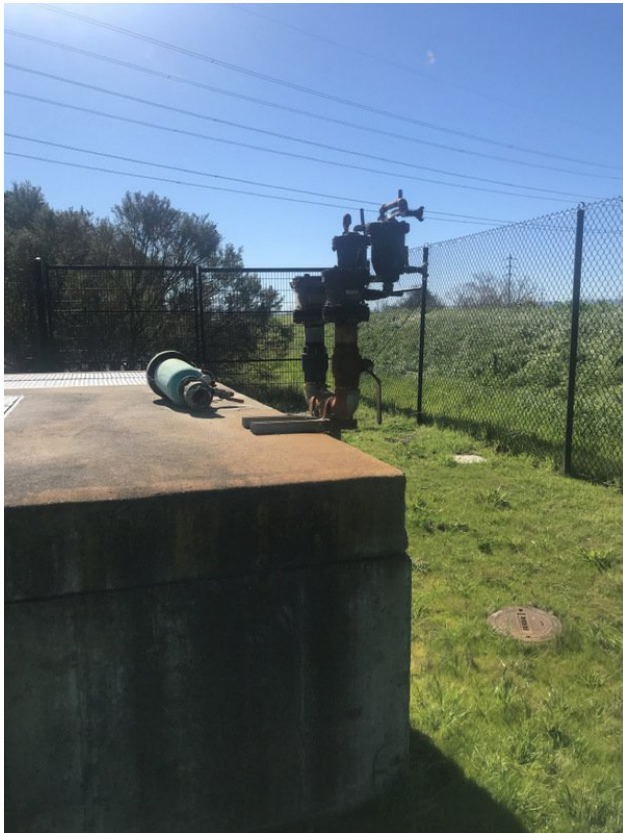
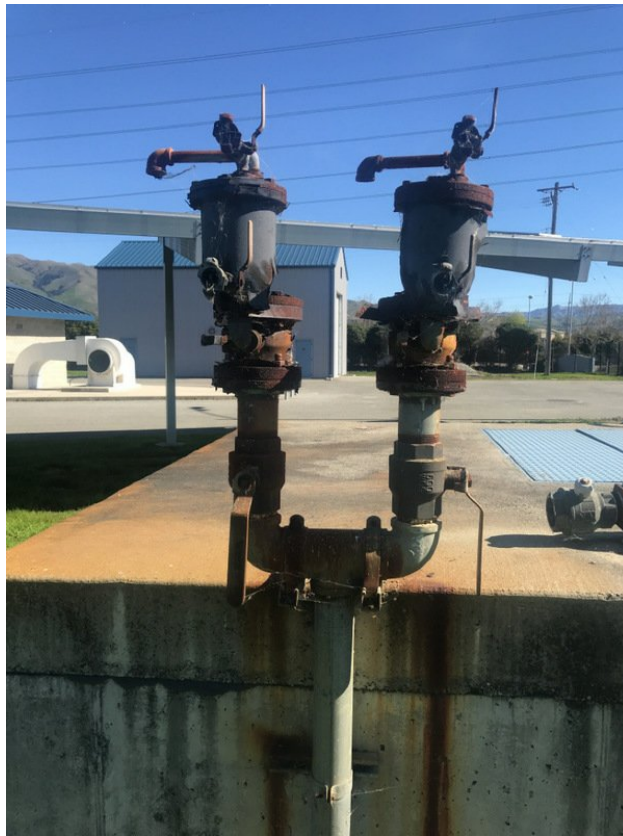
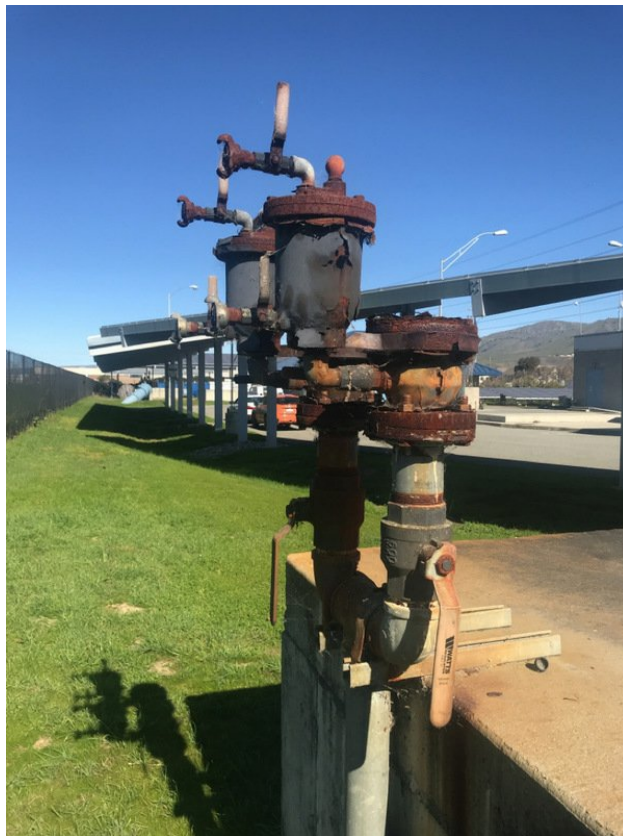
Cavitation, Coating Failure, Inadequate Supports

| Mechanical Condition Score | 5 - Failing or Failed – Asset integrity is compromised. Asset may be out of service. |

| Mechanical Performance Score | 5 - Failing or Failed – Asset is not functioning as intended or is out of service. |

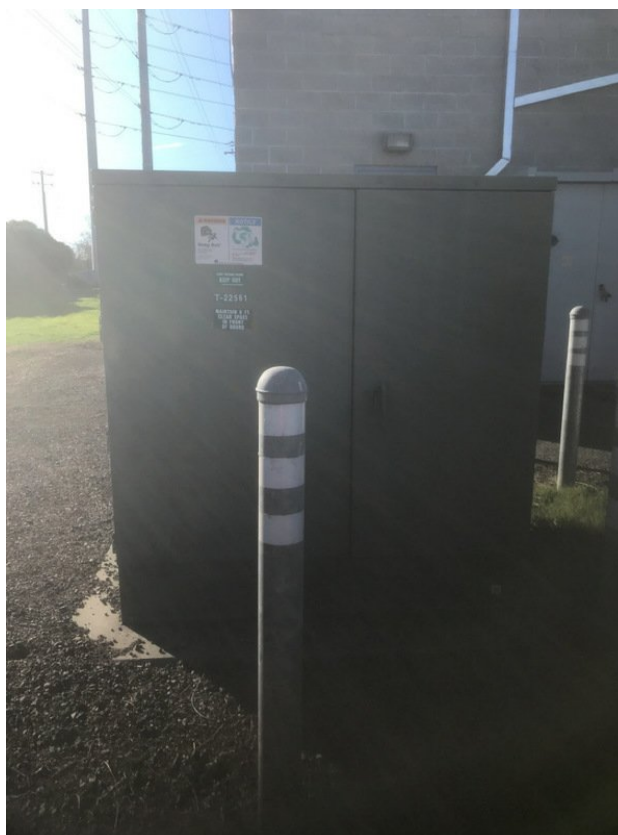
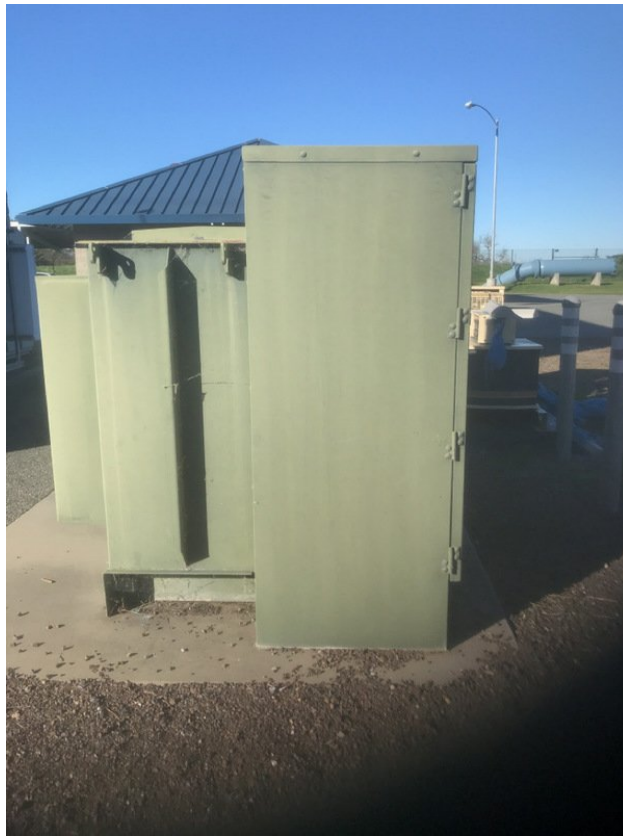
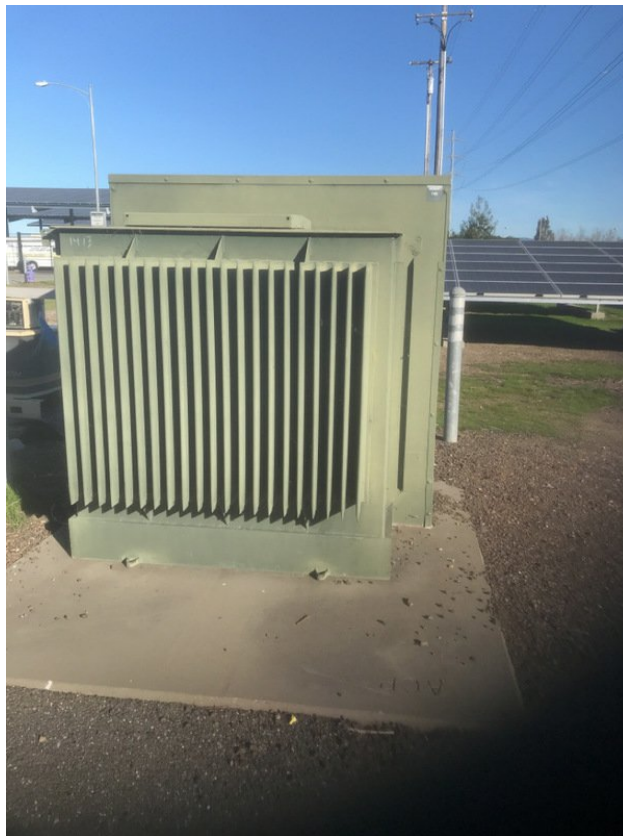
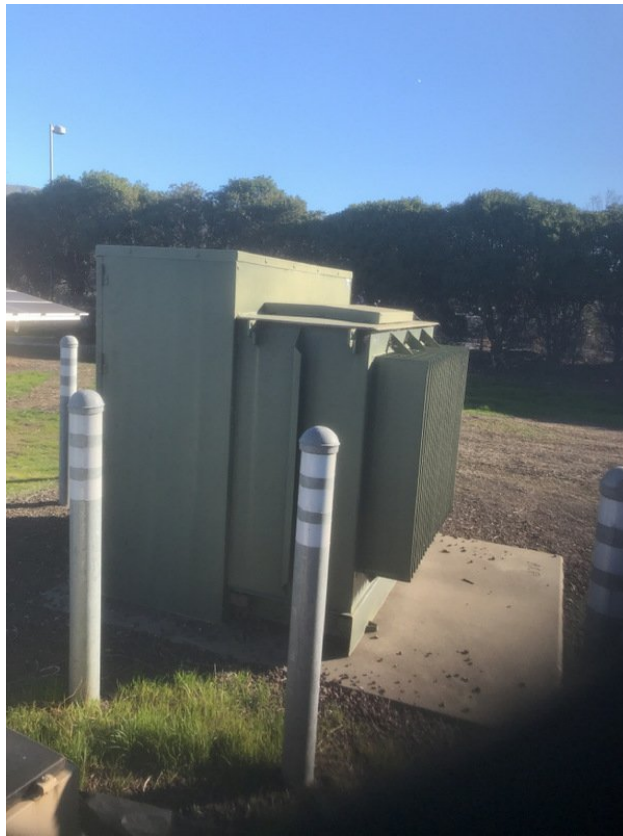
| Electrical Equipment Observations | No defects noted |
| Electrical Equipment Condition Score | 1 - Excellent |
