City of Milpitas Sewer Master Plan

Sewer Master Plan

Prepared by HydroScience Engineers, Inc.

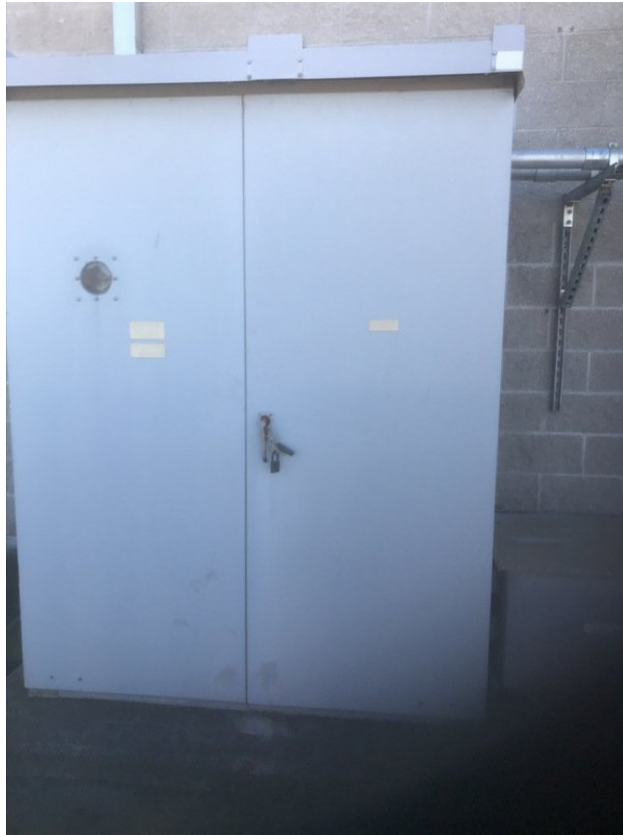
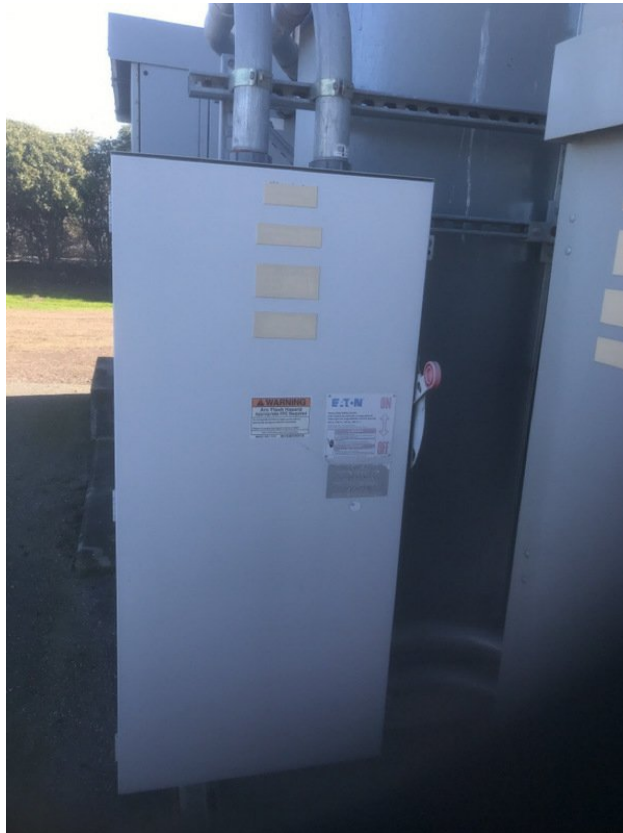
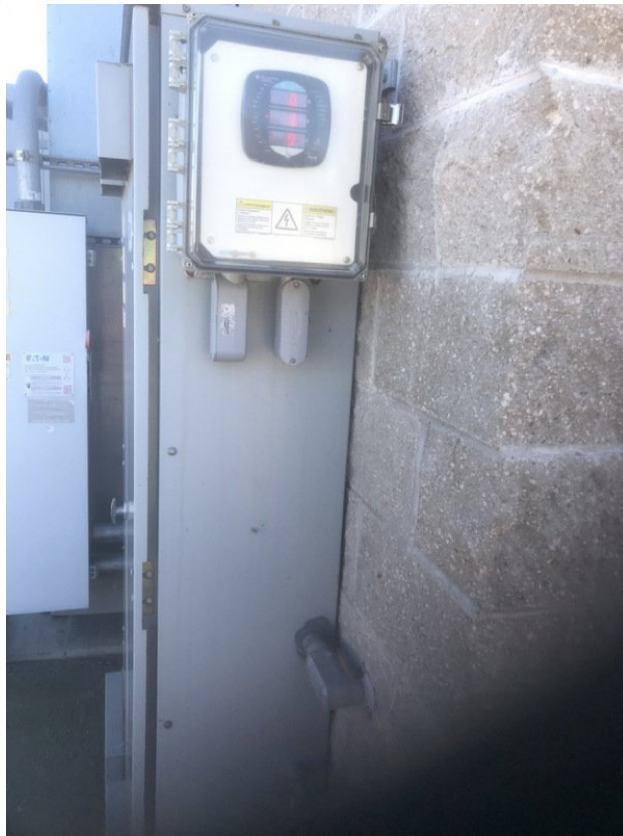
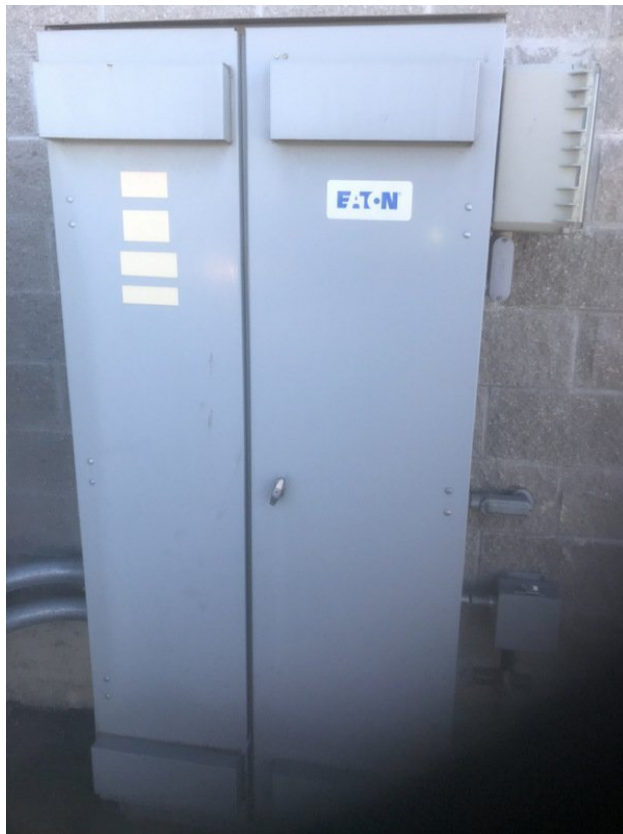
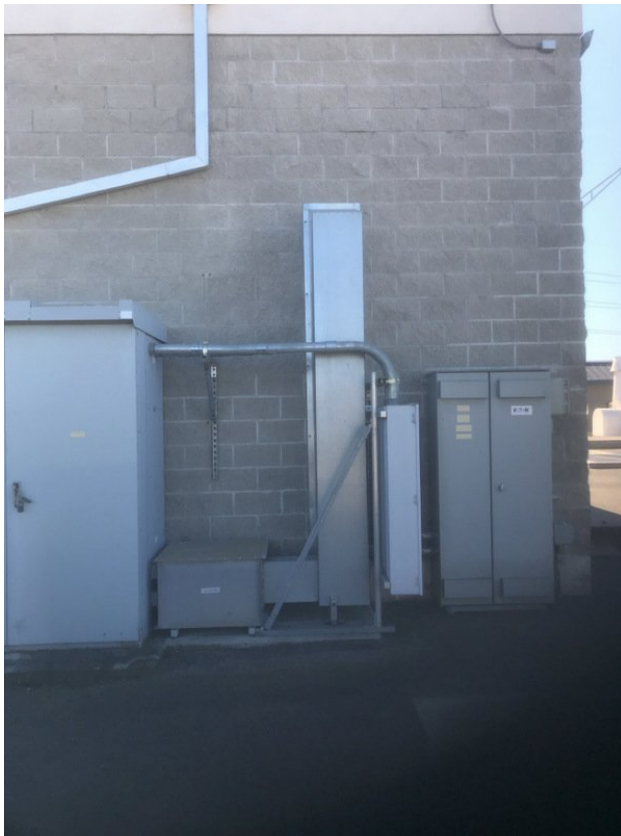
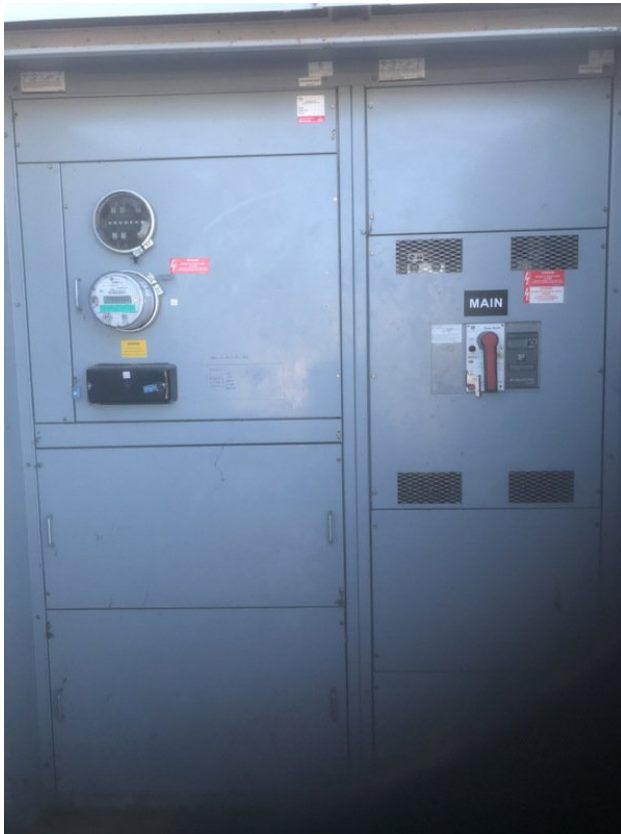
| Electrical Arcflash Labels | Missing |

| Electrical Equipment Observations | No Corrosion Noted |
| Electrical Equipment Condition Score | 1 - Excellent |

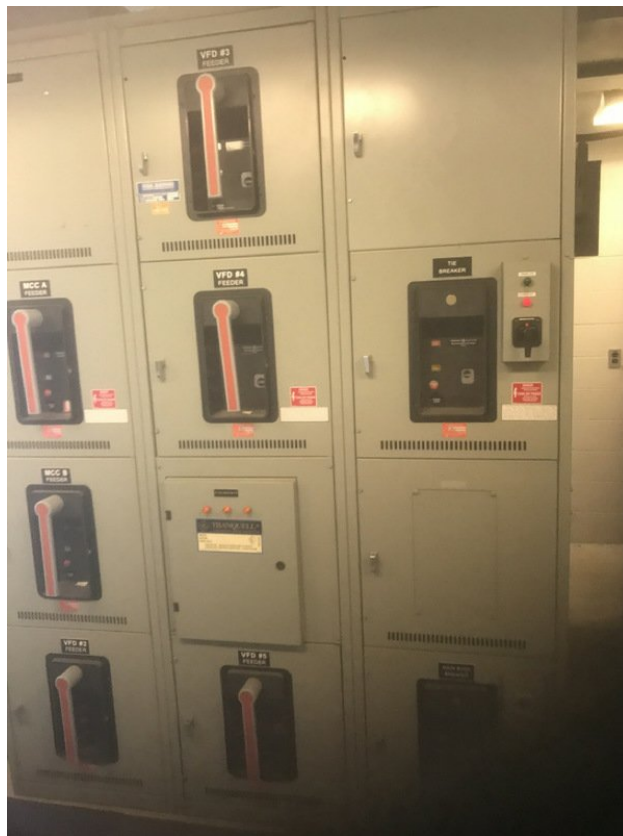
| Electrical Arcflash Labels | Missing |
| Number of Available Spares and Spaces | Two Space available |

| Electrical Equipment Observations | No Corrosion Noted |
| Electrical Equipment Condition Score | 1 - Excellent |

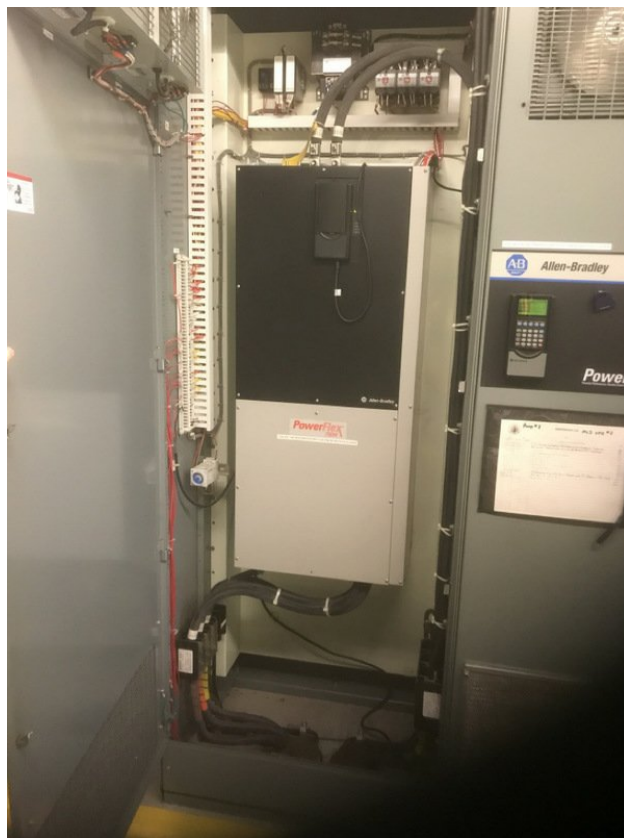
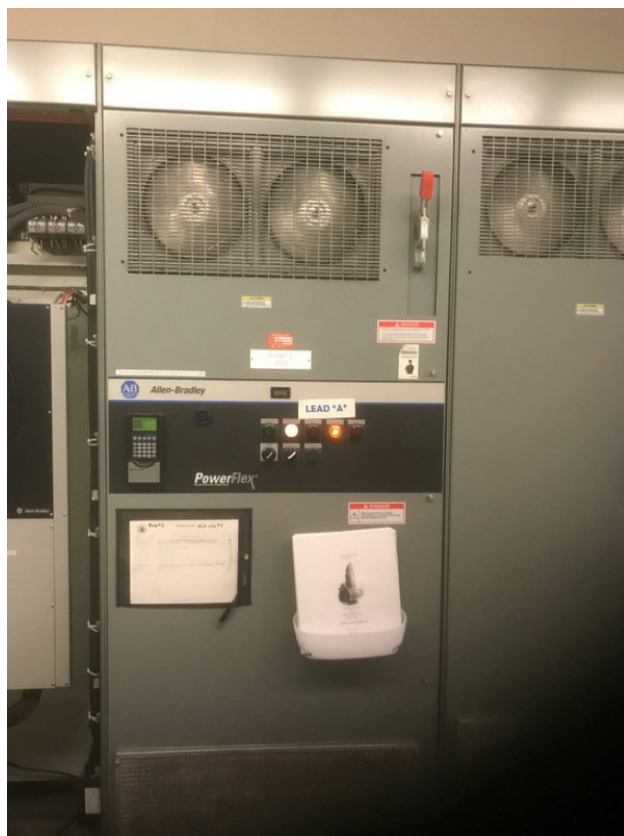
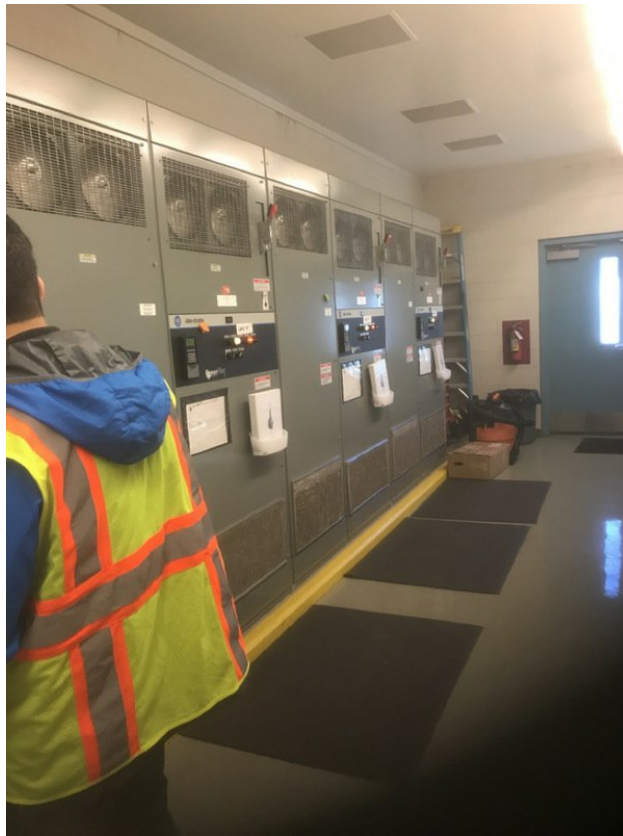
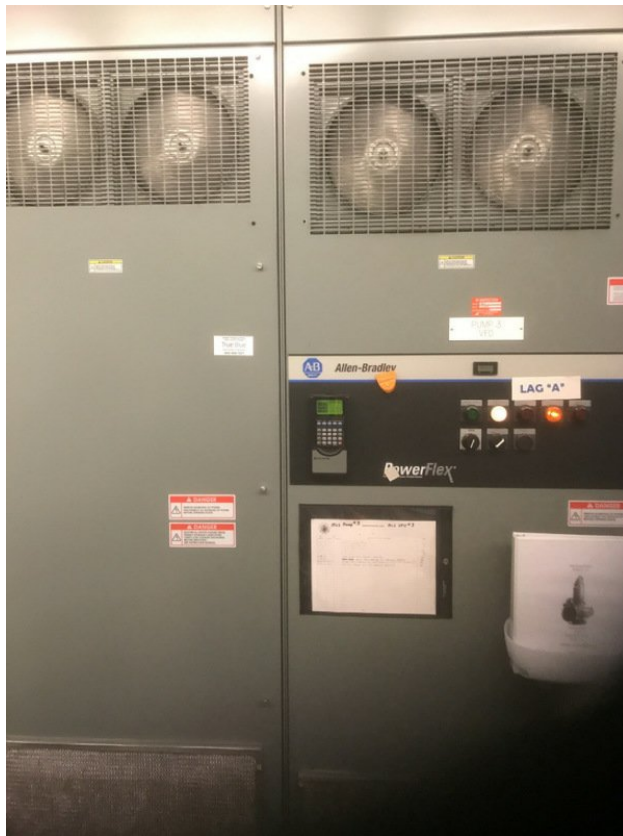
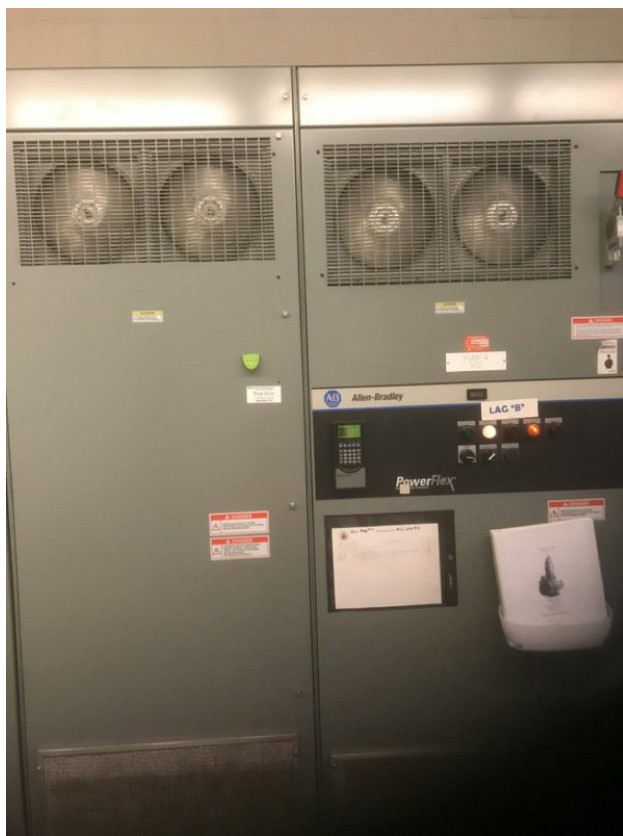
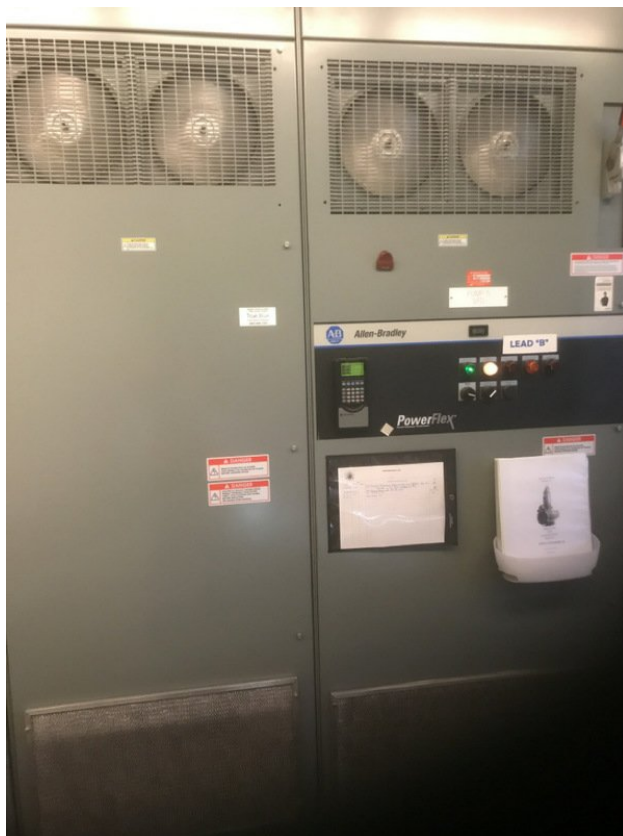
| Electrical Equipment Photos | |

| Electrical Equipment Observations | No Corrosion Noted |
| Electrical Equipment Condition Score | 4 - Integrity of Component Moderately Compromised |

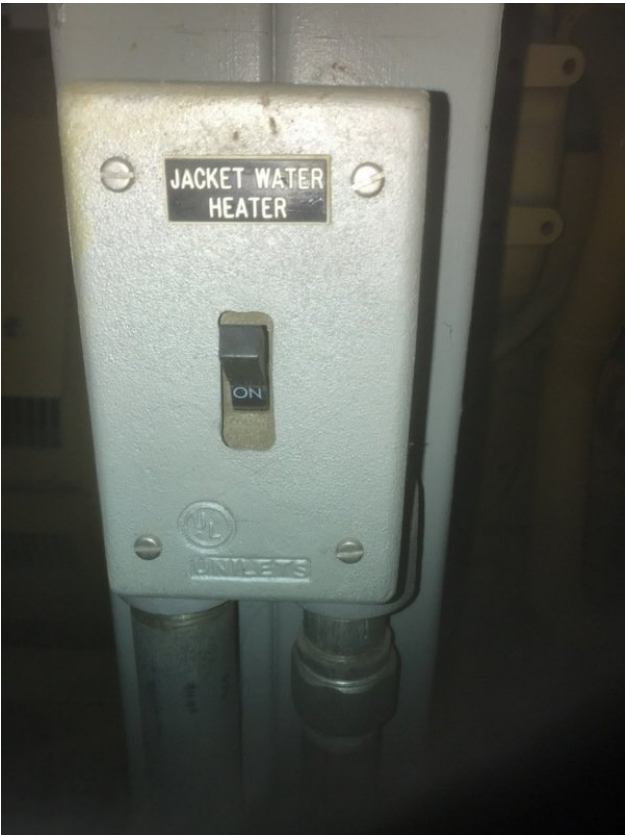
| Electrical Equipment Observations | No Corrosion Noted |
| Electrical Equipment Condition Score | 1 - Excellent |

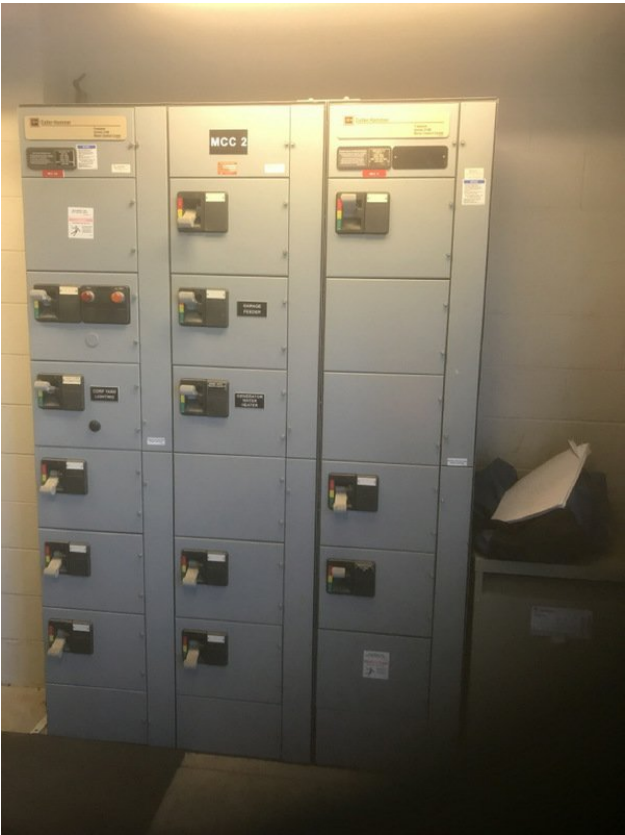
Electrical Equipment Photos

| Electrical Equipment Observations | No Corrosion Noted. |
| Electrical Equipment Condition Score | 1 - Excellent |

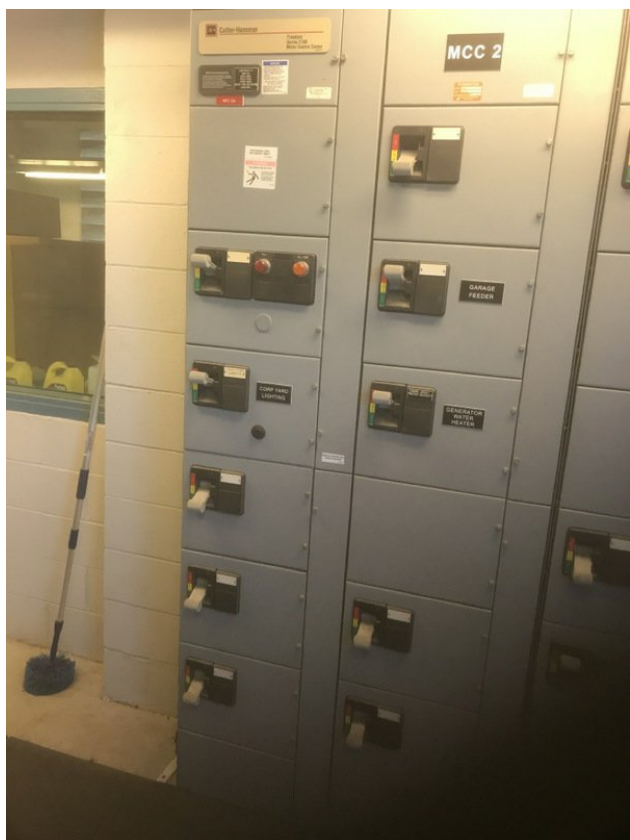
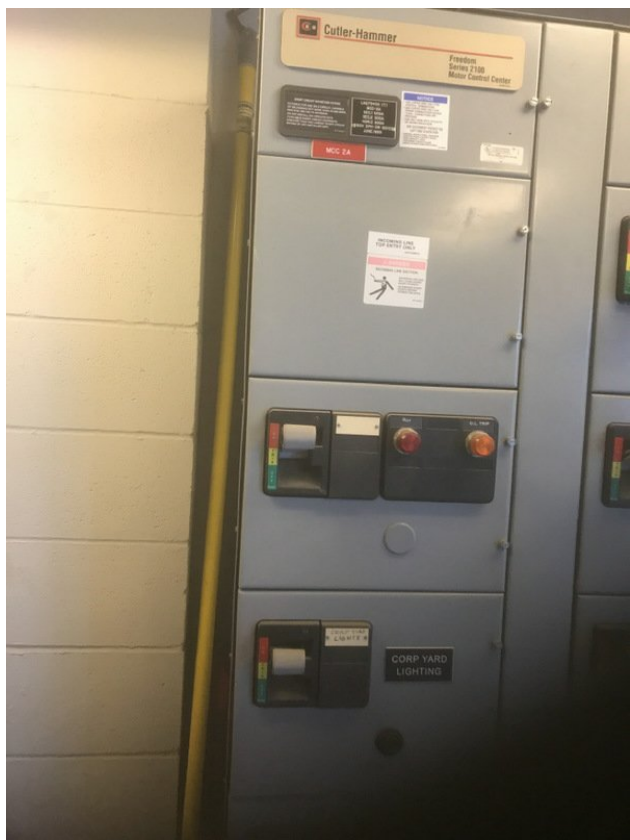
| Electrical Equipment Photos | |

| Electrical Equipment Observations | No Corrosion Noted |
| Electrical Equipment Condition Score | 1 - Excellent |

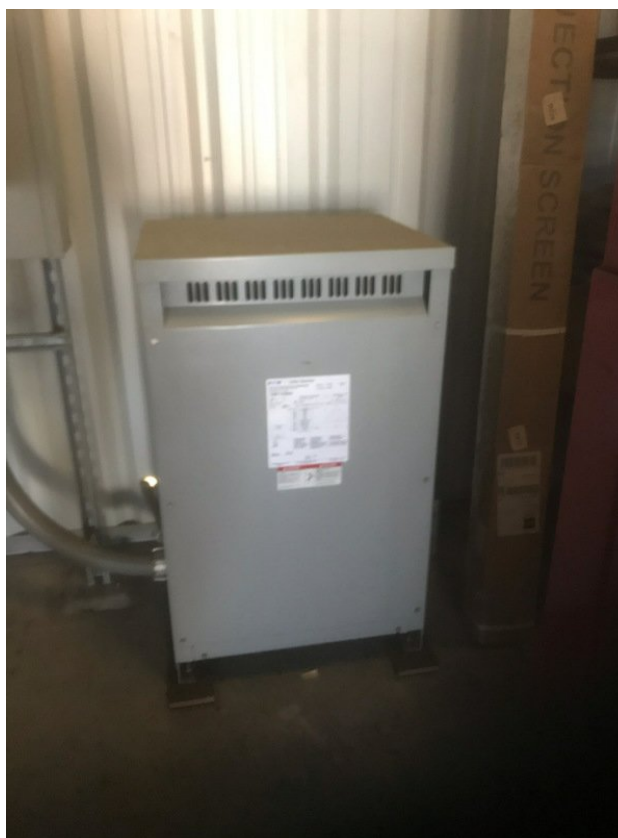
Electrical Equipment Photos

| Electrical Equipment Observations | No Corrosion Noted |
| Electrical Equipment Condition Score | 1 - Excellent |

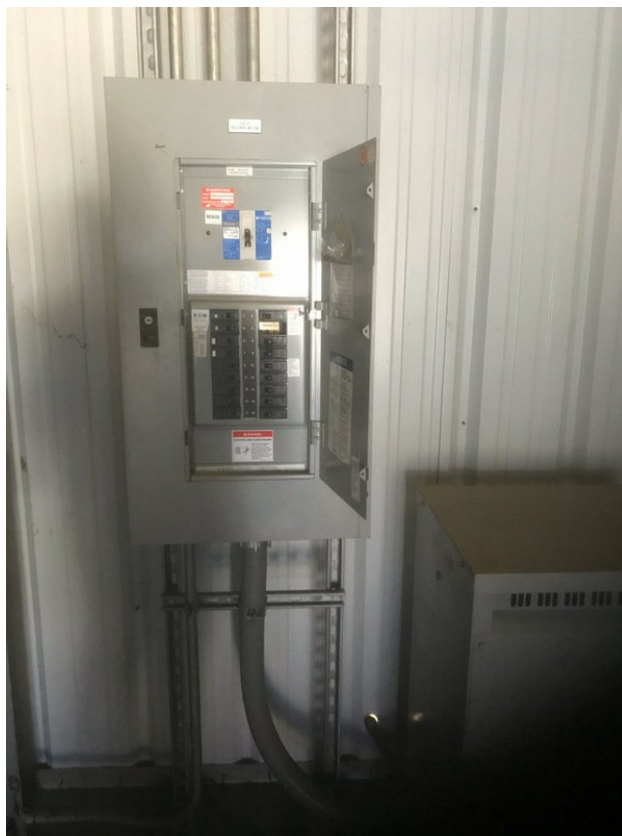
| Electrical Equipment Photos | |

| Electrical Equipment Observations | No Corrosion Noted |
| Electrical Equipment Condition Score | 1 - Excellent |

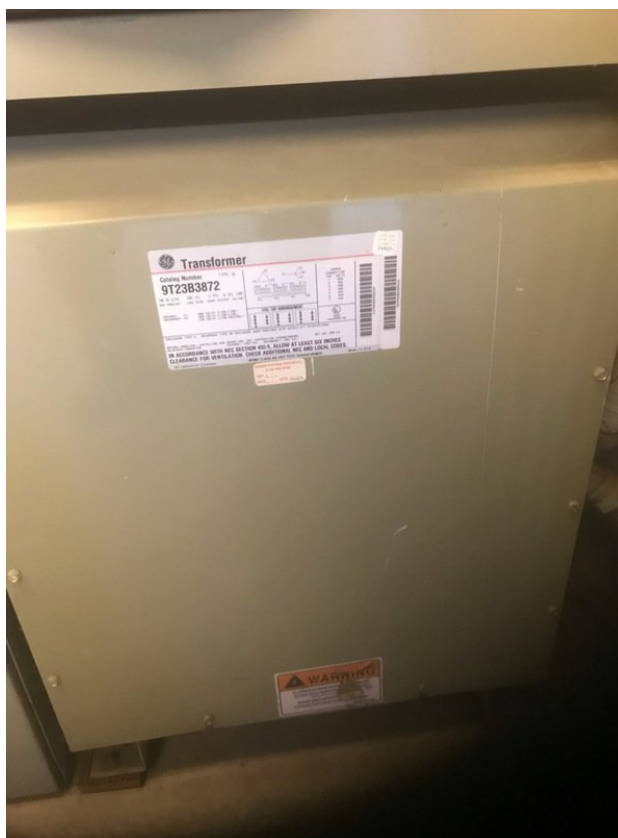
| Electrical Equipment Photos | |

| Electrical Equipment Observations | No Corrosion Noted |
| Electrical Equipment Condition Score | 1 - Excellent |

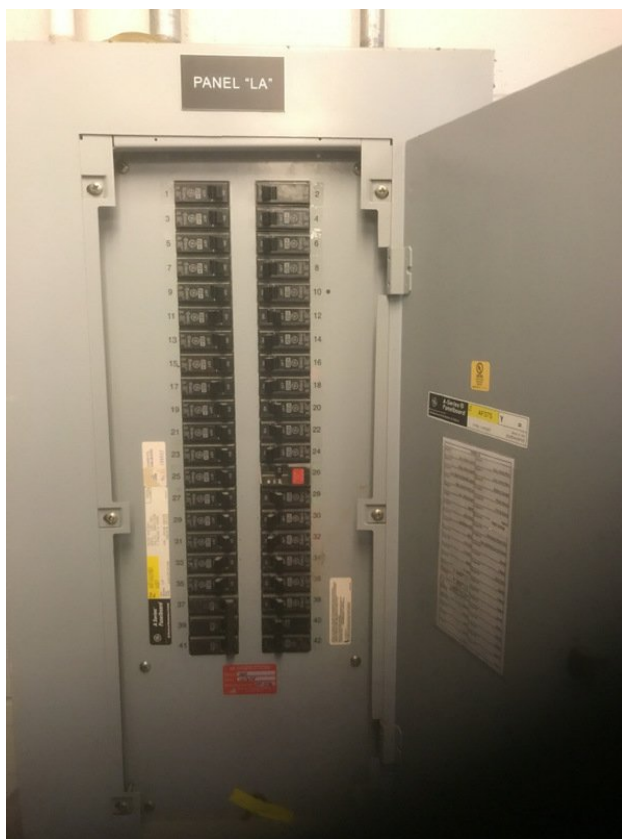
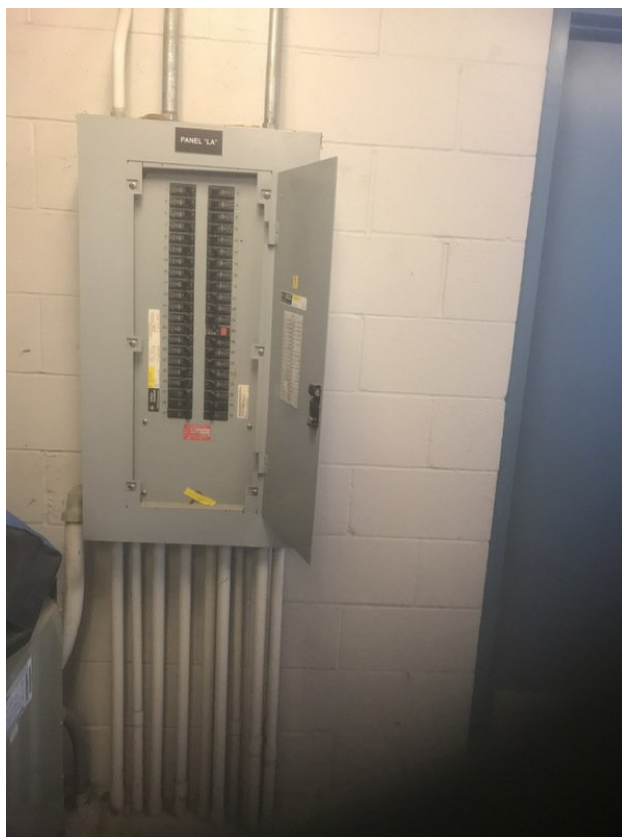
Electrical Equipment Photos

Electrical Equipment Observations

No Corrosion Noted

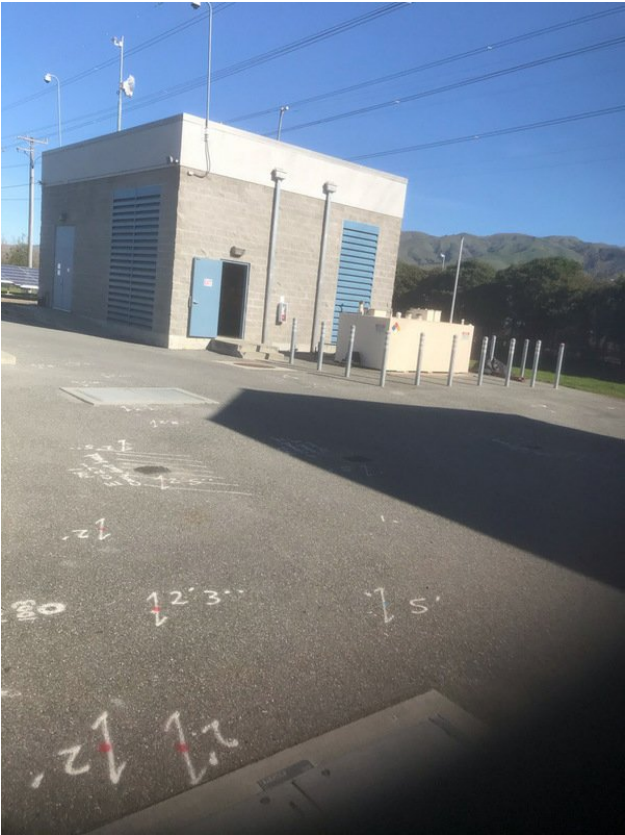
| Electrical Building Photos | |

| Electrical Building Observations | No Corrosion Noted on Conduits and Pull Boxes |
| Electrical Building Condition Score | 1 - Excellent |

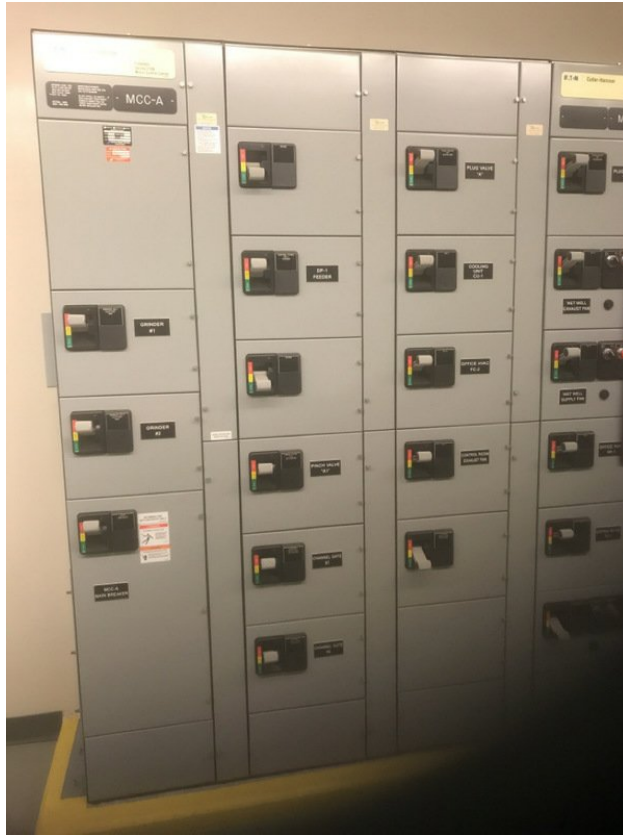
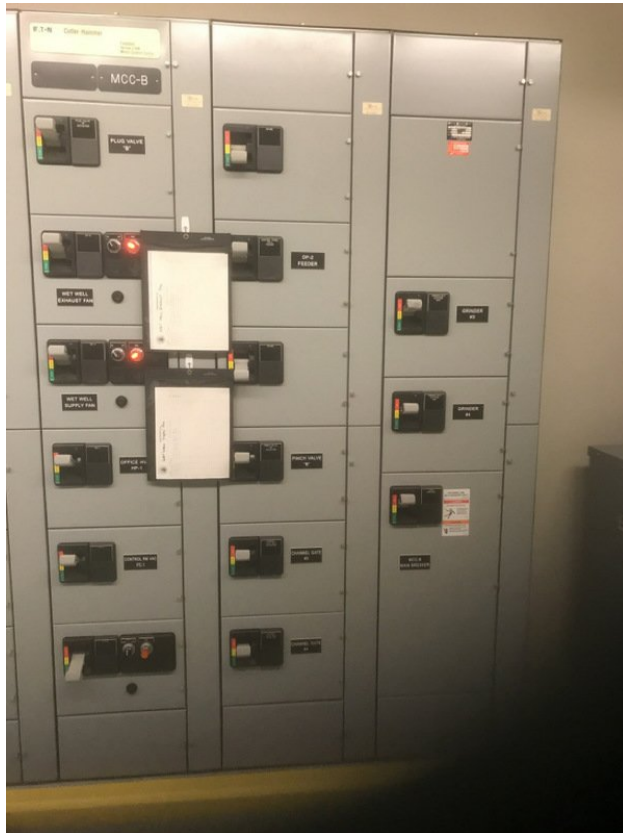
| Electrical Equipment Photos | |

| Electrical Equipment Observations | No Corrosion Noted |
| Electrical Equipment Condition Score | 1 - Excellent |

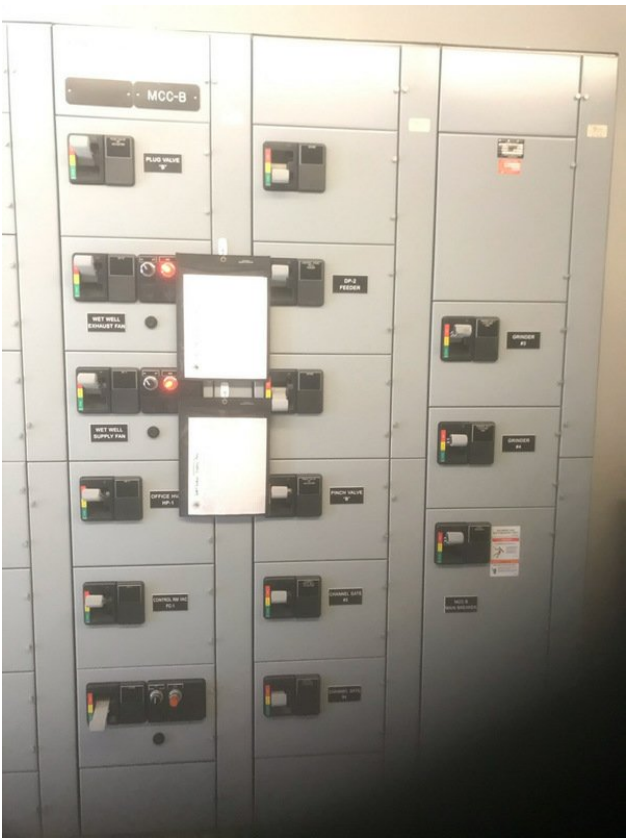
Electrical Equipment Photos

| Electrical Equipment Observations | No Corrosion Noted |
| Electrical Equipment Condition Score | 1 - Excellent |

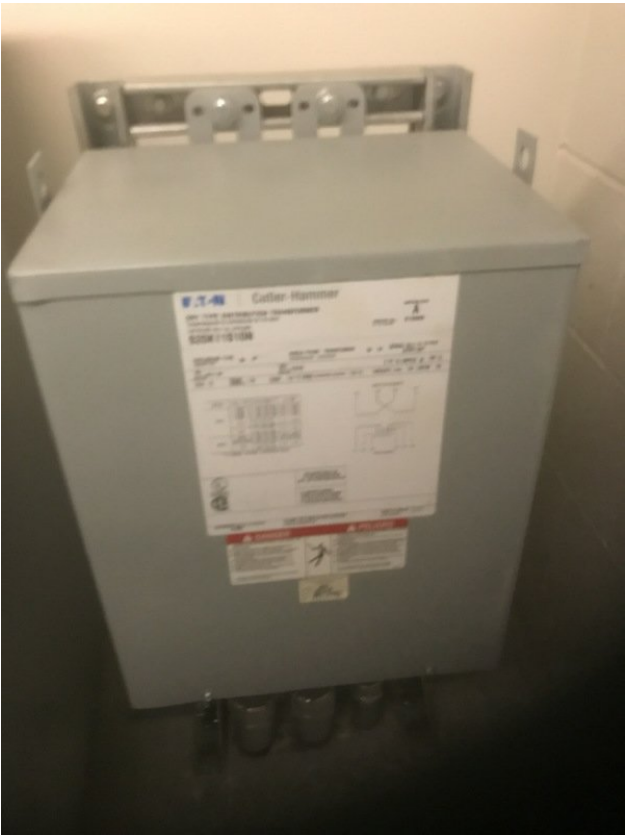
Electrical Equipment Photos

| Electrical Equipment Observations | No corrosion Noted |
| Electrical Equipment Condition Score | 1 - Excellent |

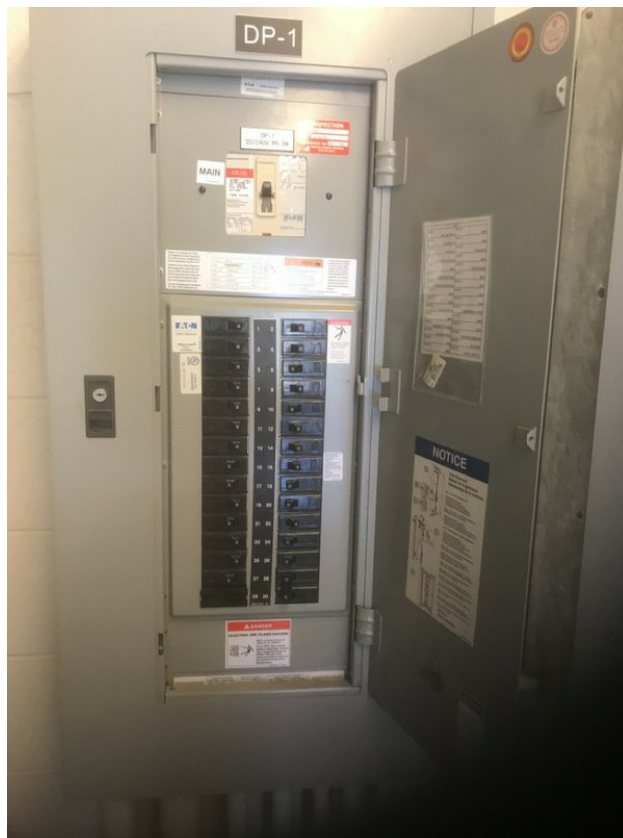
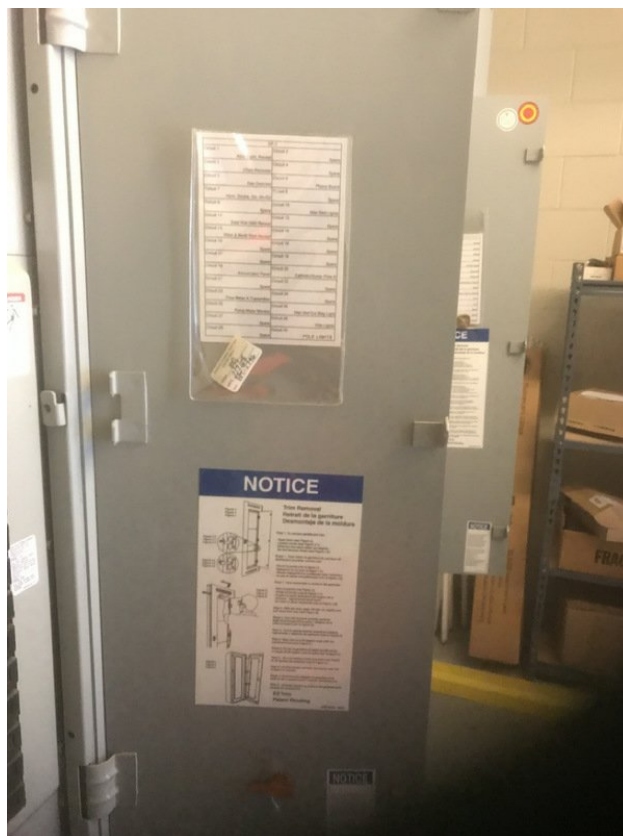
| Electrical Equipment Photos | |

| Electrical Equipment Observations | No Corrosion Noted |
| Electrical Equipment Condition Score | 1 - Excellent |

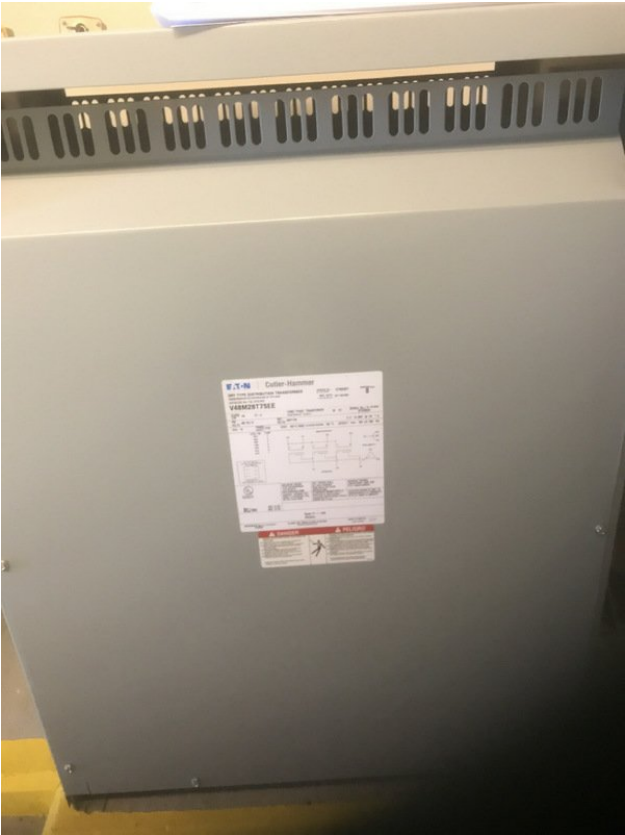
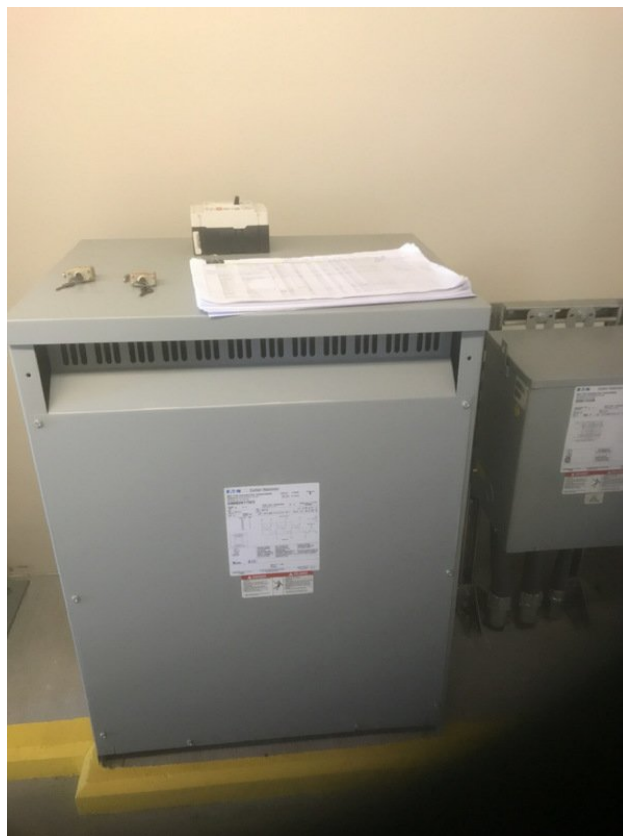
Electrical Equipment Photos

| Electrical Equipment Observations | No Corrosion Noted |
| Electrical Equipment Condition Score | 1 - Excellent |

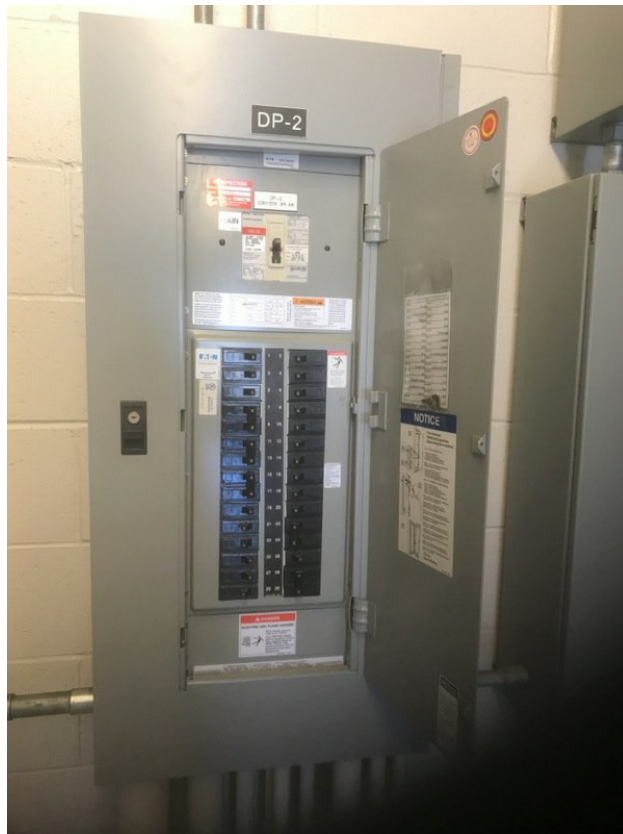
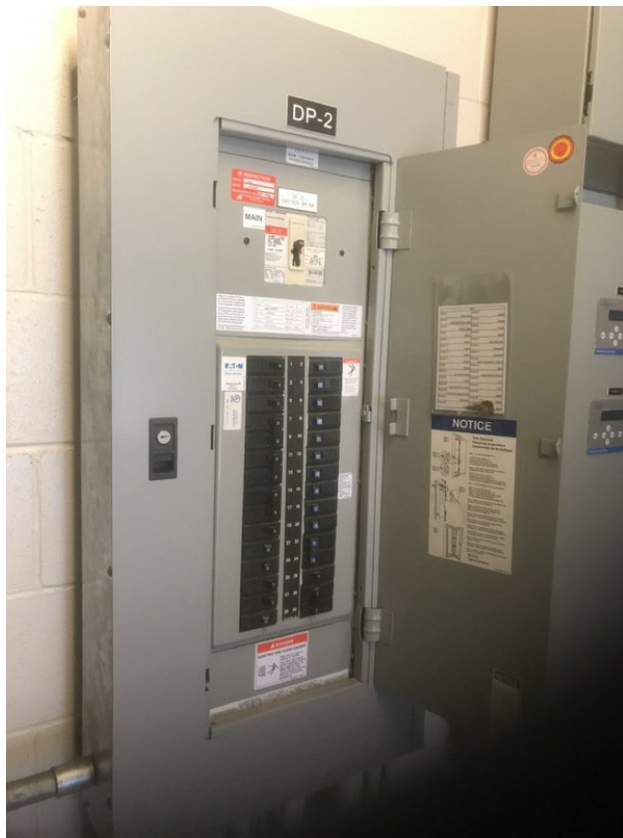
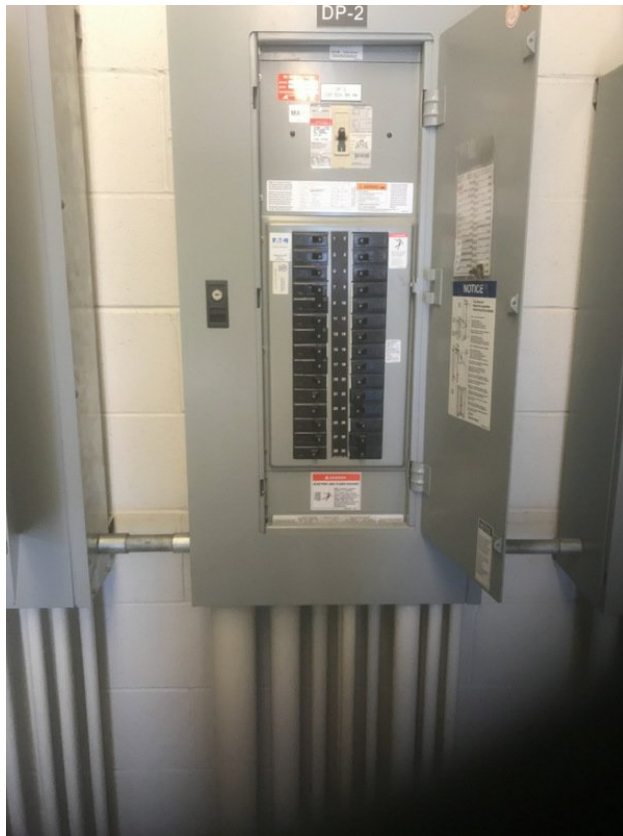
Electrical Equipment Photos

| Electrical Equipment Observations | No Corrosion Noted |
| Electrical Equipment Condition Score | 1 - Excellent |

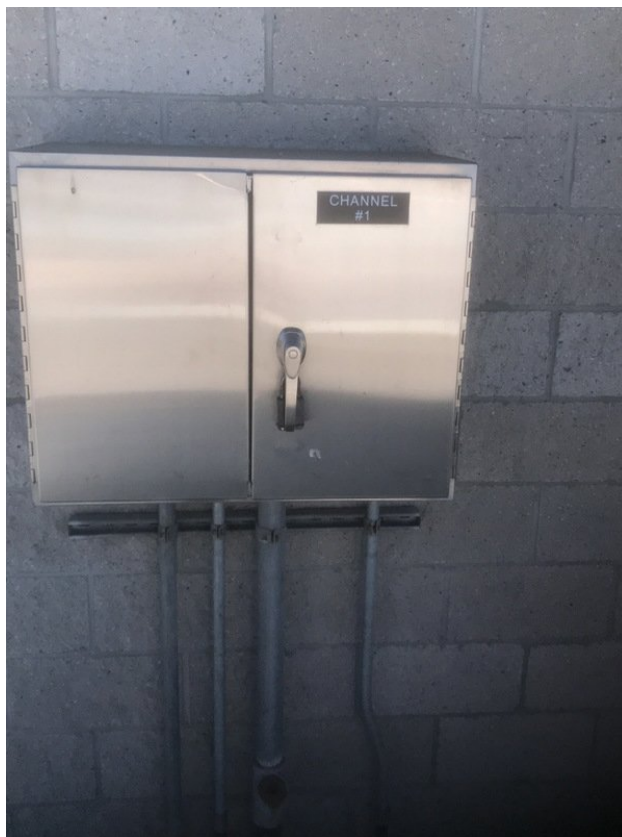
Electrical Equipment Photos

| Electrical Equipment Observations | No Corrosion Noted |
| Electrical Equipment Condition Score | 1 - Excellent |

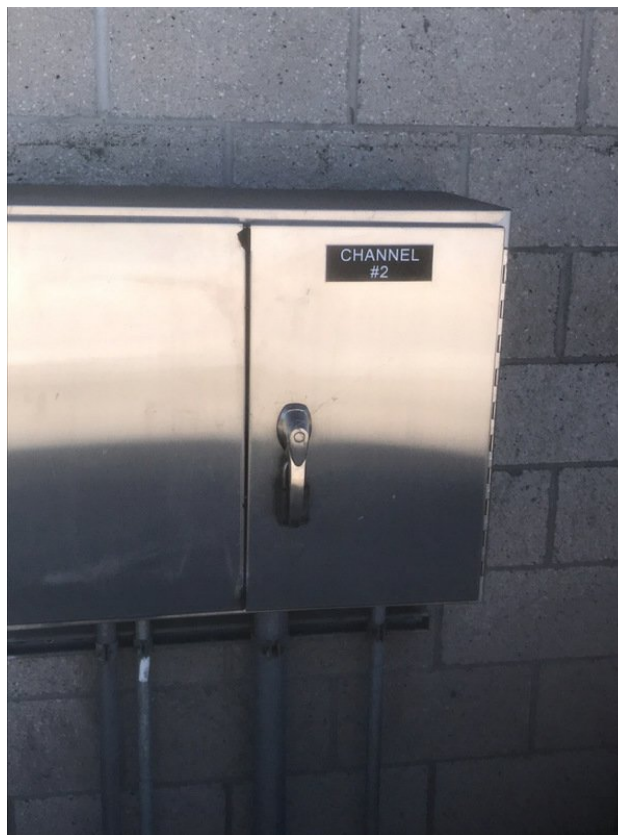
Electrical Equipment Photos

| Electrical Equipment Observations | No Corrosion Noted |
| Electrical Equipment Condition Score | 1 - Excellent |

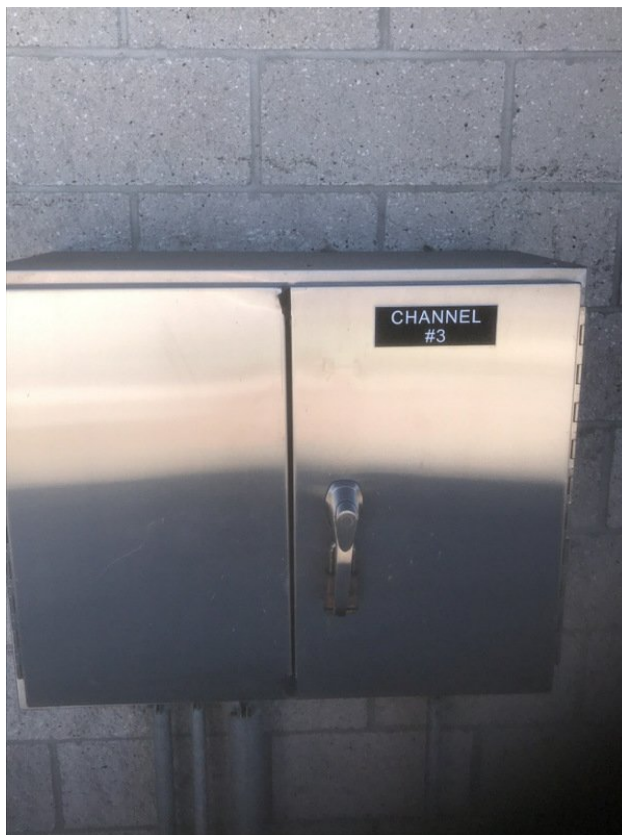
Electrical Equipment Photos

| Electrical Equipment Observations | No Corrosion Noted |
| Electrical Equipment Condition Score | 1 - Excellent |

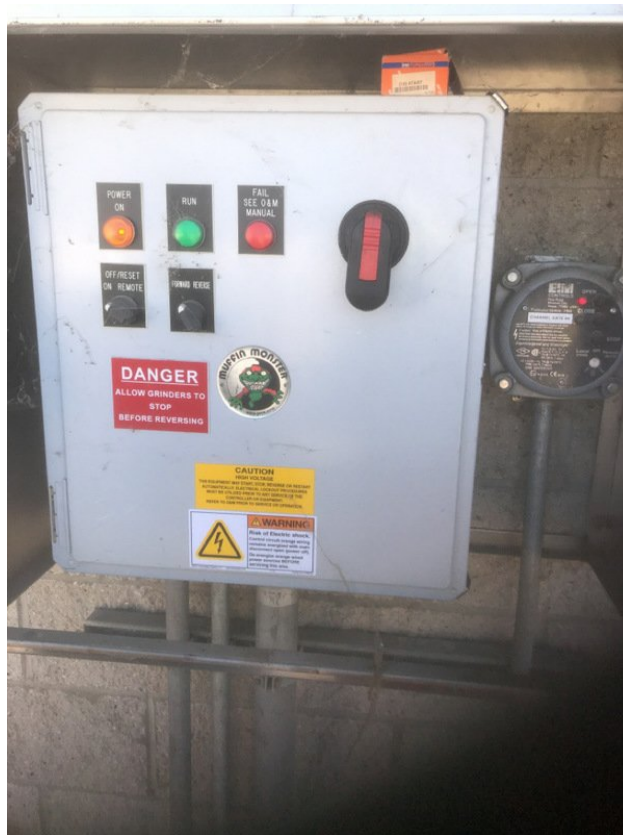
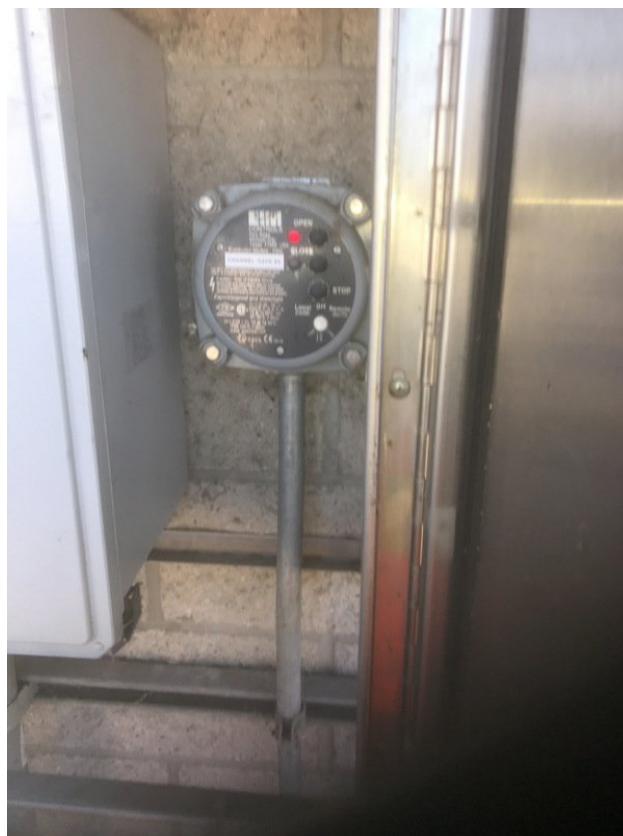
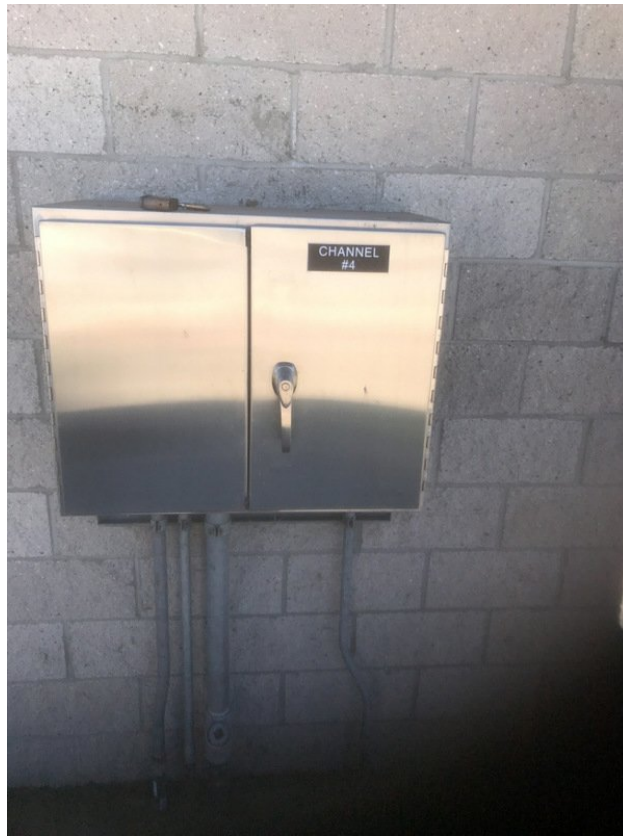
| Electrical Equipment Photos | |

| Electrical Equipment Observations | No Corrosion Noted |
| Electrical Equipment Condition Score | 1 - Excellent |

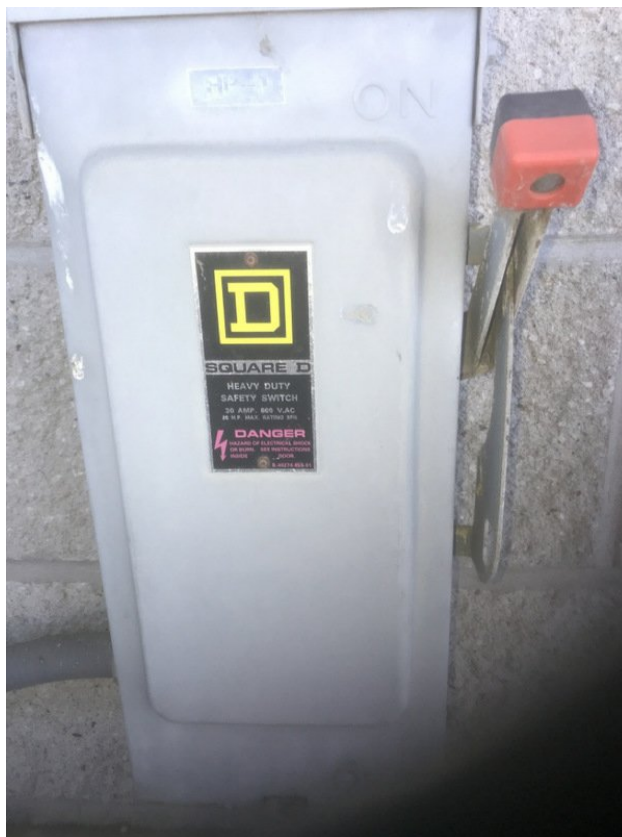
Electrical Equipment Photos

| Electrical Equipment Observations | No Corrosion Noted |
| Electrical Equipment Condition Score | 1 - Excellent |
