City of Milpitas Sewer Master Plan

Sewer Master Plan

Prepared by HydroScience Engineers, Inc.

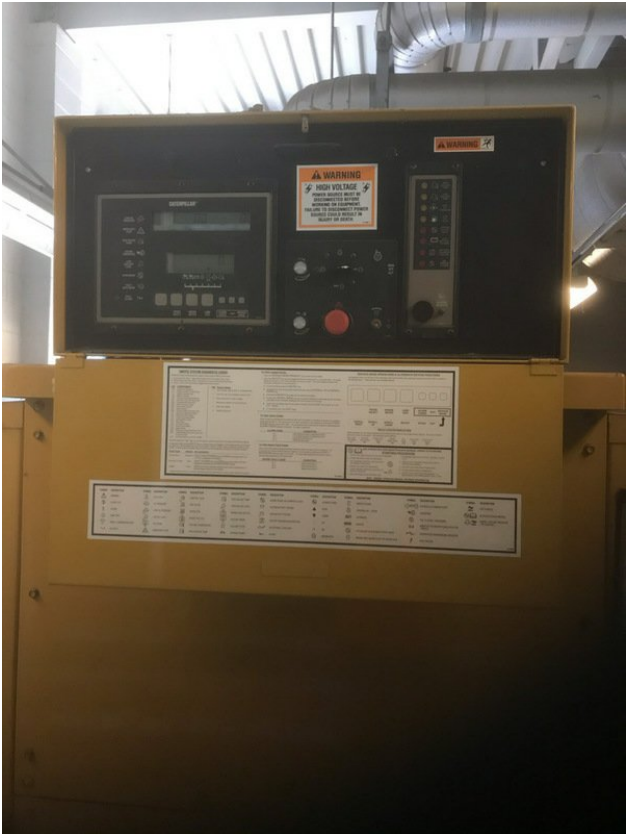
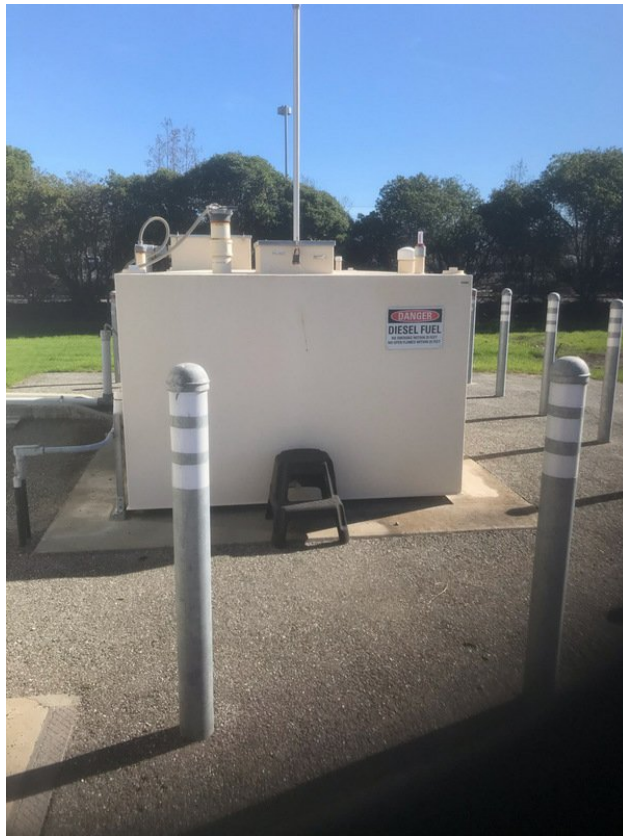
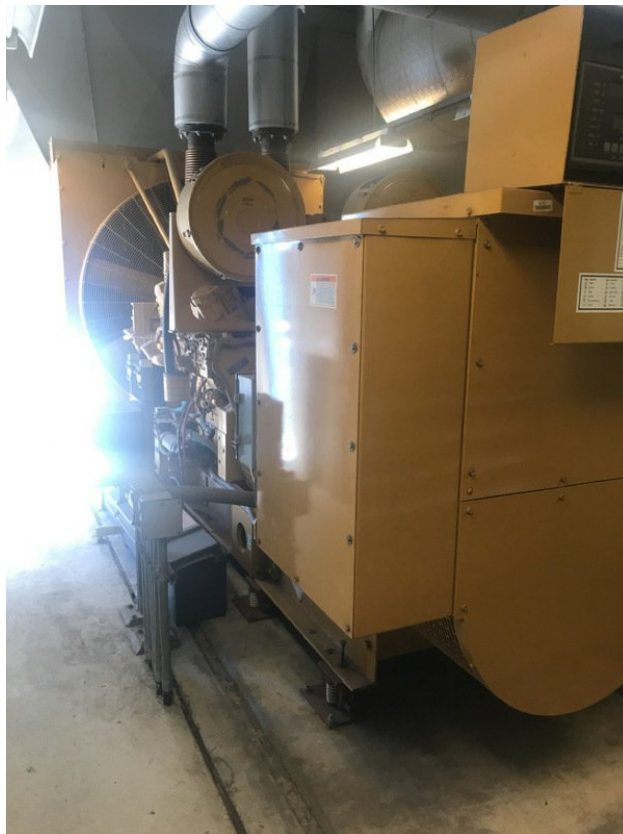
Electrical Motor Photos

| Electrical Motor Observations | No Corrosion Noted |
| Electrical Motor Condition Score | 1 - Excellent |

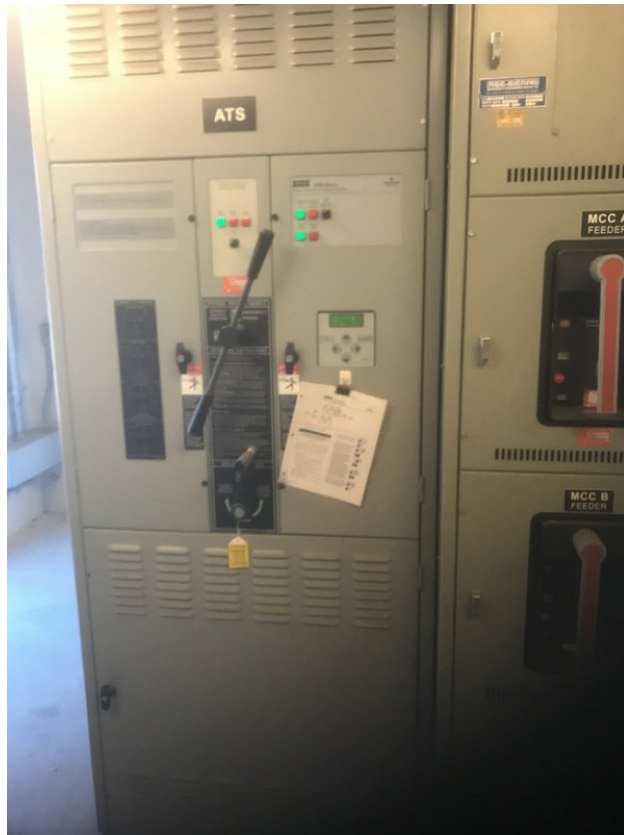
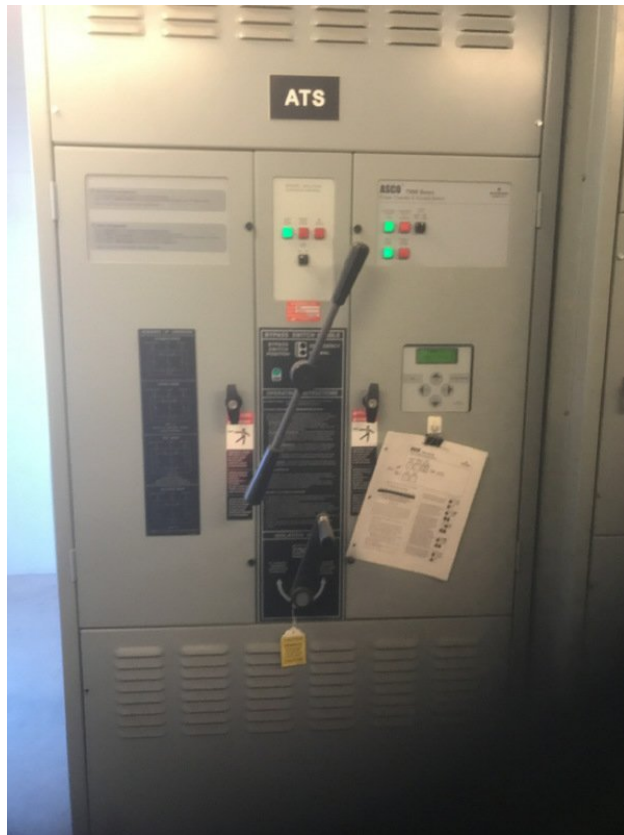
| Electrical Equipment Photos | |

| Electrical Equipment Observations | No Corrosion Noted |
| Electrical Equipment Condition Score | 1 - Excellent |

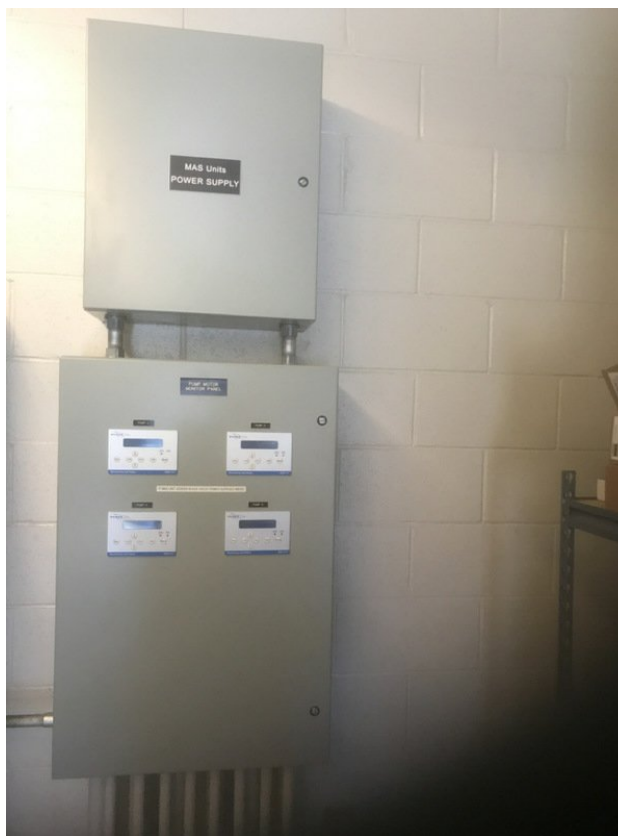
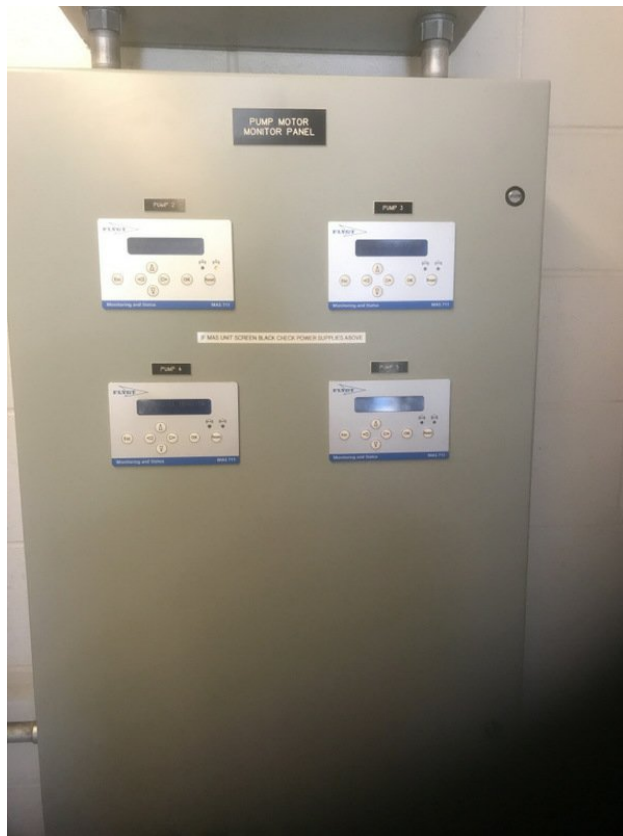
Instrumentation Photos

Instrumentation Observation Comments

No Corrosion Noted

Instrumentation Condition Score

1 - Good – No defects observed.

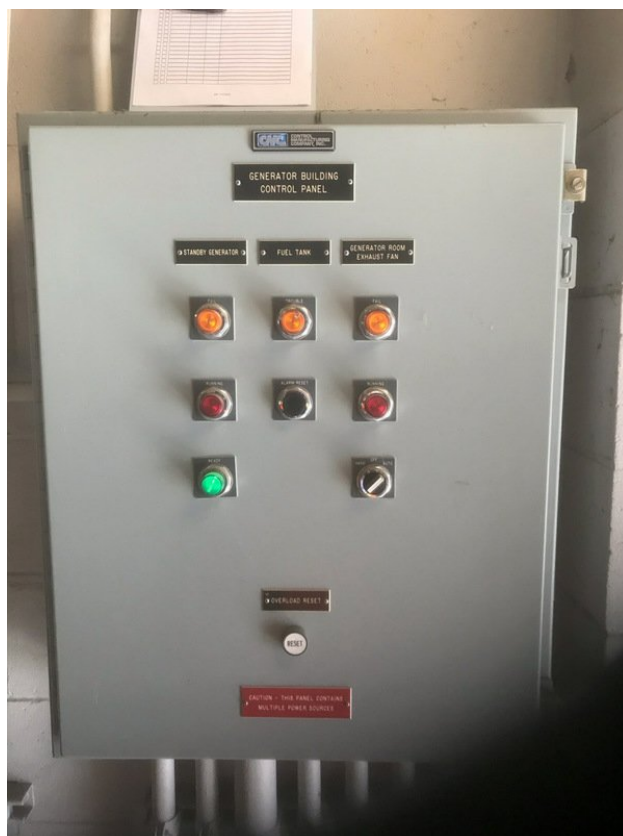
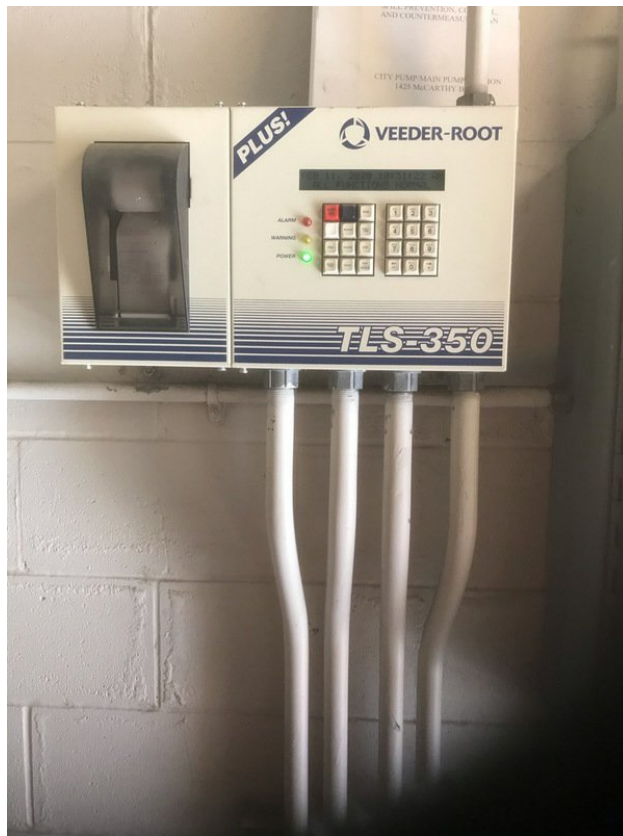
Instrumentation Photos

| Instrumentation Observation Comments | No Corrosion Noted |

| Instrumentation Condition Score | 1 - Good – No defects observed. |

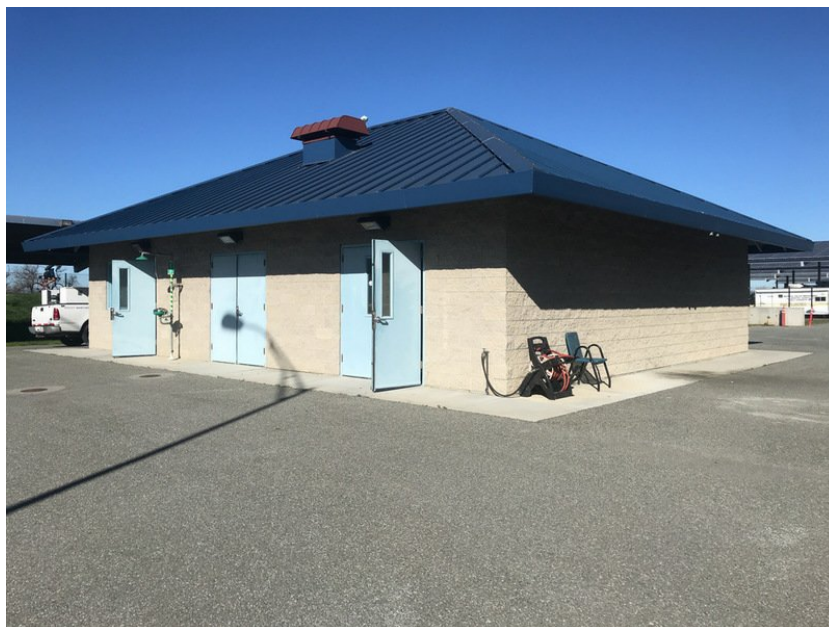
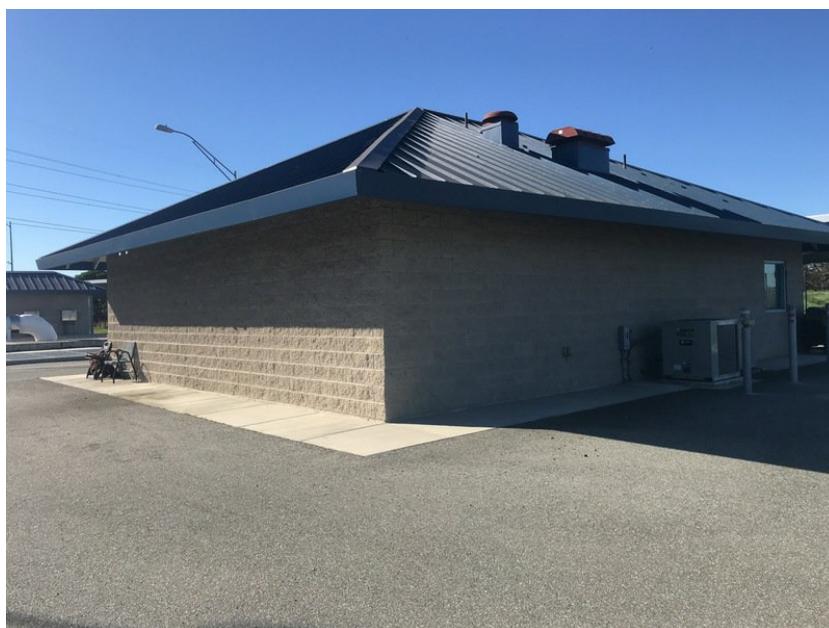
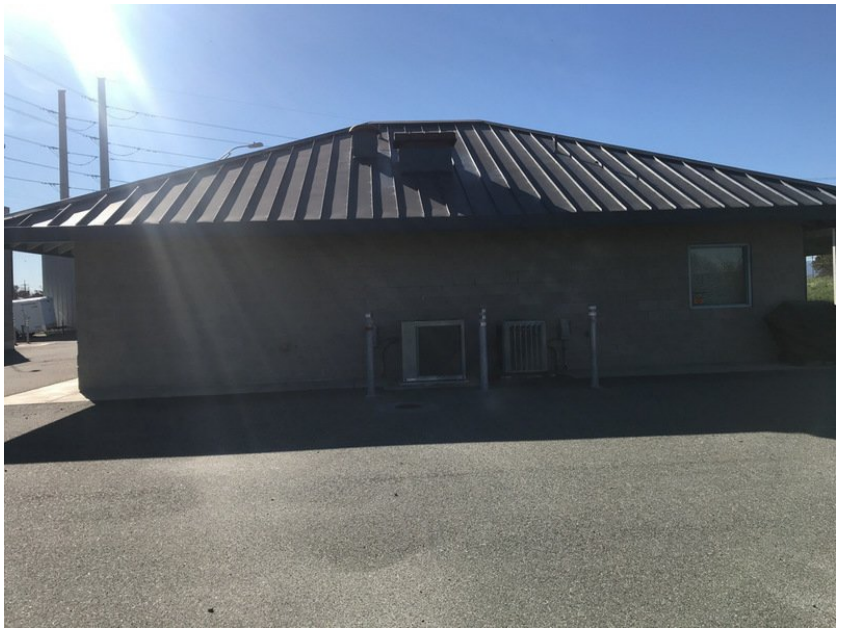
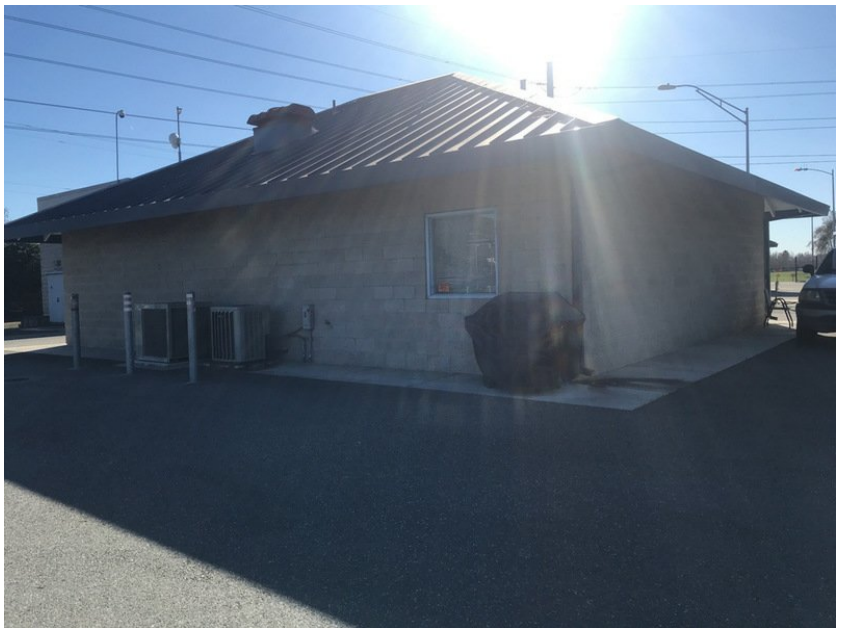
Civil Photos

| Civil Condition Score | 1 - Good – No defects observed. |

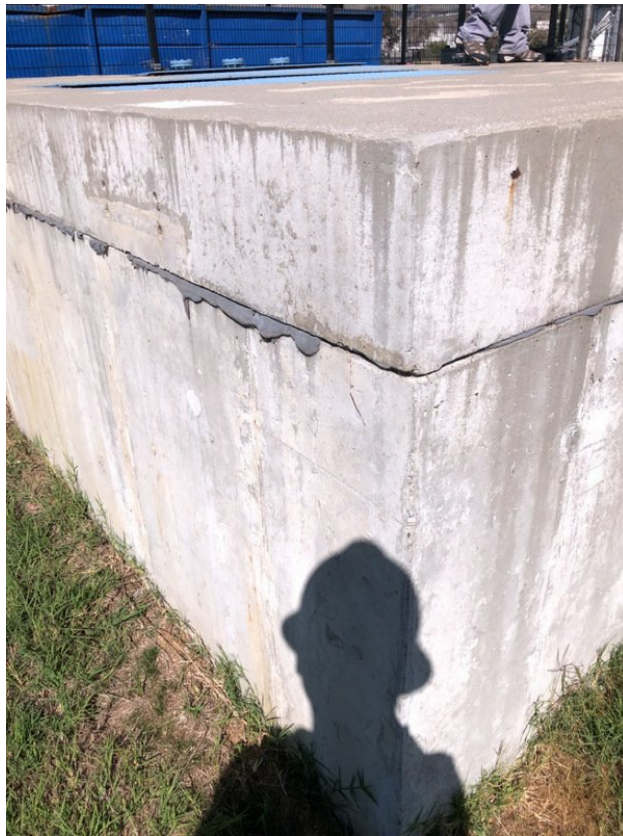
Cold joint

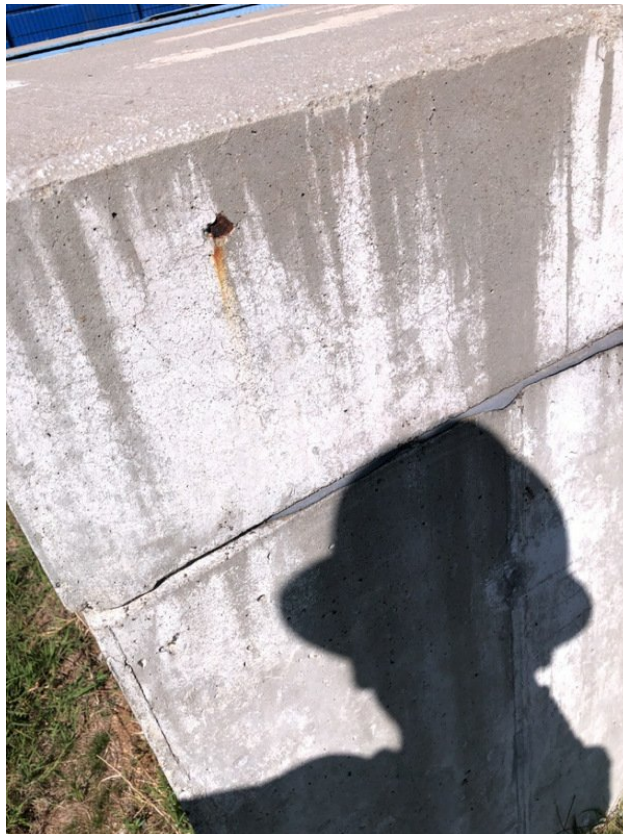
Exposed rebar

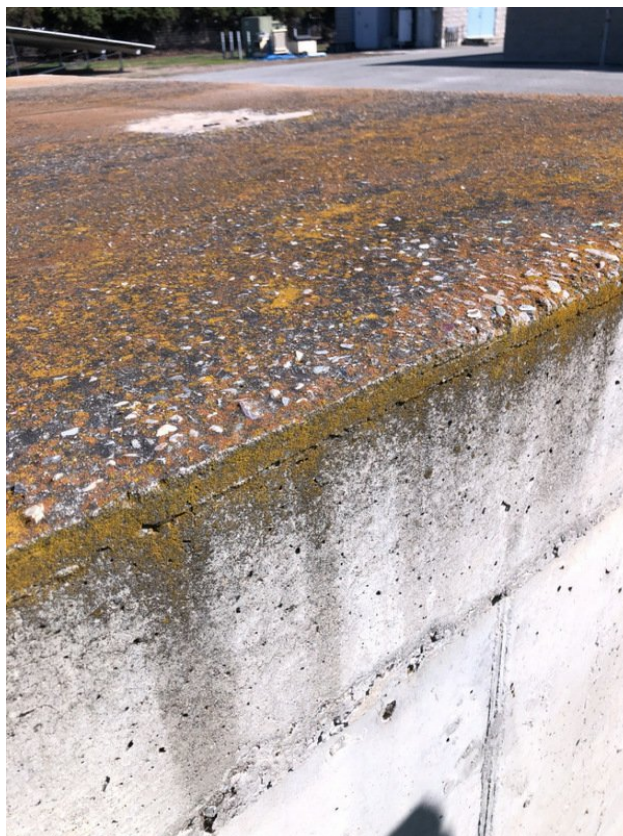
Exposed aggregates

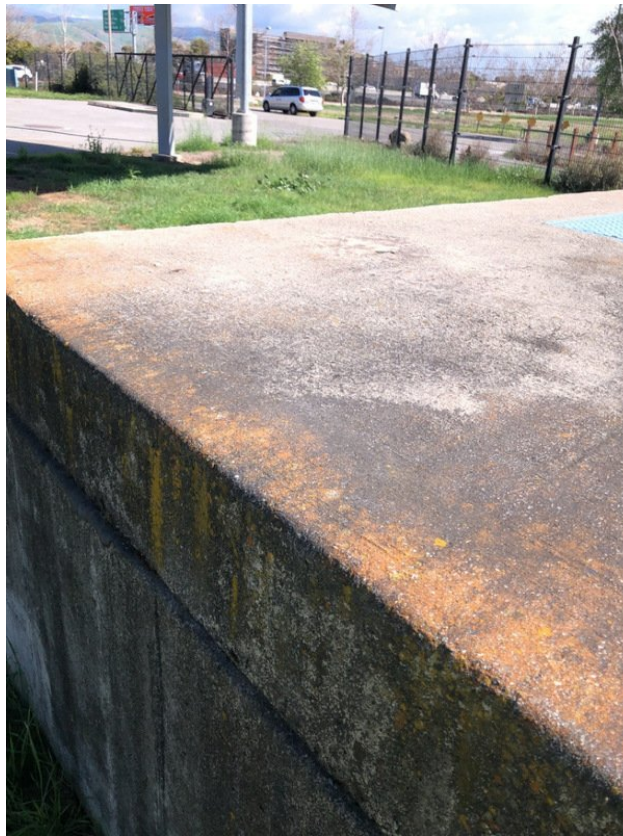
Exposed aggregates, sim to 2

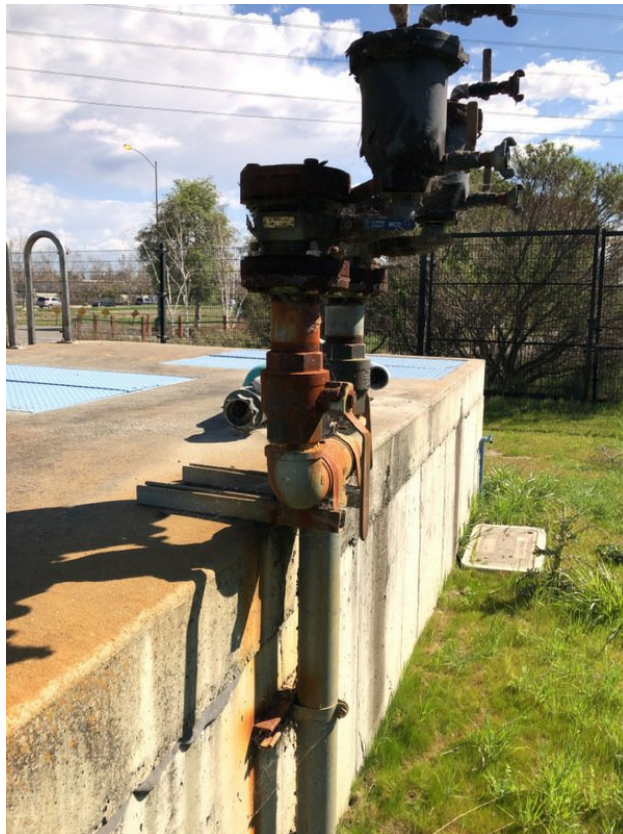
Corroded metal attachment

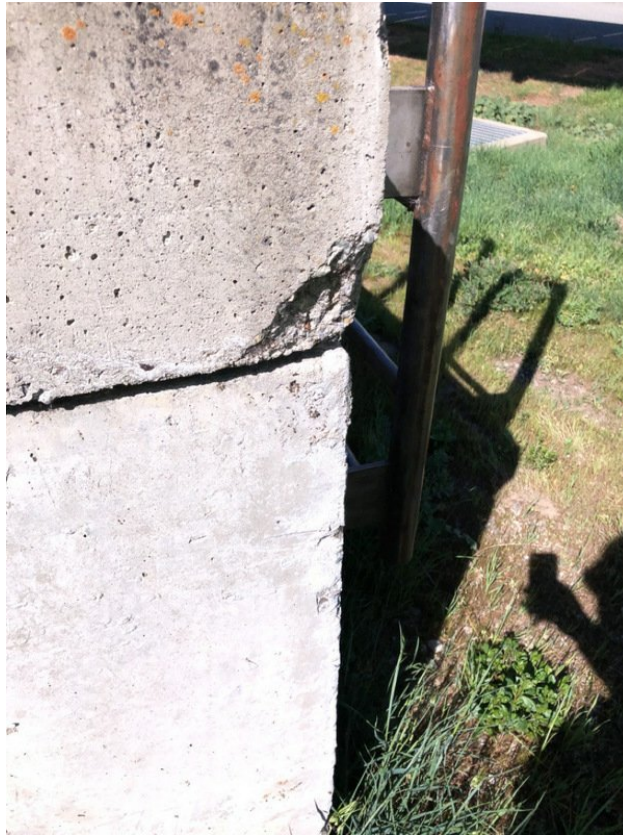
Spalling concrete

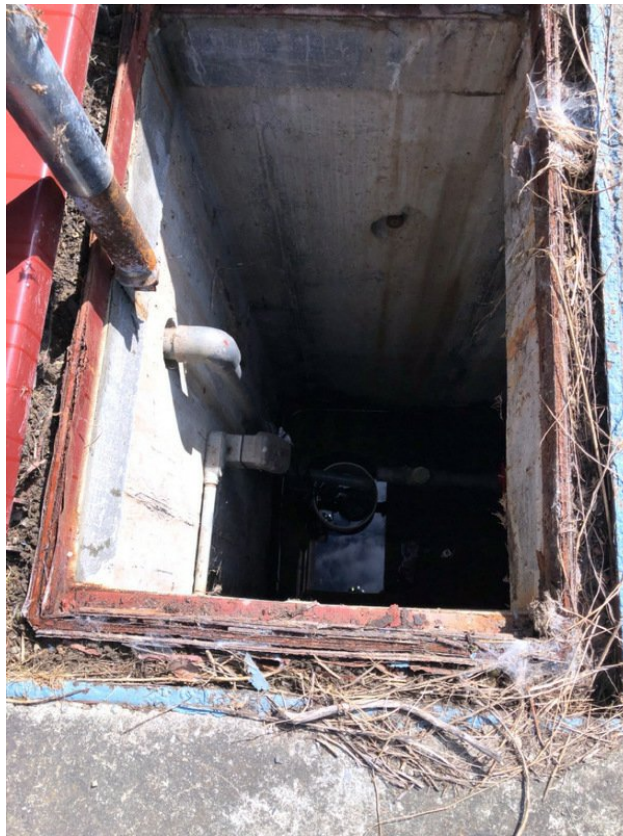
Corroded metal

Corroded metal at hatch opening

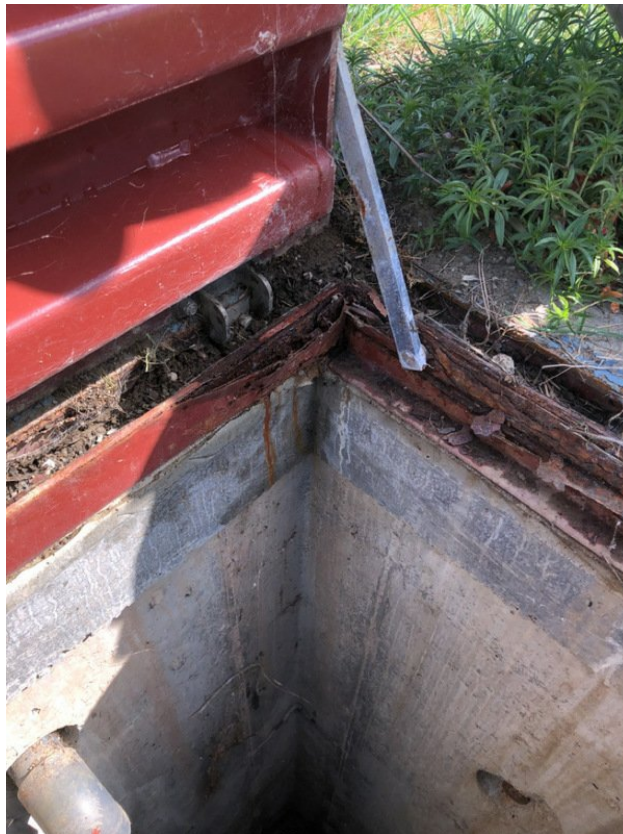
Corroded metal

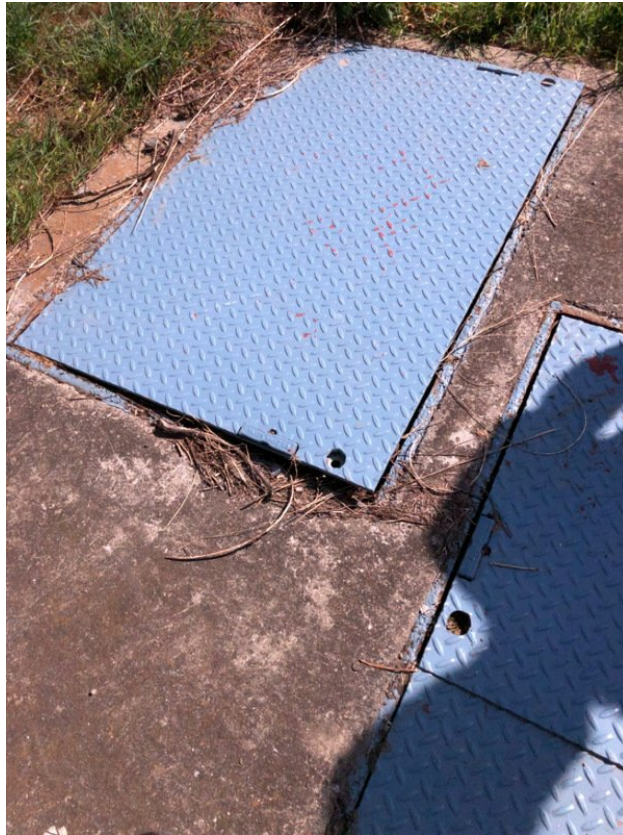
Does not close All the way due to expansion from corrosion

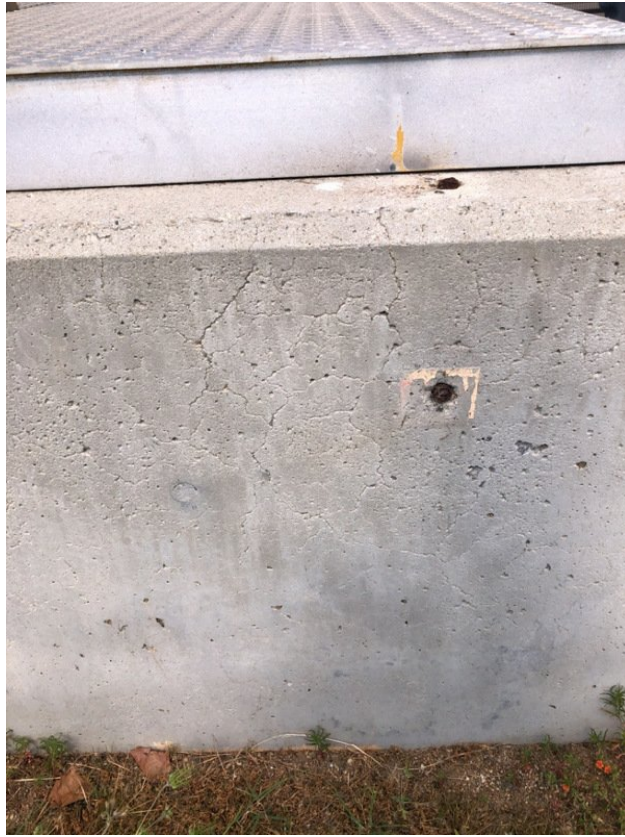
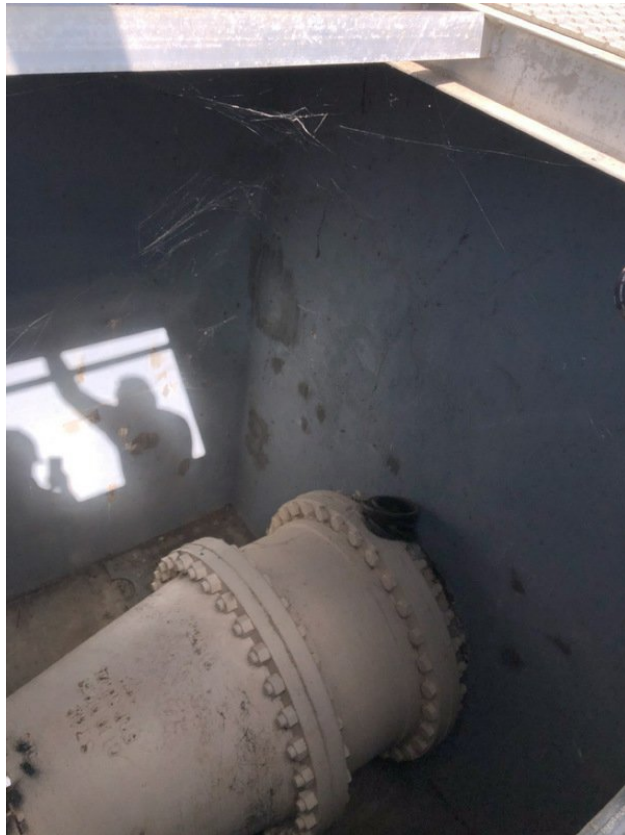
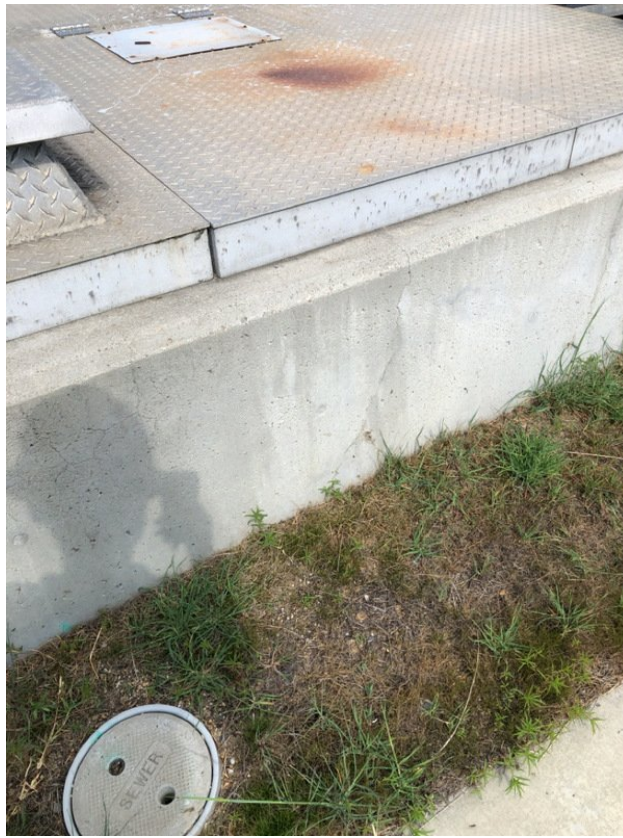
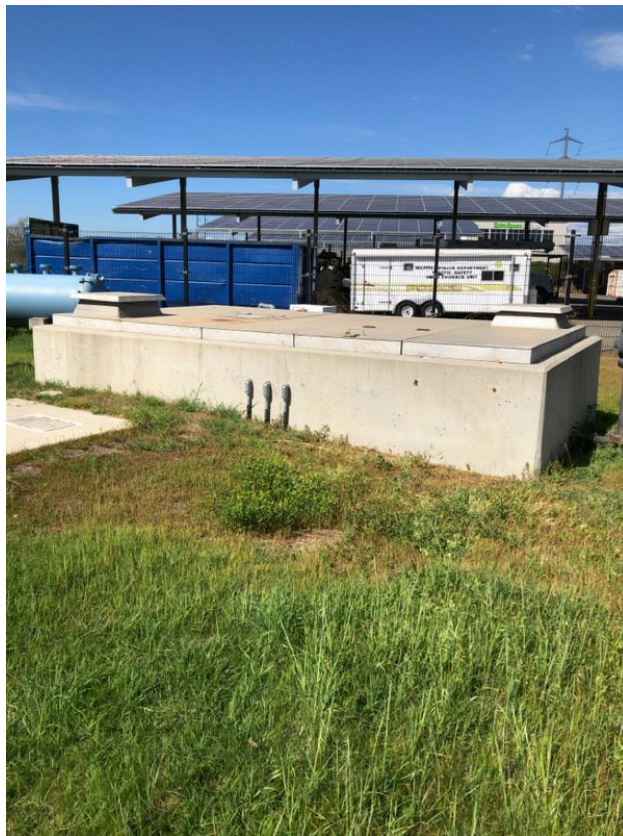
| Structural Field Assessment | Cracks in walls |

No cracking inside, surface cracks on outside, coating still present on inside

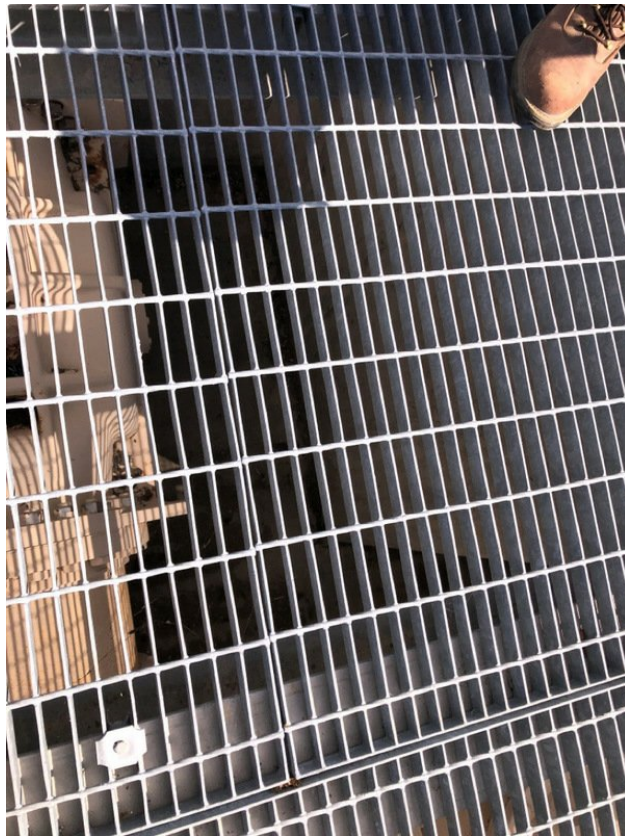
No visible cracks on inside

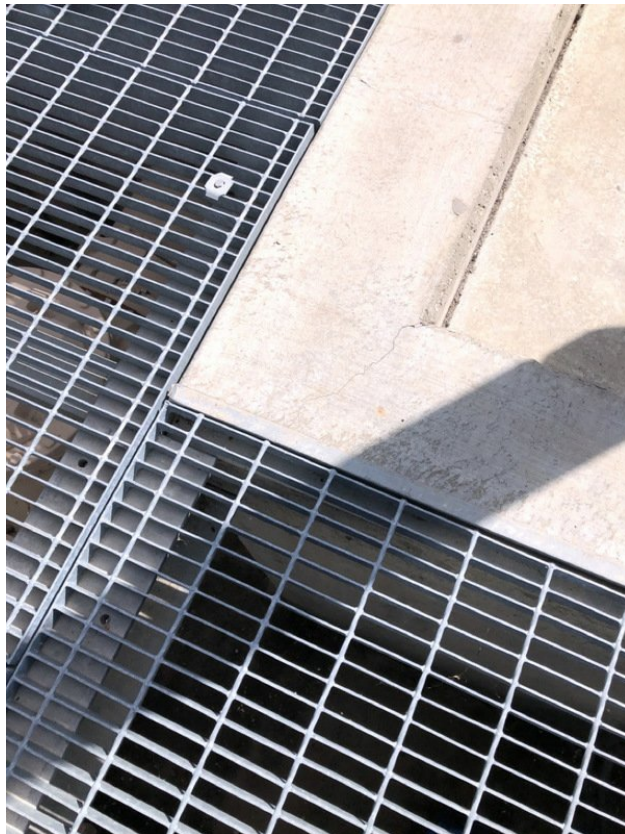
No visible cracks besides on curb outside

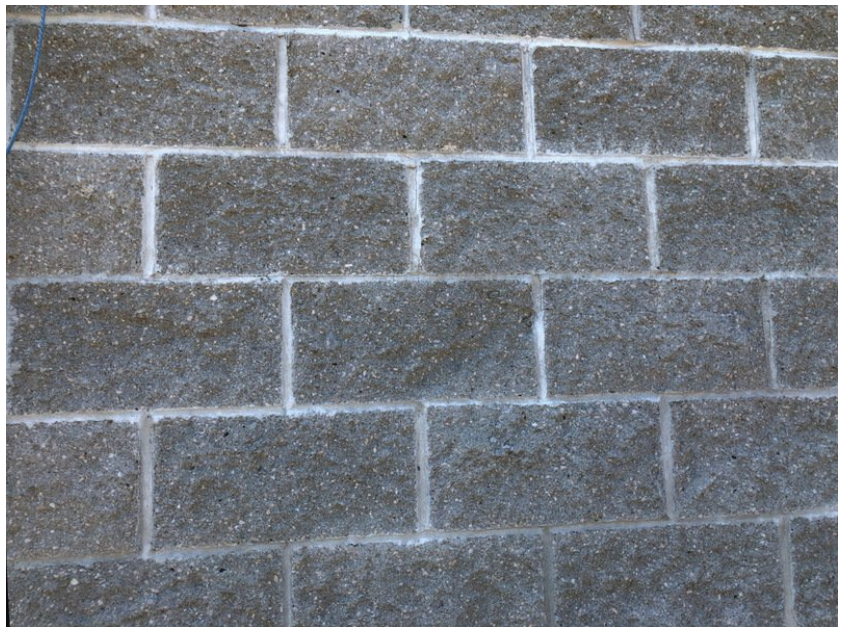
Cracks, back side

| Structural Observation Comments | Some cracks inside and outside, cosmetic cracks |

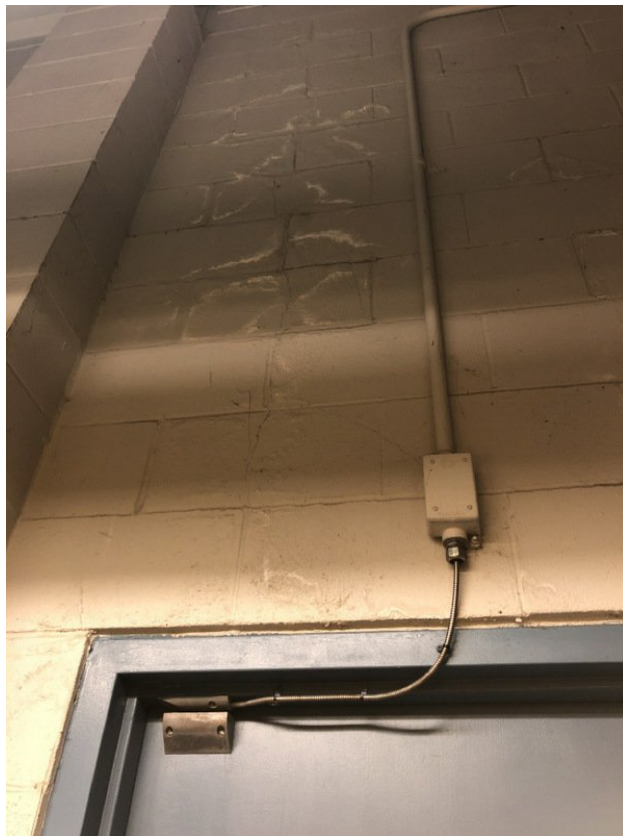
Cracks inside, right side of building

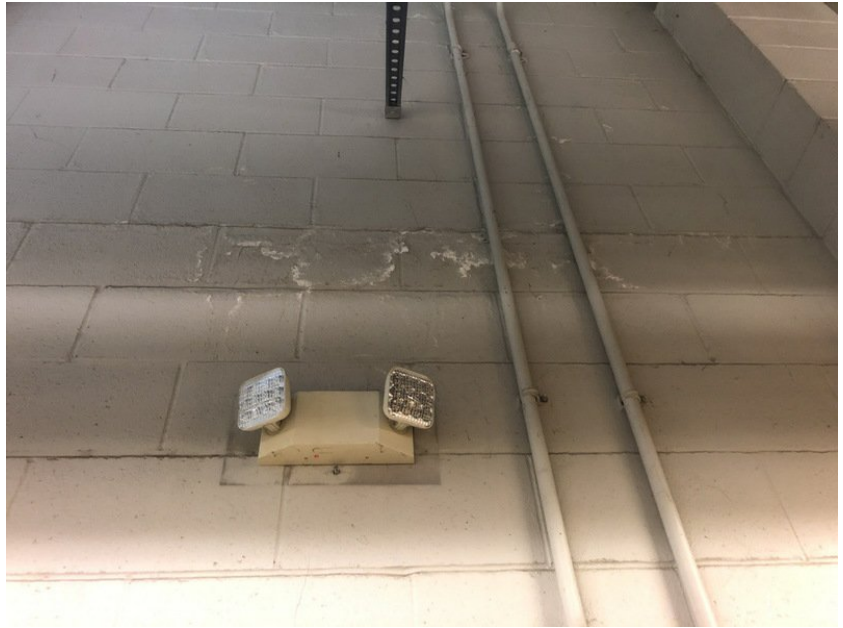
Moisture inside, right side of building

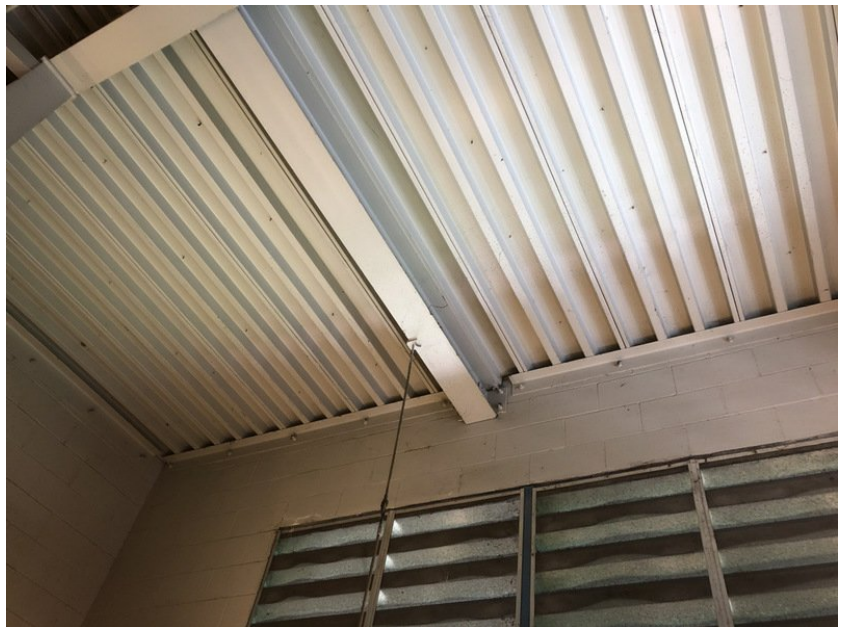
TYP wall to roof connection

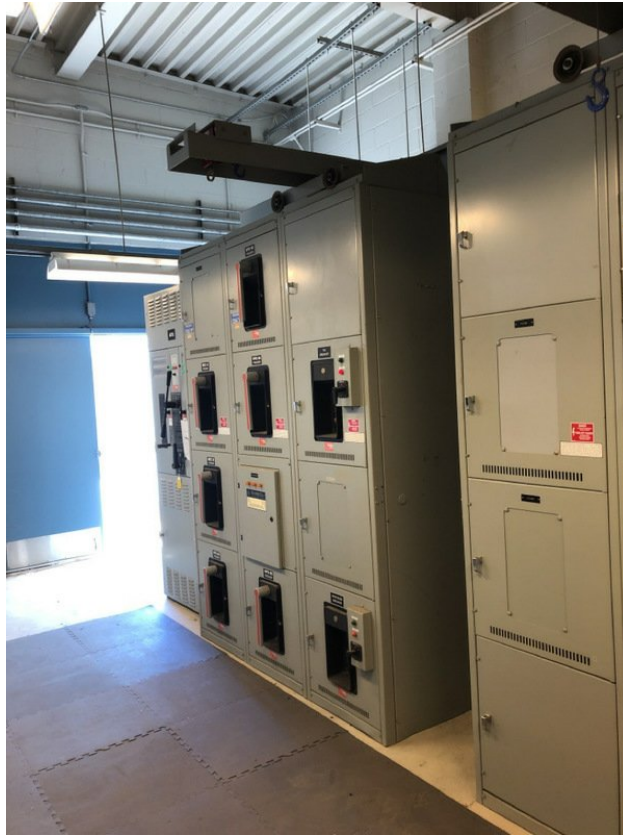
Electrical equipment supposedly anchored, though not visible outside

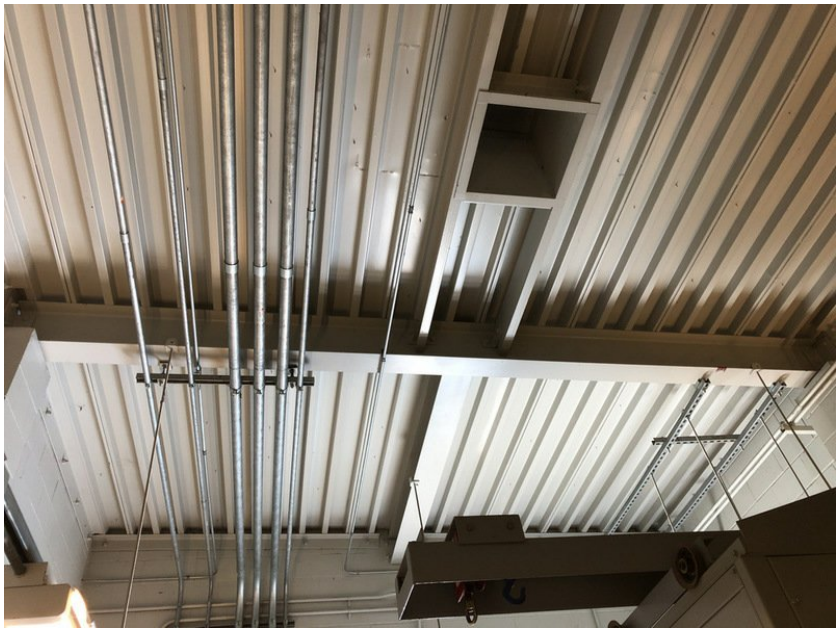
Roof beams

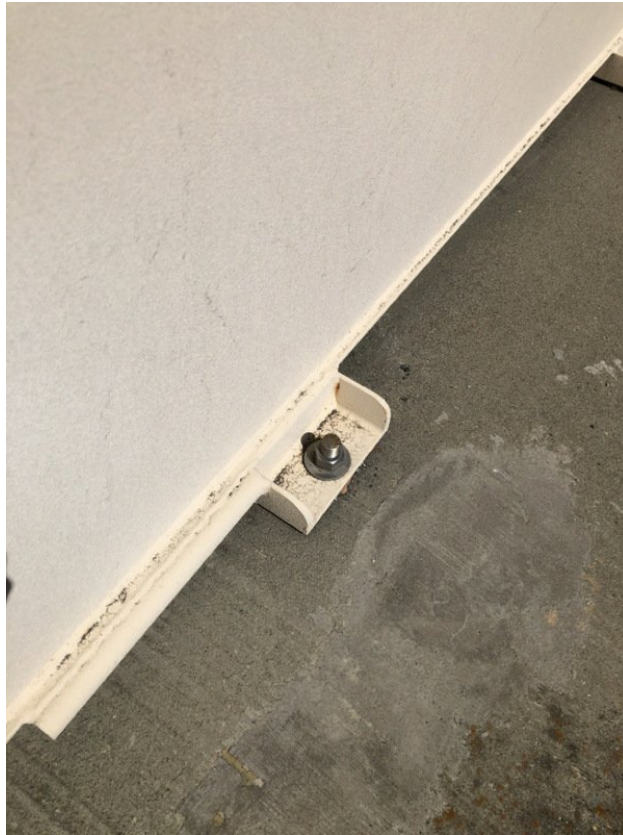
Stainless steel anchors

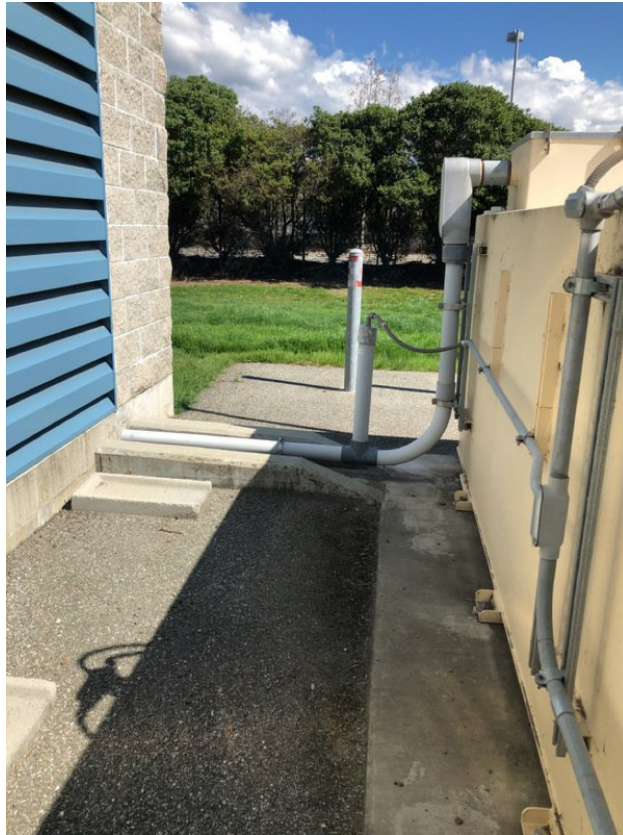
Not flexible

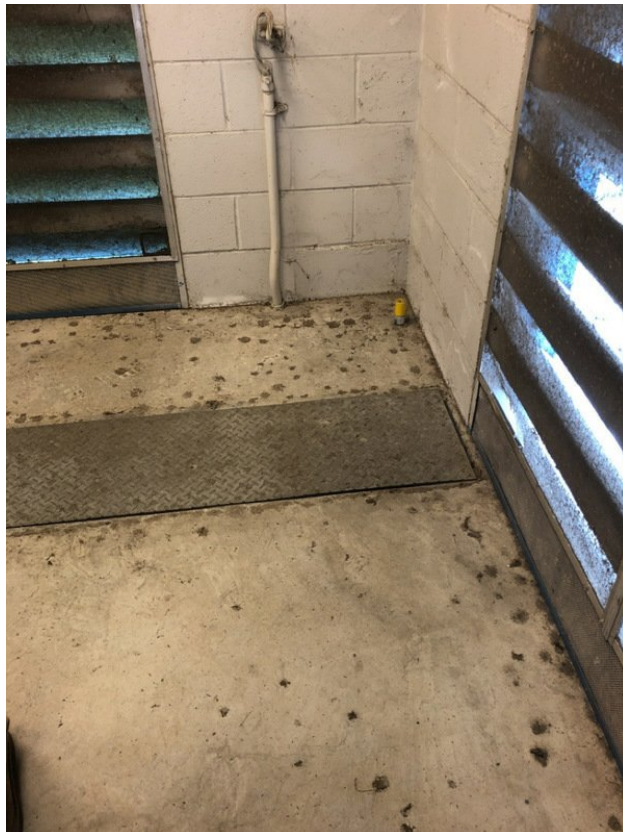
Pipe continues inside building, underneath Grating/cover plate

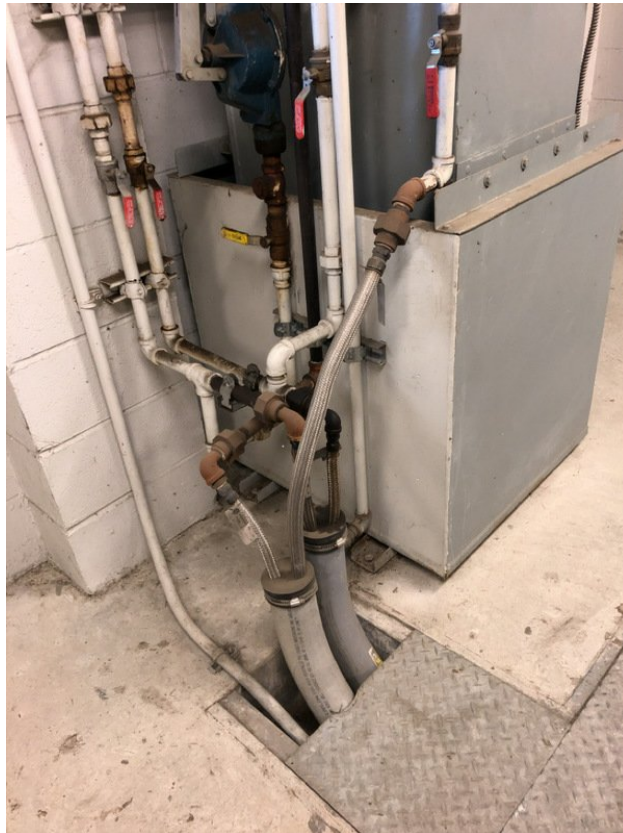
Connects to day tank, flexible coupling here

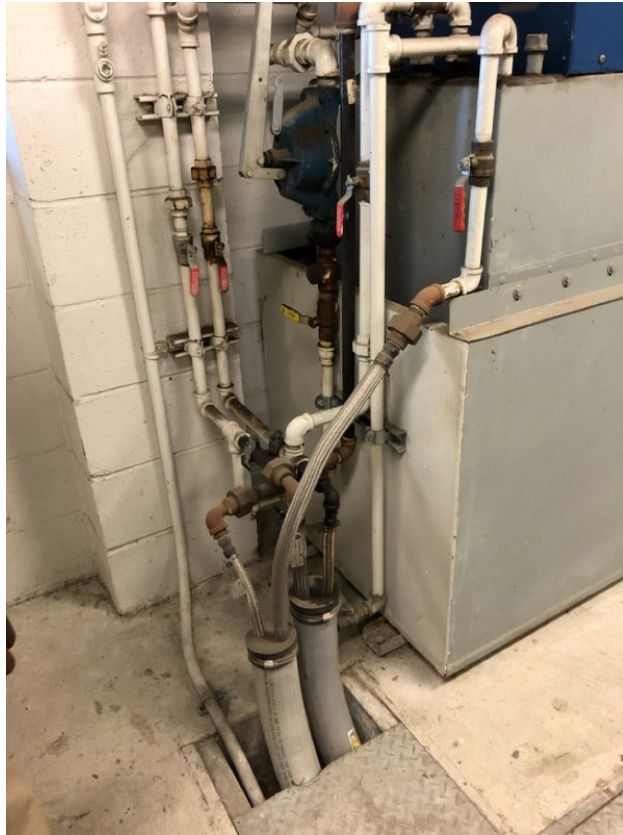
Piping on one side, piping attached to wall, flexible connection for 2 lines only (2 gray pipes coming out of slab), 4 red shutoff valves

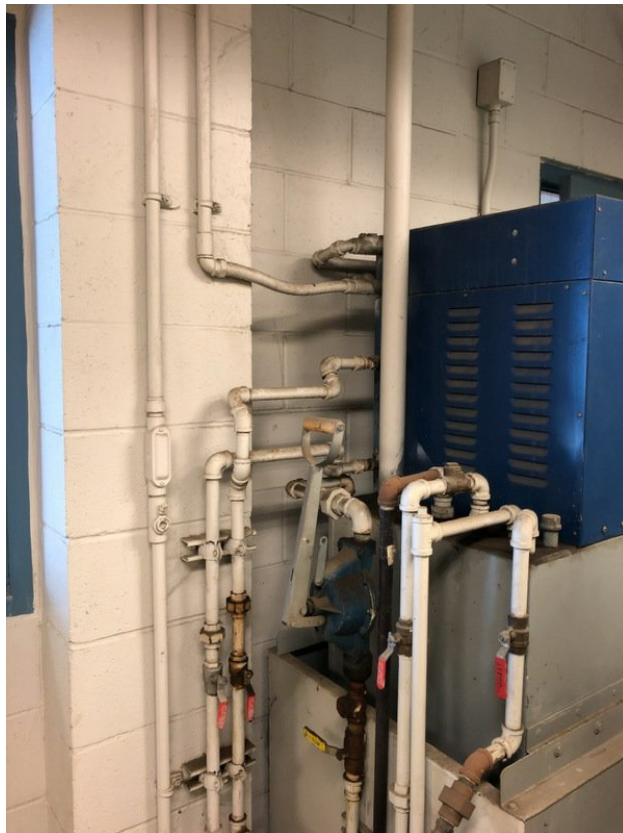
No flexible coupling here

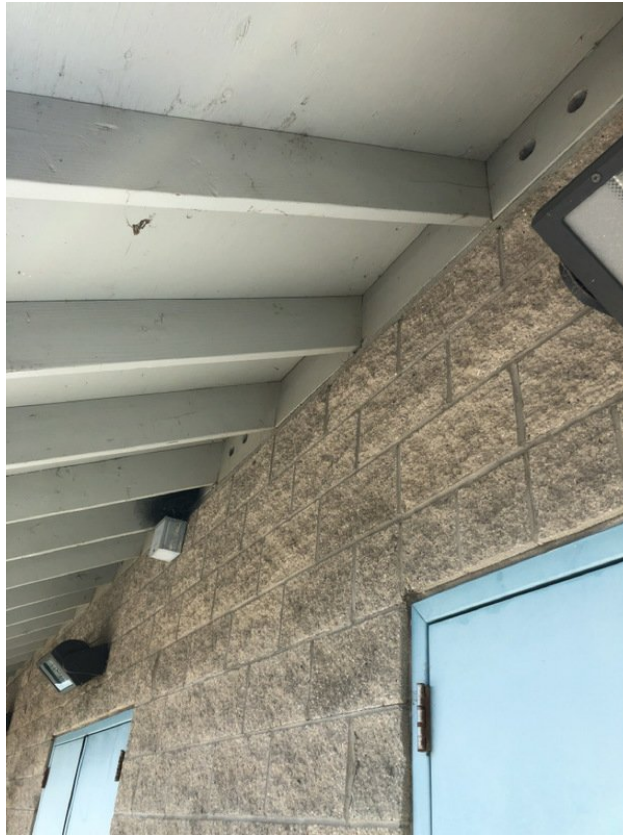
Connection to roof, from outside, vertical blocking different than what is shown on drawing

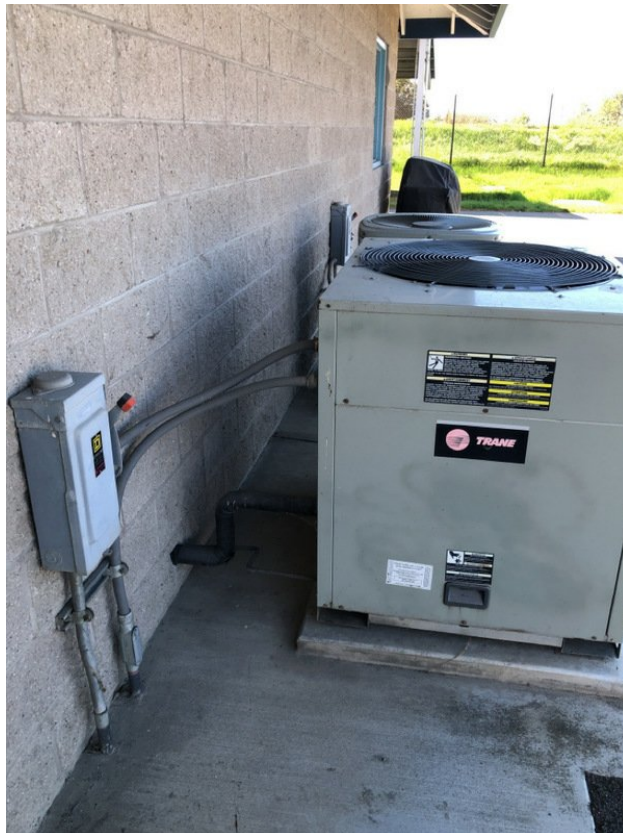
Flexible coupling

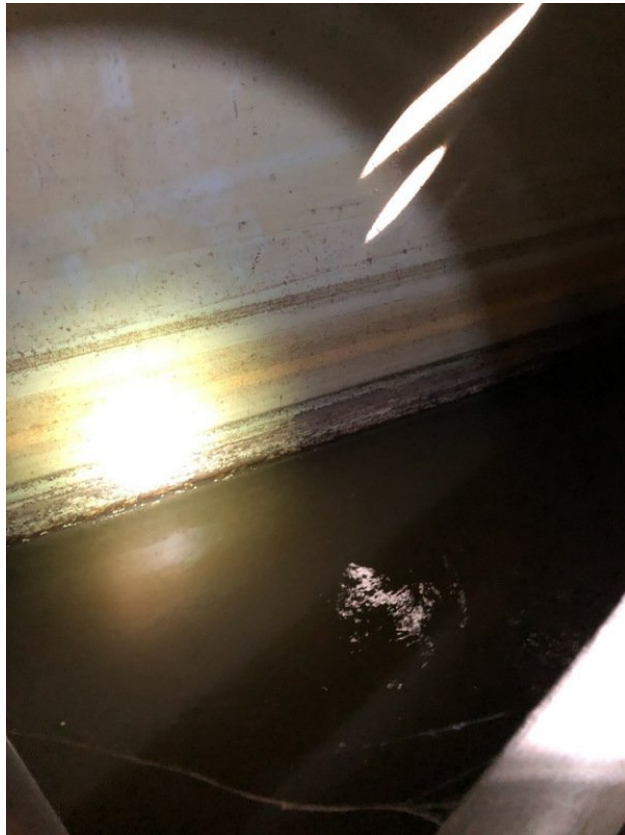
Eroding of coating and concrete, color change at bottom
