City of Milpitas Sewer Master Plan

Sewer Master Plan

Prepared by HydroScience Engineers, Inc.

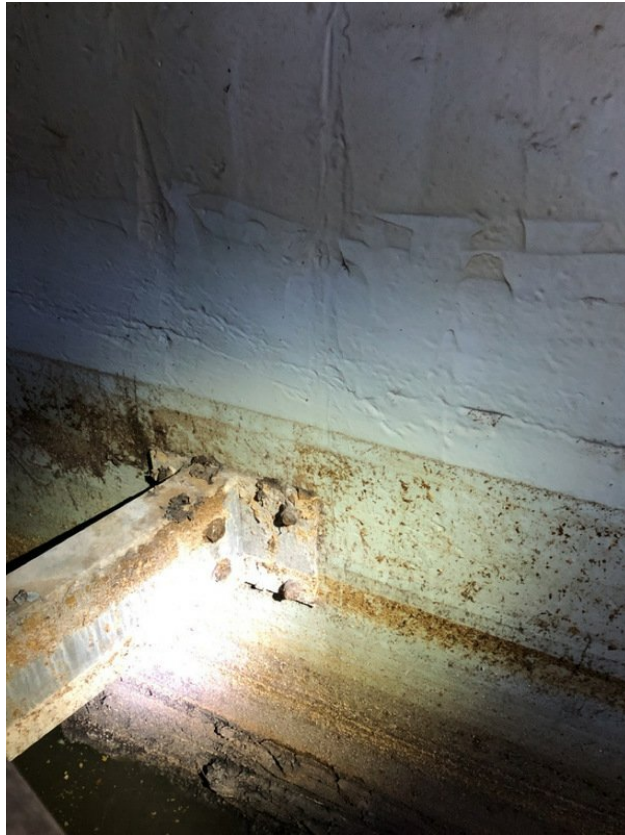
Dirt on steel not corrosion

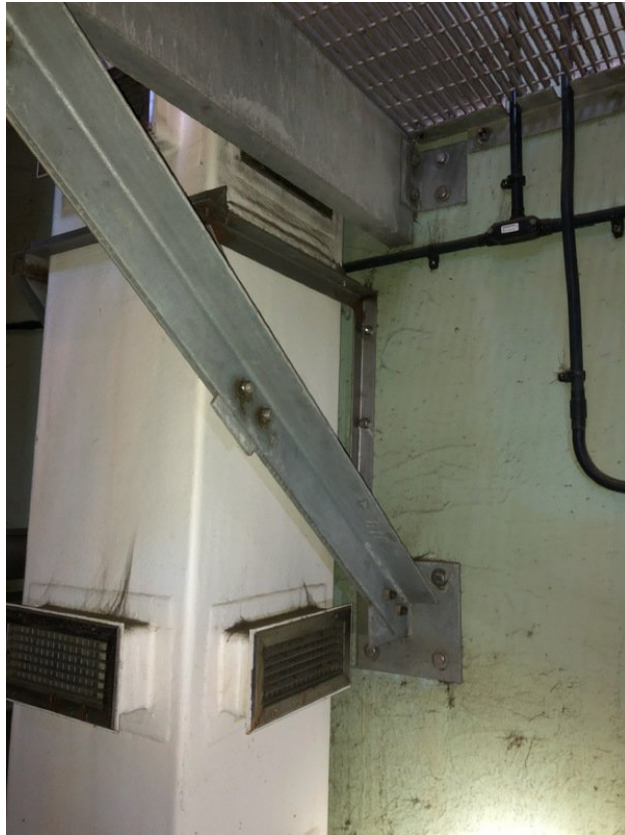
Stair knee brace connection

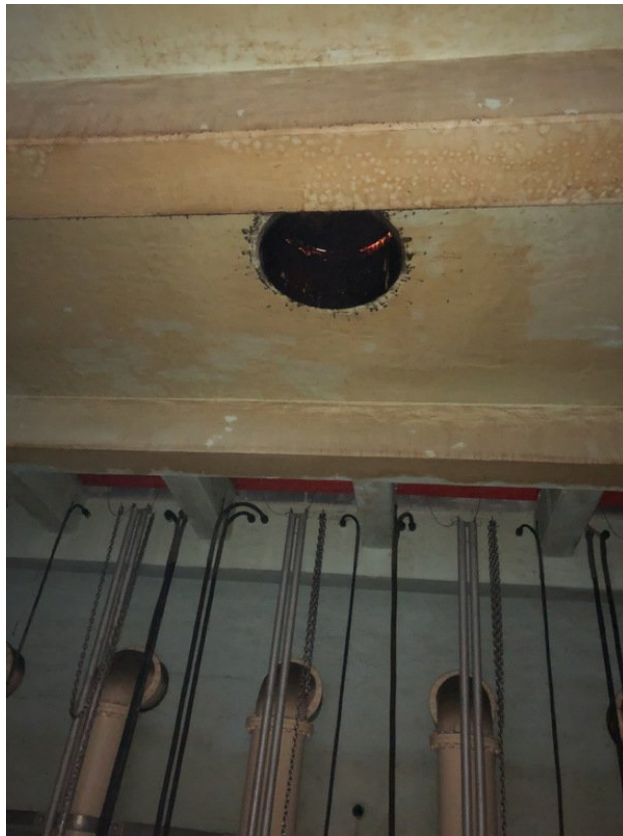
Penetration on opposite side of grit chamber

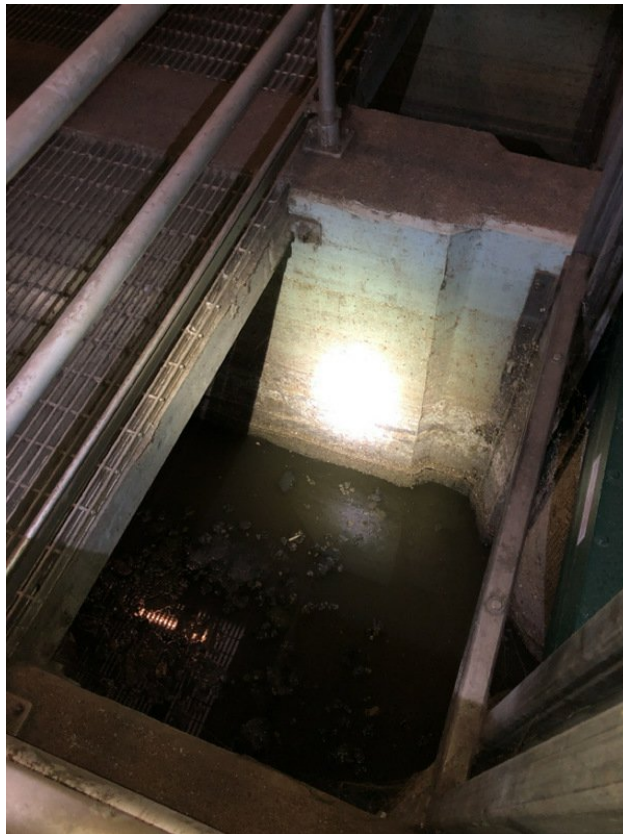
Compromised coating

| Structural Observation Comments | Coating appears to be deteriorating towards bottom, tanks were in operation, no inspection of walls and slab below liquid line |

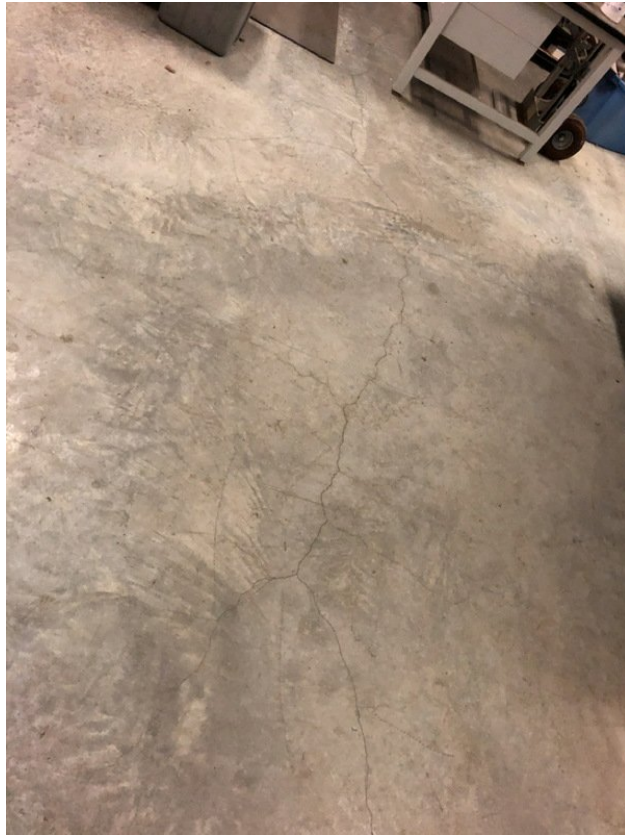
Cracks in slab, inside view, when it rains, water propagation follows cracks (water may have come up through cracks)

Water accumulation inside when it's raining, water seeps thru slab

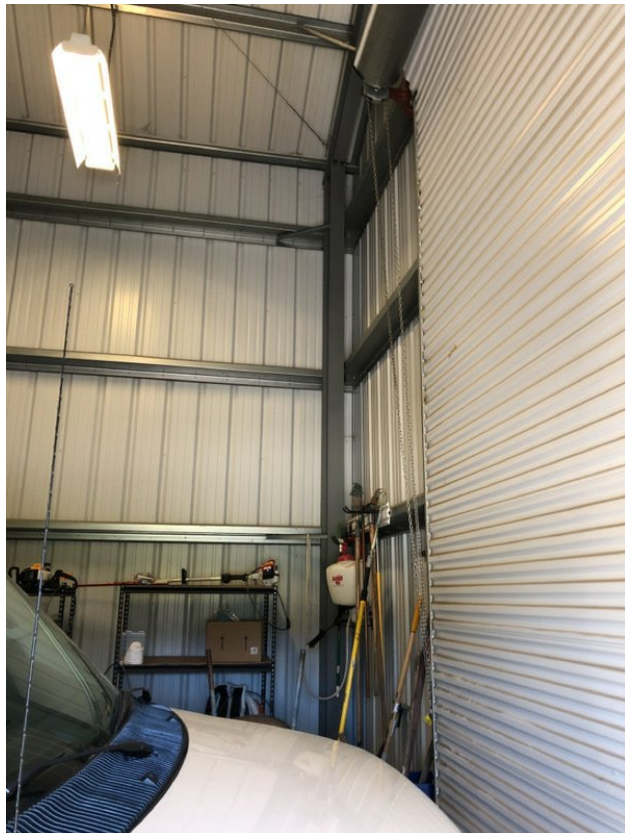
TYP wind girts

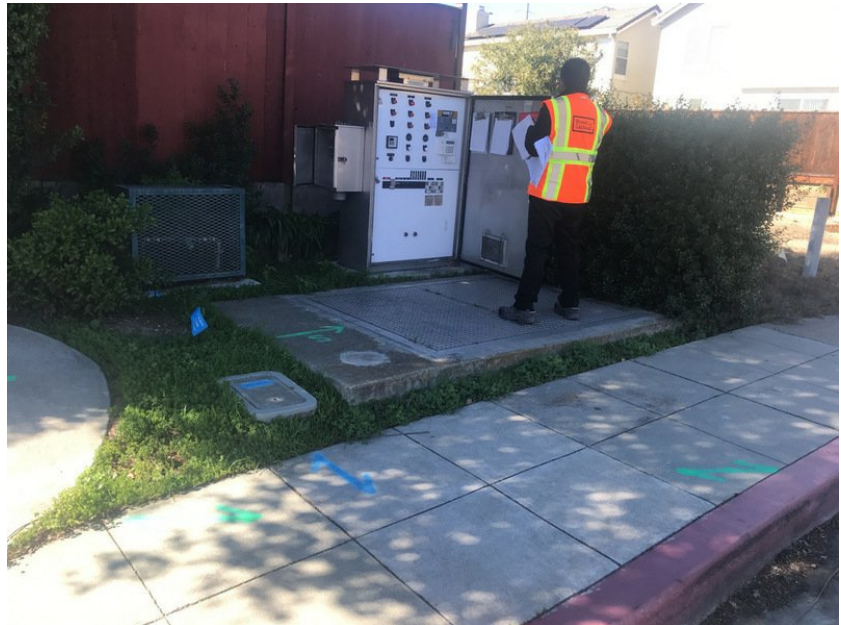
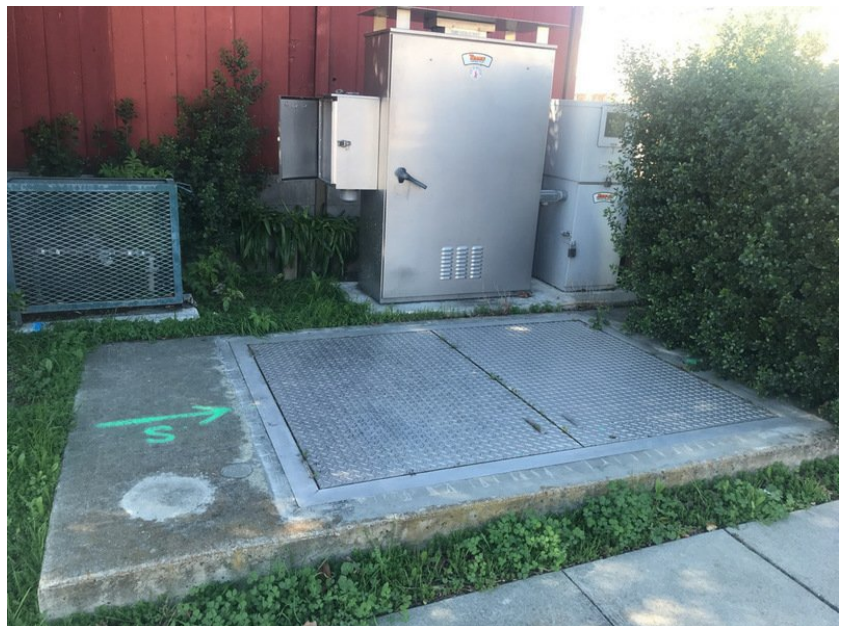
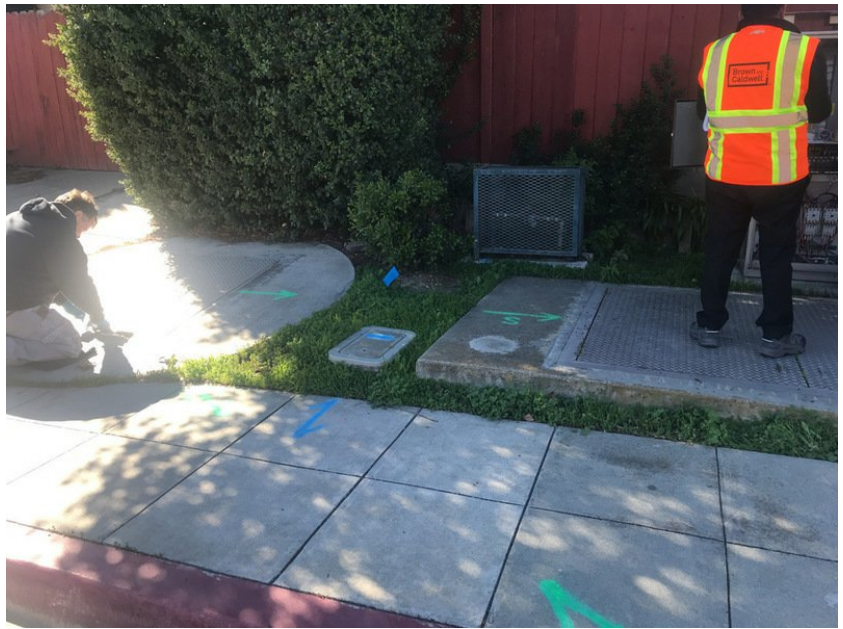
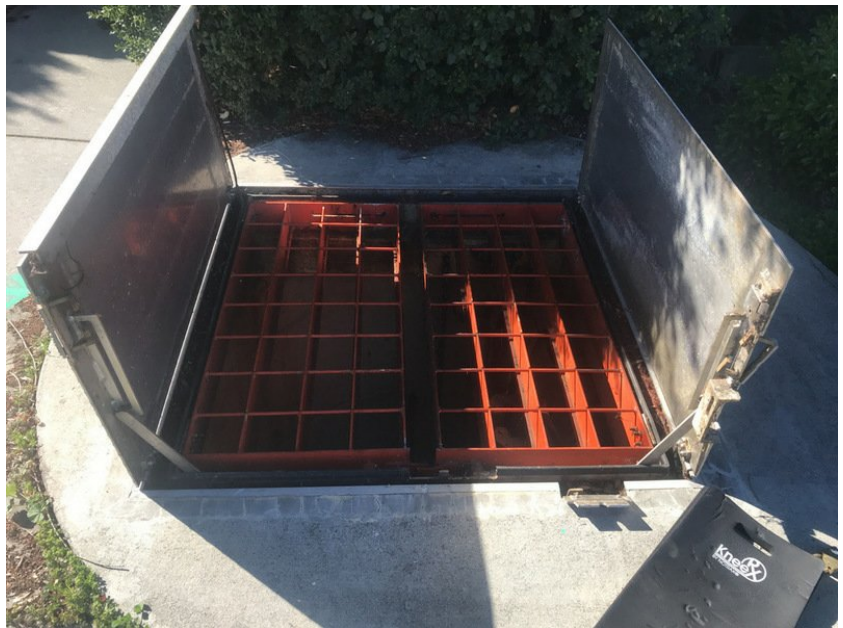
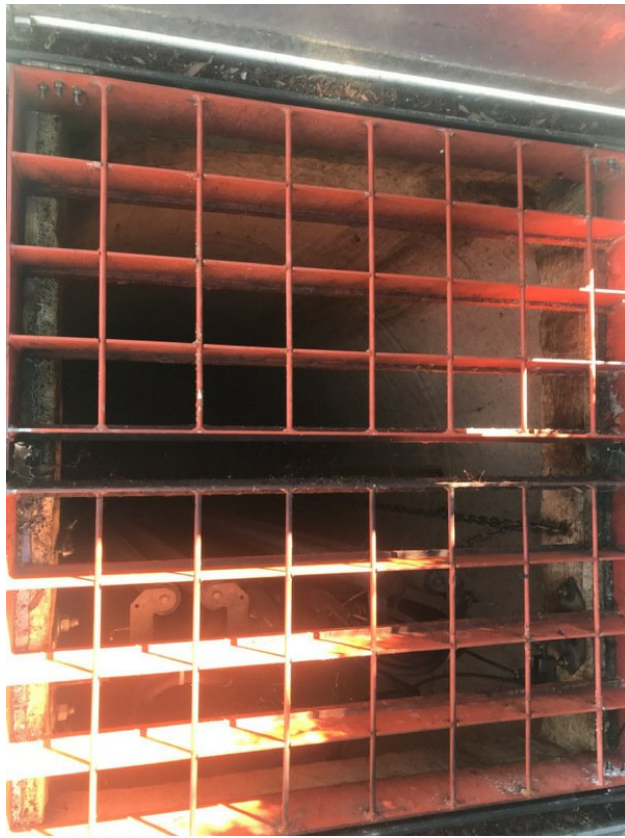
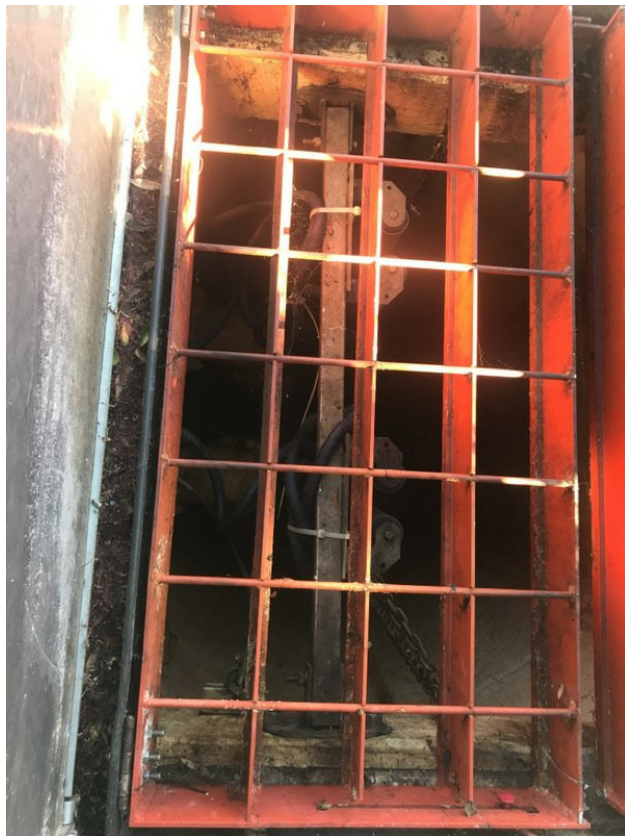
Civil Photos

1 - Good - No defects observed.

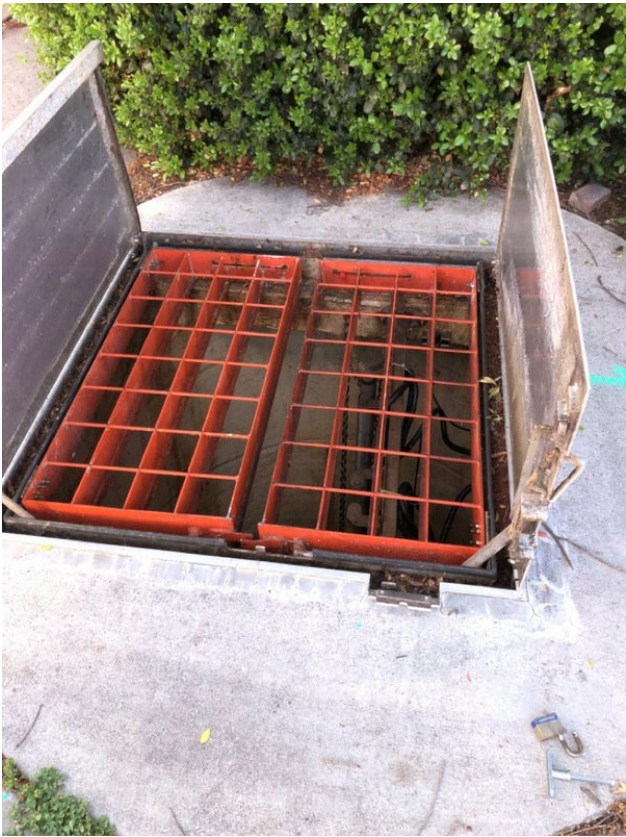
Structural Photos

| Structural Condition Score | 1 - Good – No defects observed. |

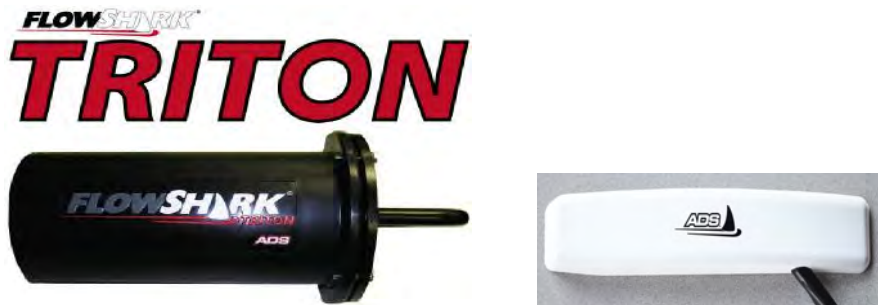
Flow Monitoring Equipment

The **ADS FlowShark Triton** monitor was selected for this project. This flow monitor is an area velocity flow monitor that uses both the Continuity and Manning's equations to measure flow.

The ADS FlowShark Triton monitor consists of data acquisition sensors and a battery-powered microcomputer. The microcomputer includes a processor unit, data storage, and an on-board clock to control and synchronize the sensor recordings. The monitor was programmed to acquire and store depth of flow and velocity readings at 5-minute intervals.

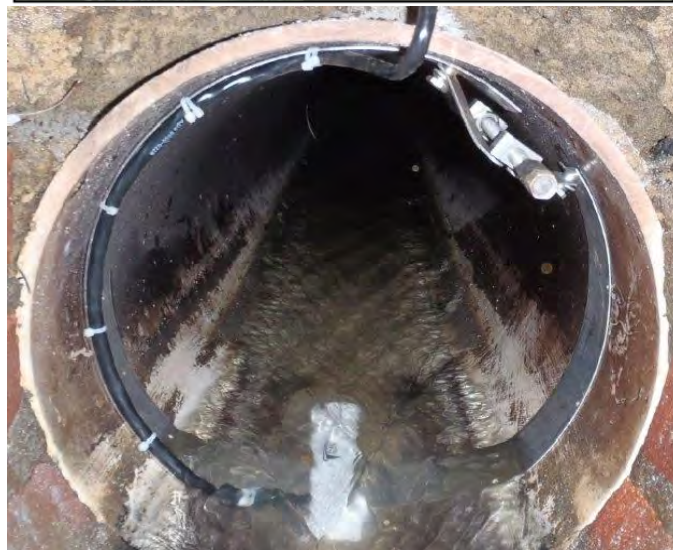
In pipes up to 42 inches in diameter, the sensors were mounted on expandable stainless steel rings, inserted at least a foot upstream into influent pipes and tightened against the inside walls of the pipes. Influent pipe installations reduce the influences of turbulence and backwater often caused by changes in channel geometry in manholes.

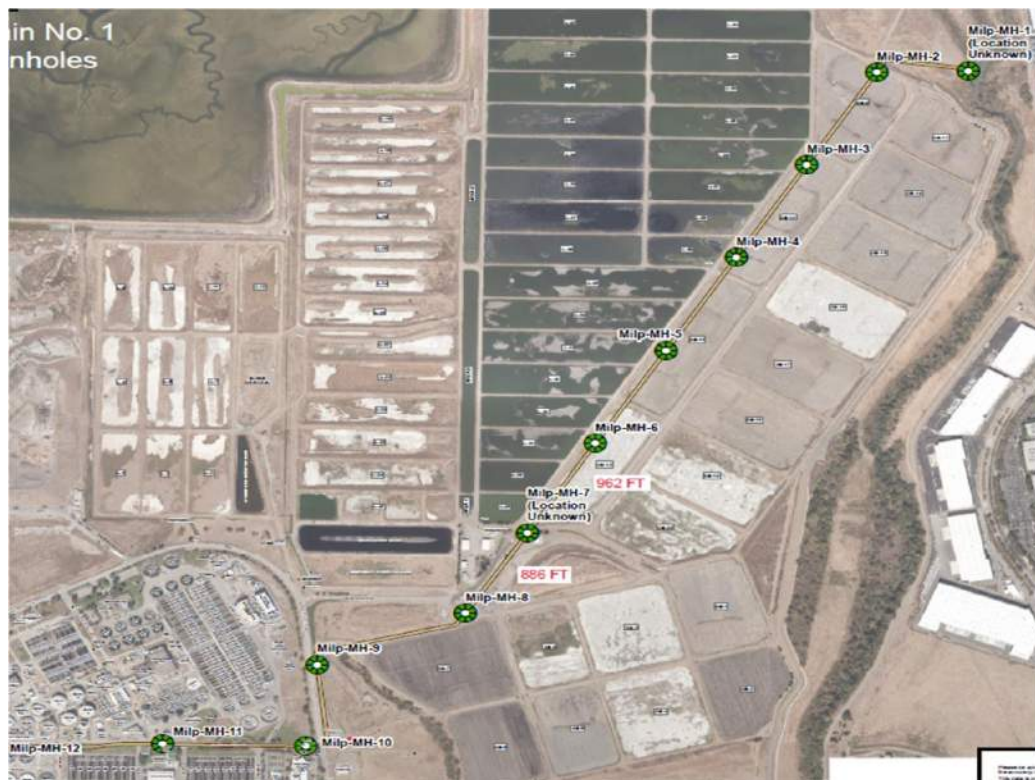
Figure 2- Force Main A Alignment

The entire FM-A (**Figure 02**) is located within the Santa Clara-San Jose Wastewater Treatment Plant property, and the City of Milpitas has an easement to maintain and operate the facility at any time (**Attachment B**). Without any additional provisions or requirements mentioned in the easement, the City of San Jose requires the City of Milpitas to enter into Right of Entry agreement (**Attachment C**) to access the City right-of-way for any work. The City attorney reviewed the languages in the easement and re-affirmed that the City of Milpitas has the right to access and perform work necessary without any further restriction by San Jose. Due to the schedule and need to investigate the FM-A, Engineering applied for a Right of Entry permit and tabled the discussion of the City of Milpitas rights to their Right of way. The permit process took approximately 3 months.

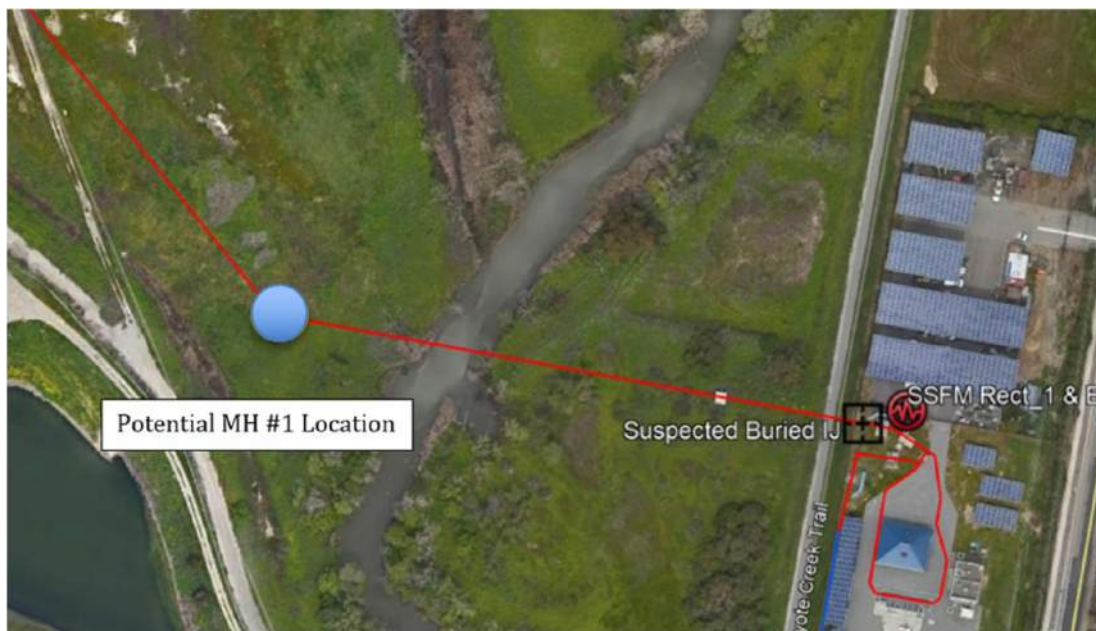
Figure 4: Force Main Manhole #1 Location

Manhole #1: Per Record Drawings, the manhole is located adjacent to Coyote Creek (**Figure 04**) under District jurisdiction. The manhole was not found because the permit issued by Valley Water is limited to pedestrian access and no excavation or removal of vegetation allowed. In order to locate the manhole, heavy equipment will have to be used to excavate and remove the vegetation around the area.

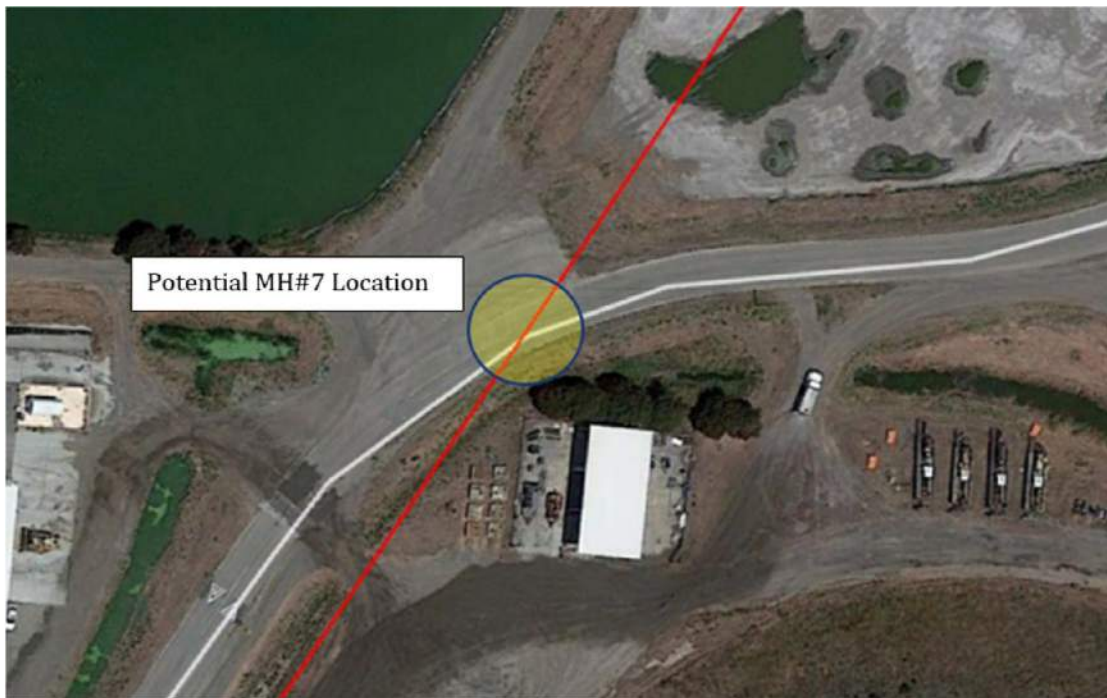
Figure 5: Force Main Manhole #7 Location

Manhole #7: Per Record Drawings, the manhole is approximate 972 feet from manhole #6 (**Figure 05**). Contractor was unable to locate the manhole and speculated it is buried under the existing access road.

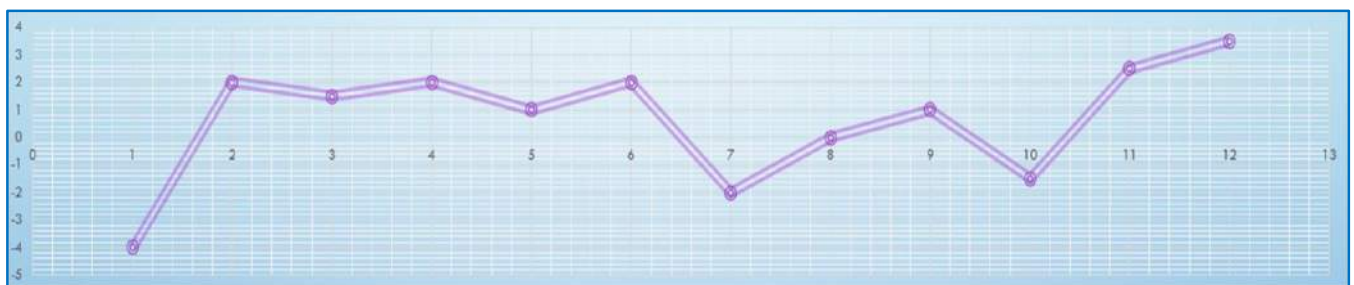
Figure 6: Force Main Profile

According to the force main profile shown in **Figure 06**, manhole #7 is a critical access point to remove debris from pipe segment between manhole 6-7, 7-8 & 8-9 because it is the low point in the system.

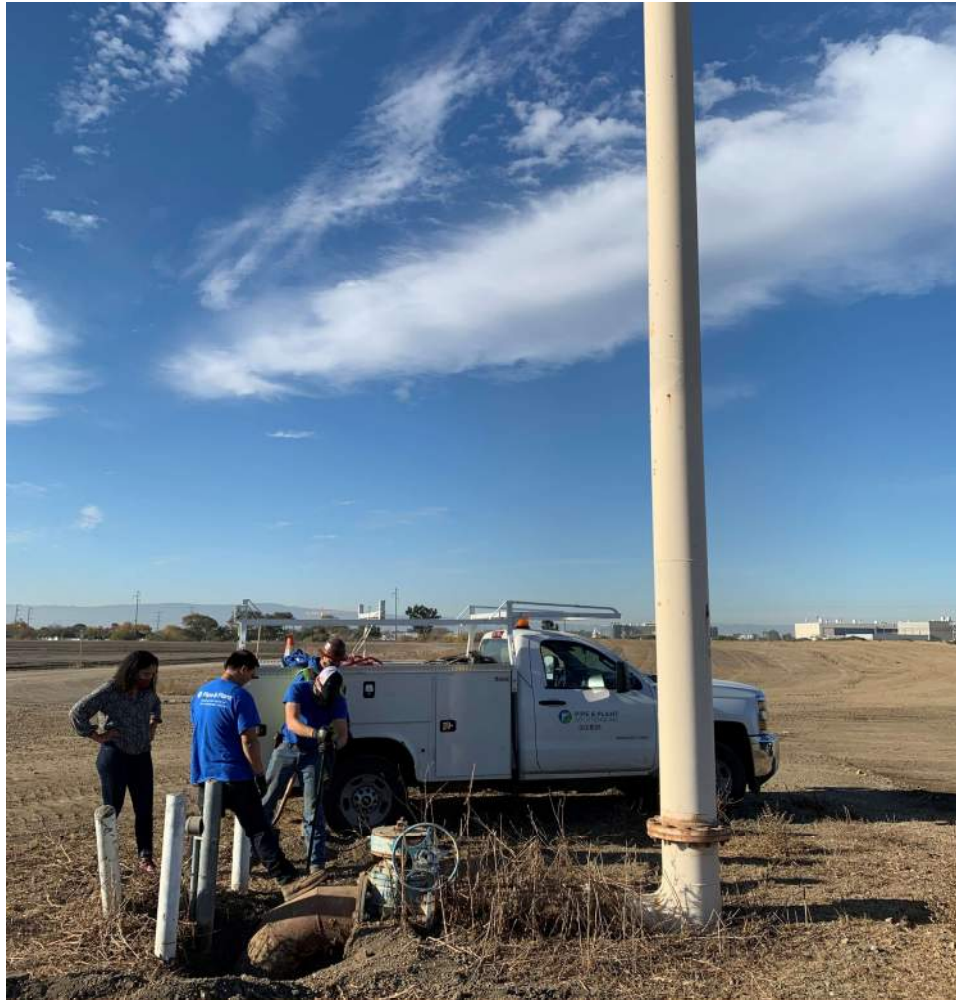
Figure 7: Force Main Manhole #8 Location

Manhole #8: Contractor searched for the manhole without success but found a 30' high vertical pipe where the manhole should be located as shown in **Figure 07**. It is assumed the manhole was modified for this vertical pipe. Public Works staff does not have knowledge or the functionality of this pipe. The City does not have existing records of this modification.

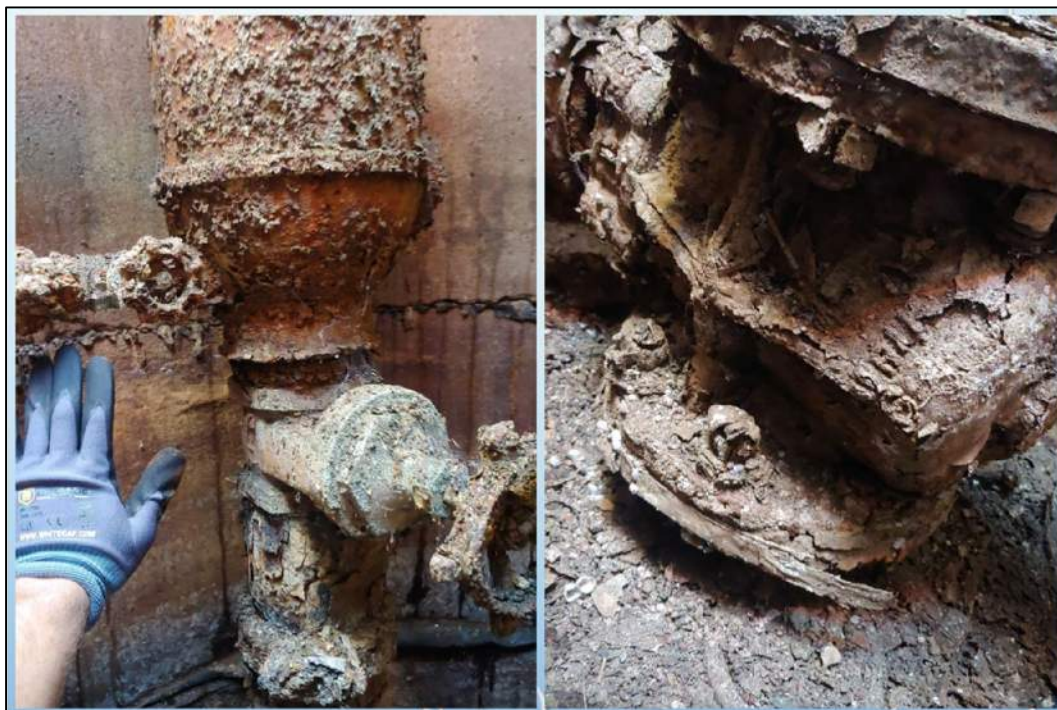
Figure 9: Corroded Air Release Valve and Blind Flange

The Contractor investigated available manholes and the internal components including air release valves, bolts, gaskets and blind flanges. The components in manholes #9-12 appeared to be in good conditions. However, components in manholes #2 – 6, located in the lagoon area, are significantly corroded and not functional, see **Figure 8 & 9**.

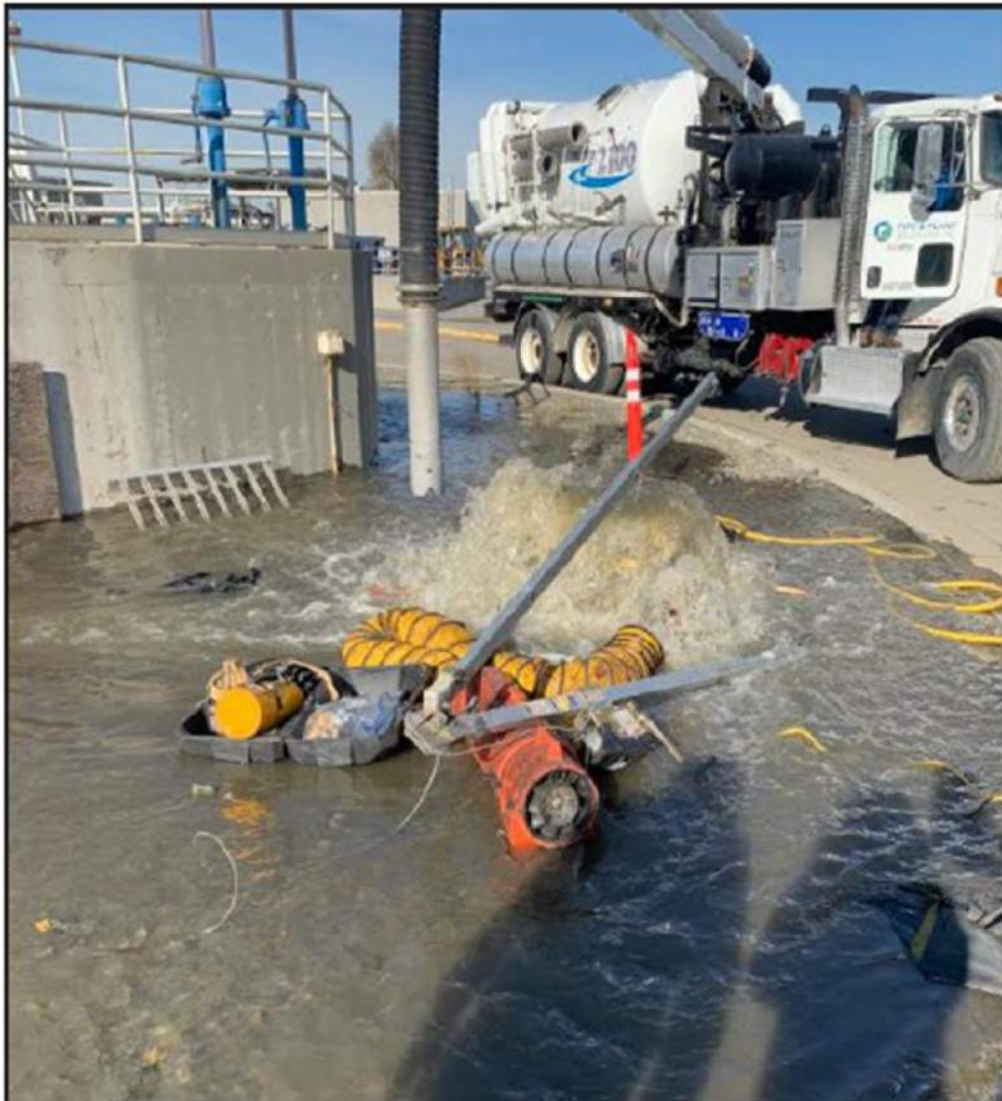
Figure 10: Sewer Overflow at MH #12

overflow and allow the contractor to re-install the blind flange. The non-functional sliding gate caused effluent to backflow into the entire system because the elevation of force main A is lower than the Milpitas Structure. Such condition will create the potential overflow situation at other manholes similar to that encountered at manhole #12. To conduct any inspections of FM-A by CCTV, the sliding gate needs to be repaired to isolate the force main from one another.
