# HOME2 SUITES MILPITAS, CA

## ARBORIST REPORT AND TREE INVENTORY

**GEOTECHNICAL INVESTIGATION  
HOME 2 SUITES 4-STORY HOTEL  
1301 CALIFORNIA CIRCLE  
MILPITAS, CALIFORNIA 95035**

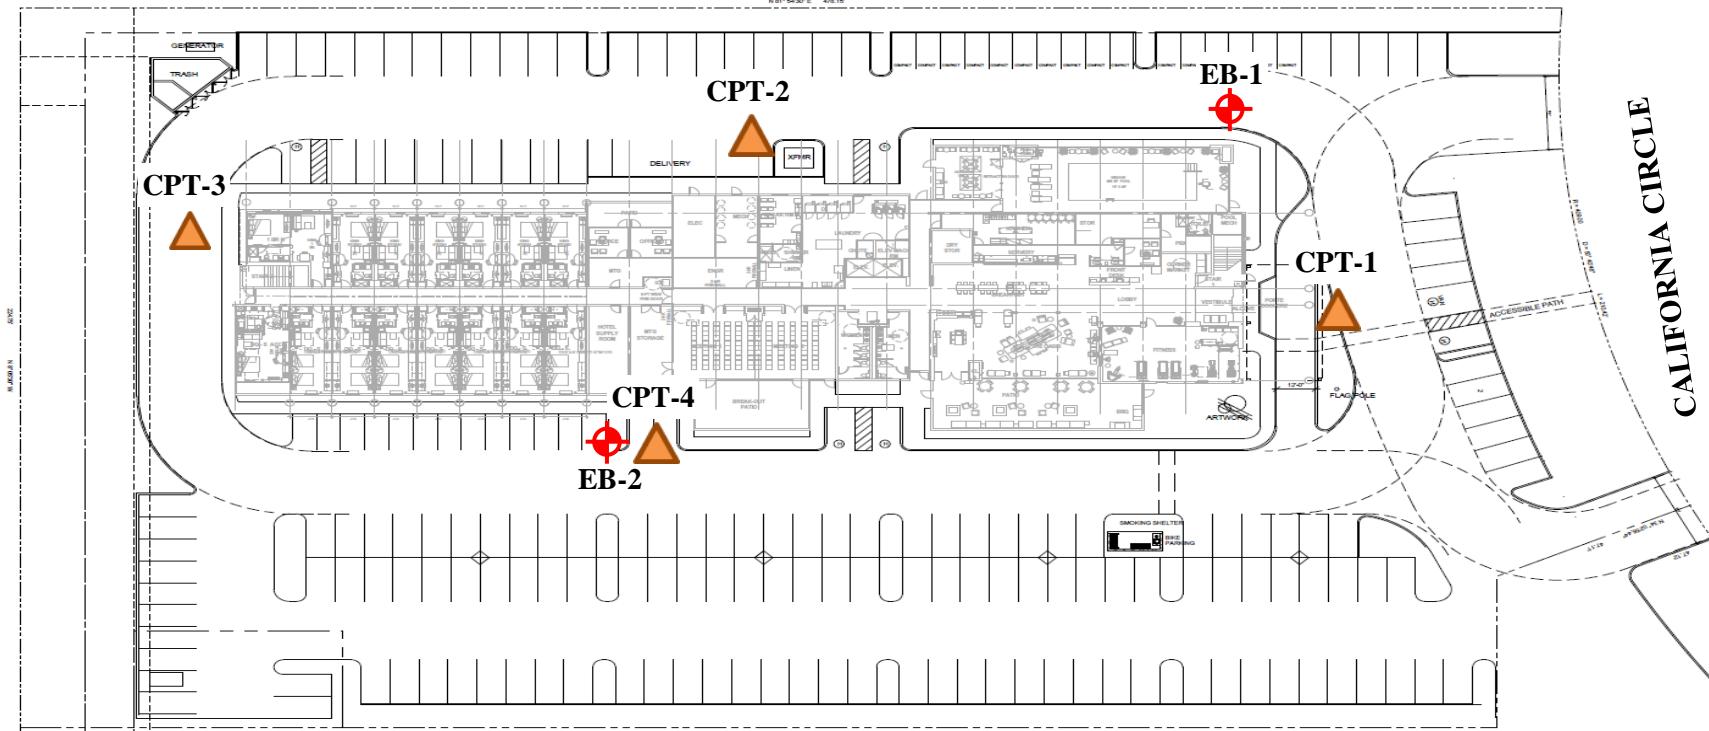
EB-2 Approximate Locations of Exploratory Borings.  
 CPT-4 Approximate Locations of Cone Penetration Tests.

- Review of geologic and seismic conditions in the site vicinity and evaluate the potential for geologic hazards to impact the site.
- Subsurface exploration consisting of drilling, sampling, and logging of two exploratory borings and four cone penetration tests (CPT) in the area of the proposed hotel building.
- Laboratory testing of selected samples to aid in soil classification and to help evaluate the engineering properties of the soils encountered.
- Engineering analysis and evaluation of the subsurface data to develop geotechnical design criteria for the project. Our analyses included evaluation of liquefaction potential and ground settlement due to fill and building loads.
- Preparation of this report presenting our recommendations for the proposed construction.

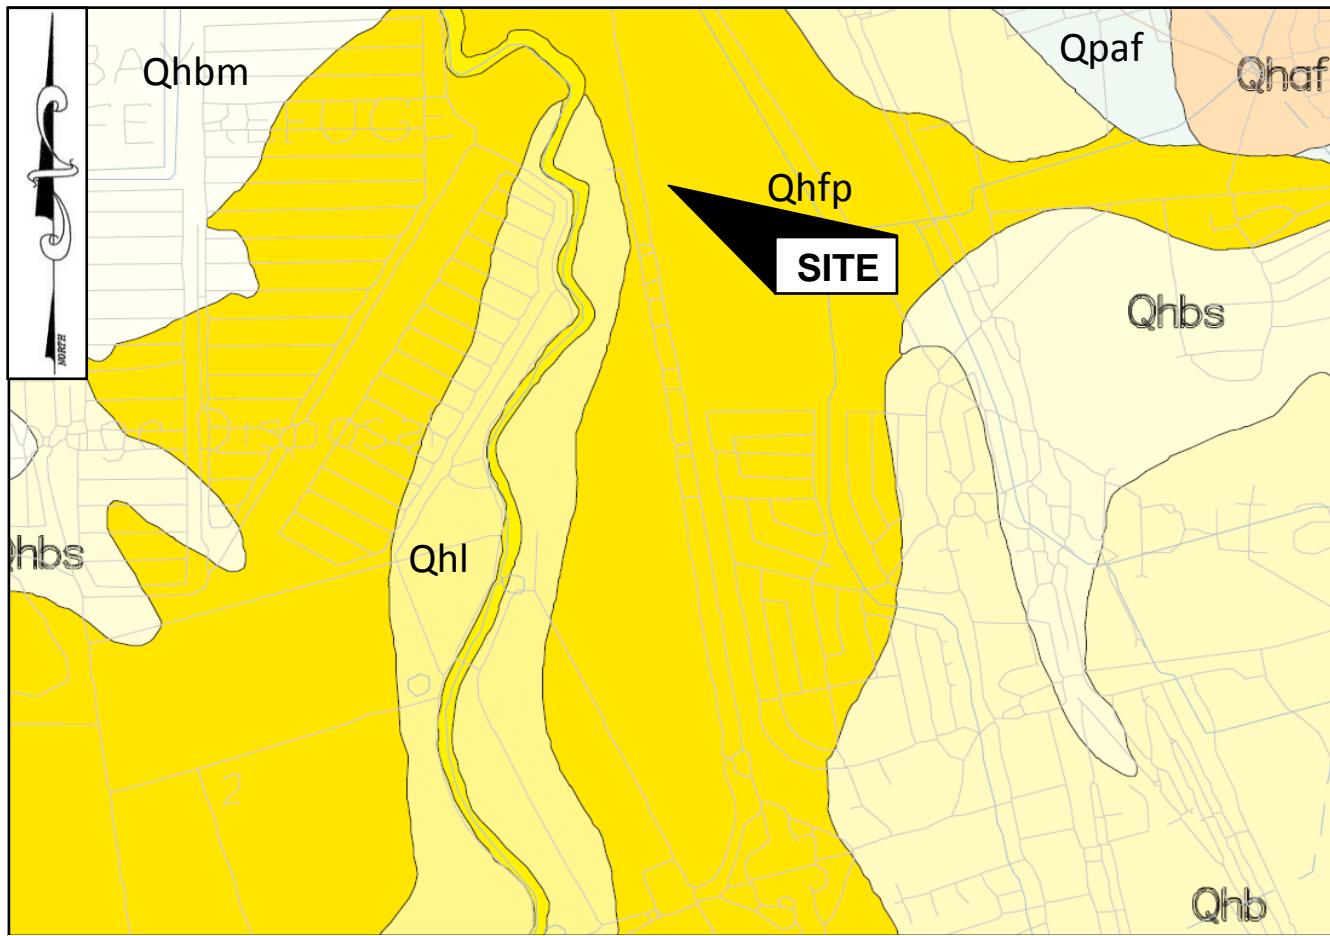
**FIGURE 3**  
**OCTOBER 2016**  
**PROJECT NO. 3464-1A**

<b>Qhl</b>	Stream Channel Deposits	<b>Qhaf</b>	Alluvial Fan Deposits (Holocene)	
<b>Qhfp</b>	Floodplain Deposits	<b>Qpaf</b>	Alluvial Fan Deposits (Pleistocene)	
<b>Qhb</b>	Floodbasin Deposits	Geologic Contact - dashed where approximate, dotted where inferred.		
<b>Qhbs</b>	Salt-affected Floodplain Deposits			
<b>Qhbm</b>	Estuary Deposits

**VICINITY GEOLOGIC MAP**  
**HOME 2 SUITES 4-STORY HOTEL**  
**MILPITAS, CALIFORNIA**

consist of sandy and silty clay, with lenses of silt, sand and pebbles in localized areas. The geology of the site vicinity is shown on the Vicinity Geologic Map, Figure 3.

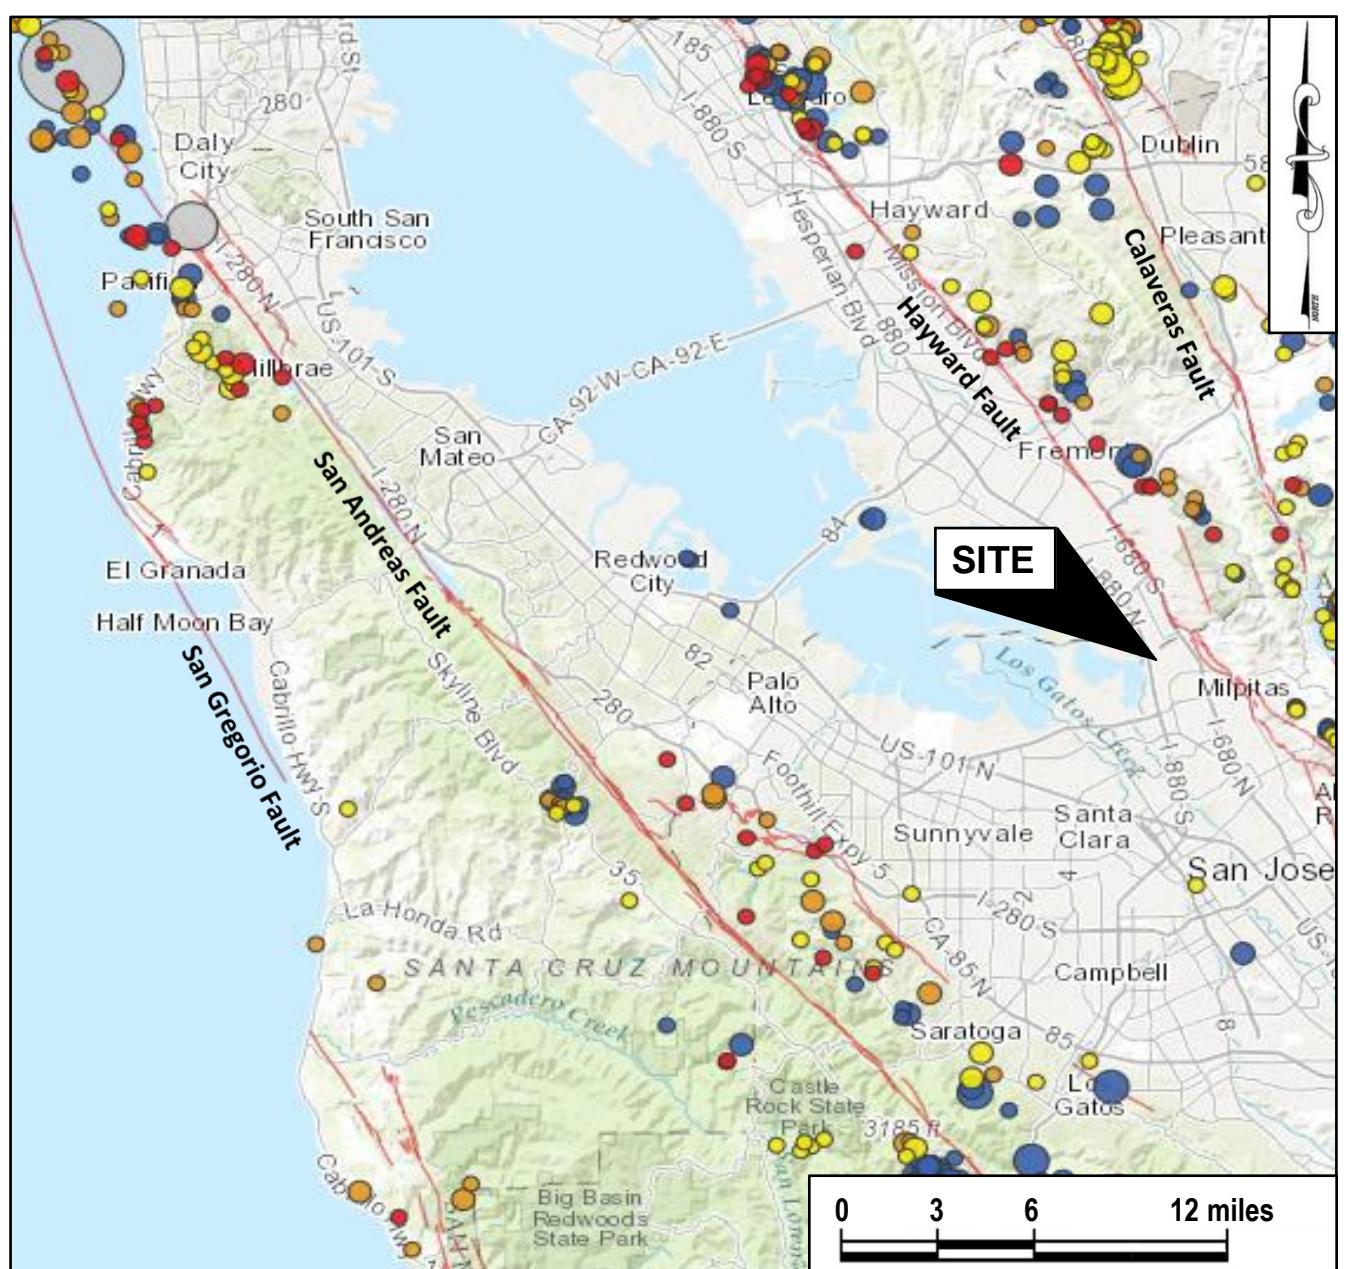
**FIGURE 4**  
**OCTOBER 2016**  
**PROJECT NO. 3464-1A**

Earthquakes with M5+ from 1900 to 1980, M2.5+ from 1980 to January 2015. Faults with activity in last 15,000 years. Based on data sources from Northern California Earthquake Data Center and USGS Quaternary Fault and Fold Database, accessed May 2015.

**REGIONAL FAULT AND SEISMICITY MAP**  
**HOME 2 SUITES 4-STORY HOTEL**  
**MILPITAS, CALIFORNIA**

The San Francisco Bay Area is an active seismic region. Earthquakes in the region result from strain energy constantly accumulating because of the northwestward movement of the Pacific Plate relative to the North American Plate. On average about 1.6-inches of movement occur per year. Historically, the Bay Area has experienced large, destructive earthquakes in 1838, 1868, 1906, and 1989. The faults considered most likely to produce large earthquakes in the area include the San Andreas, Hayward, San Gregorio, and Calaveras faults. The Calaveras fault is located approximately 5.9 miles northeast of the site. The San Andreas and San Gregorio faults are located approximately 16 and 28 miles southwest of the site, respectively. These faults and significant earthquakes that have been documented in the Bay Area are listed in Table 1 on the following page and are shown on the Regional Fault and Seismicity Map, Figure 4.

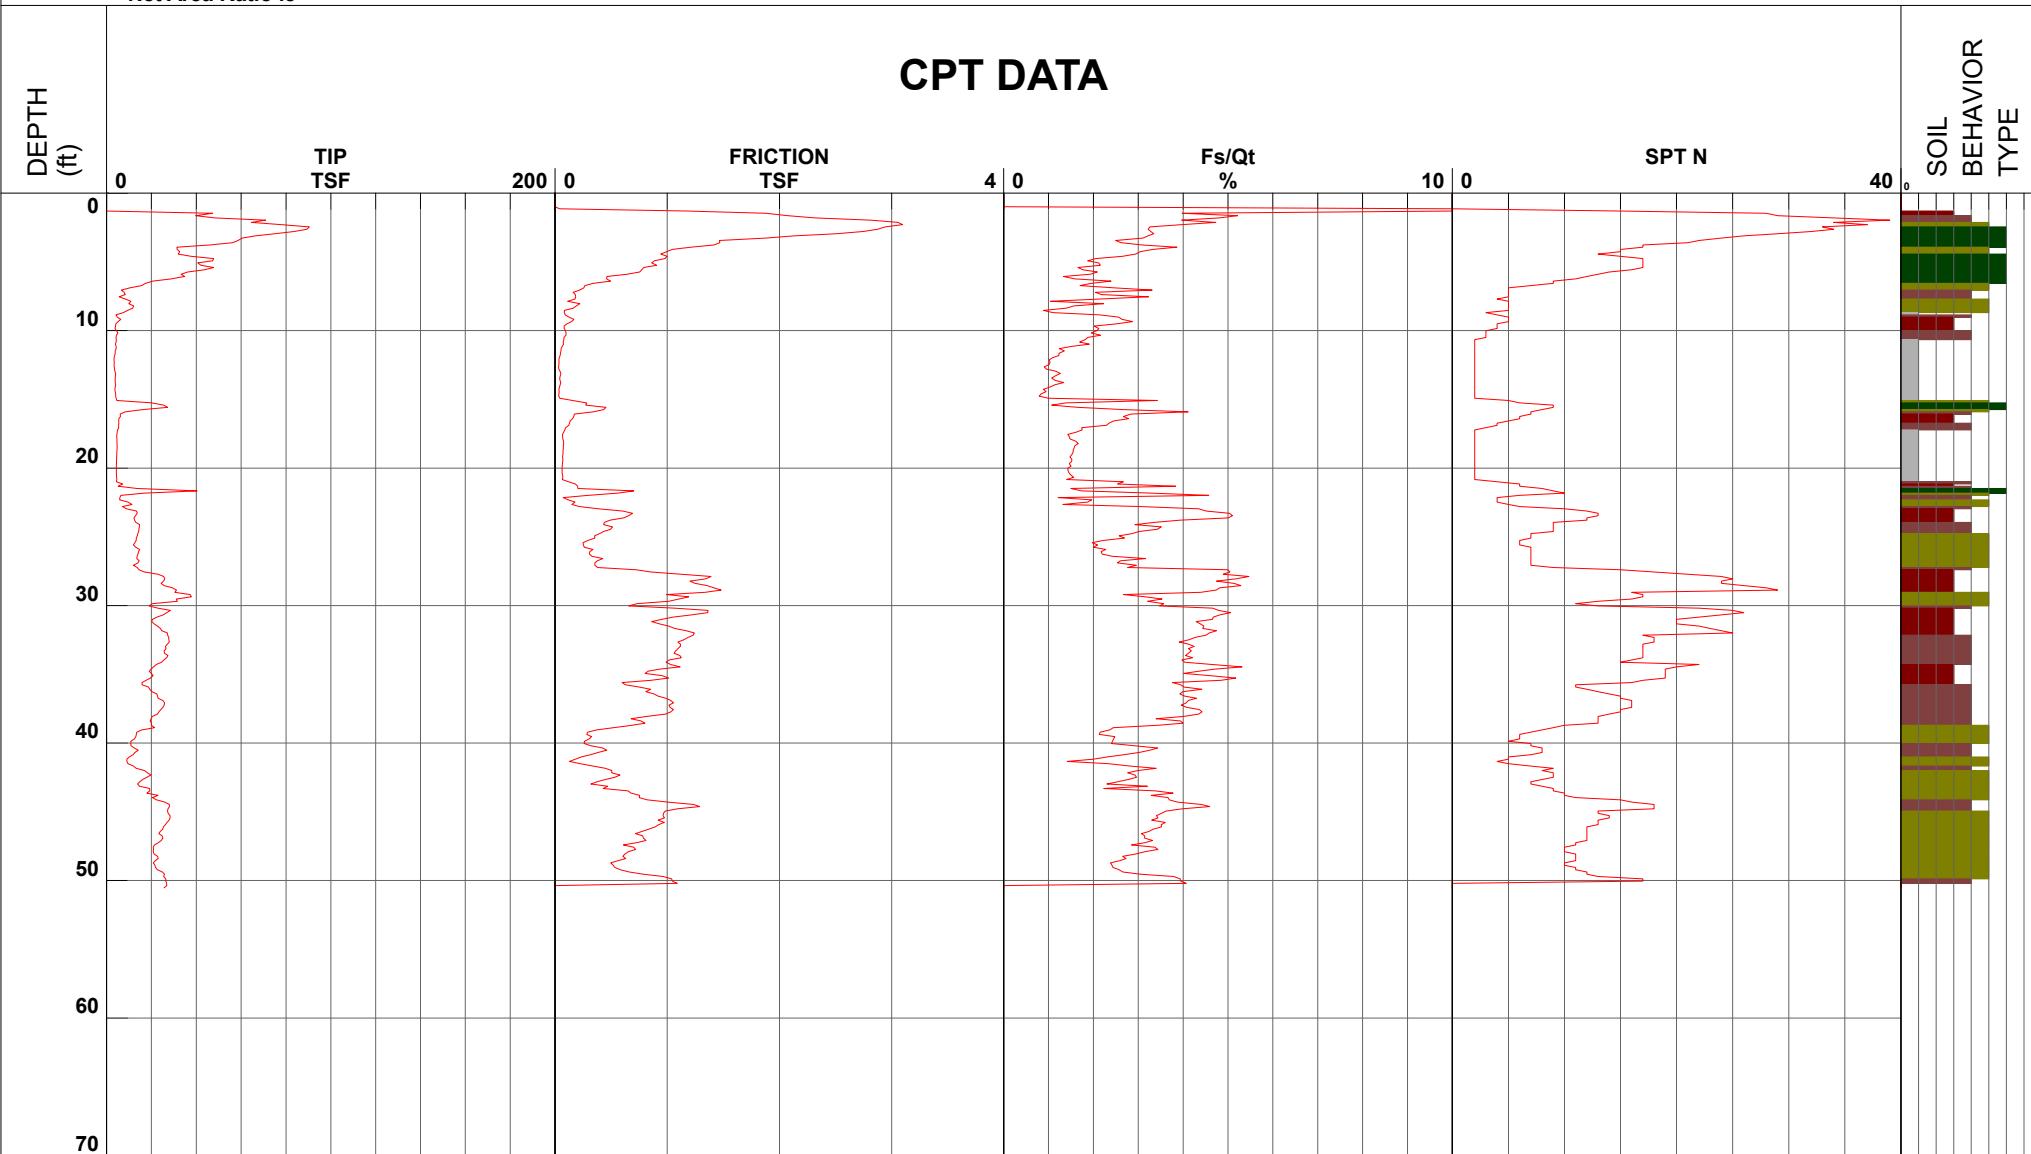
Project	Home 2 Suites 4-Story Hotel	Operator	JH-KK	Filename	SDF(054).cpt
Job Number	3464-1A	Cone Number	DDG1333	GPS	
Hole Number	CPT-01	Date and Time	9/9/2016 10:30:34 AM	Maximum Depth	
EST GW Depth During Test	10.00 ft				50.52 ft

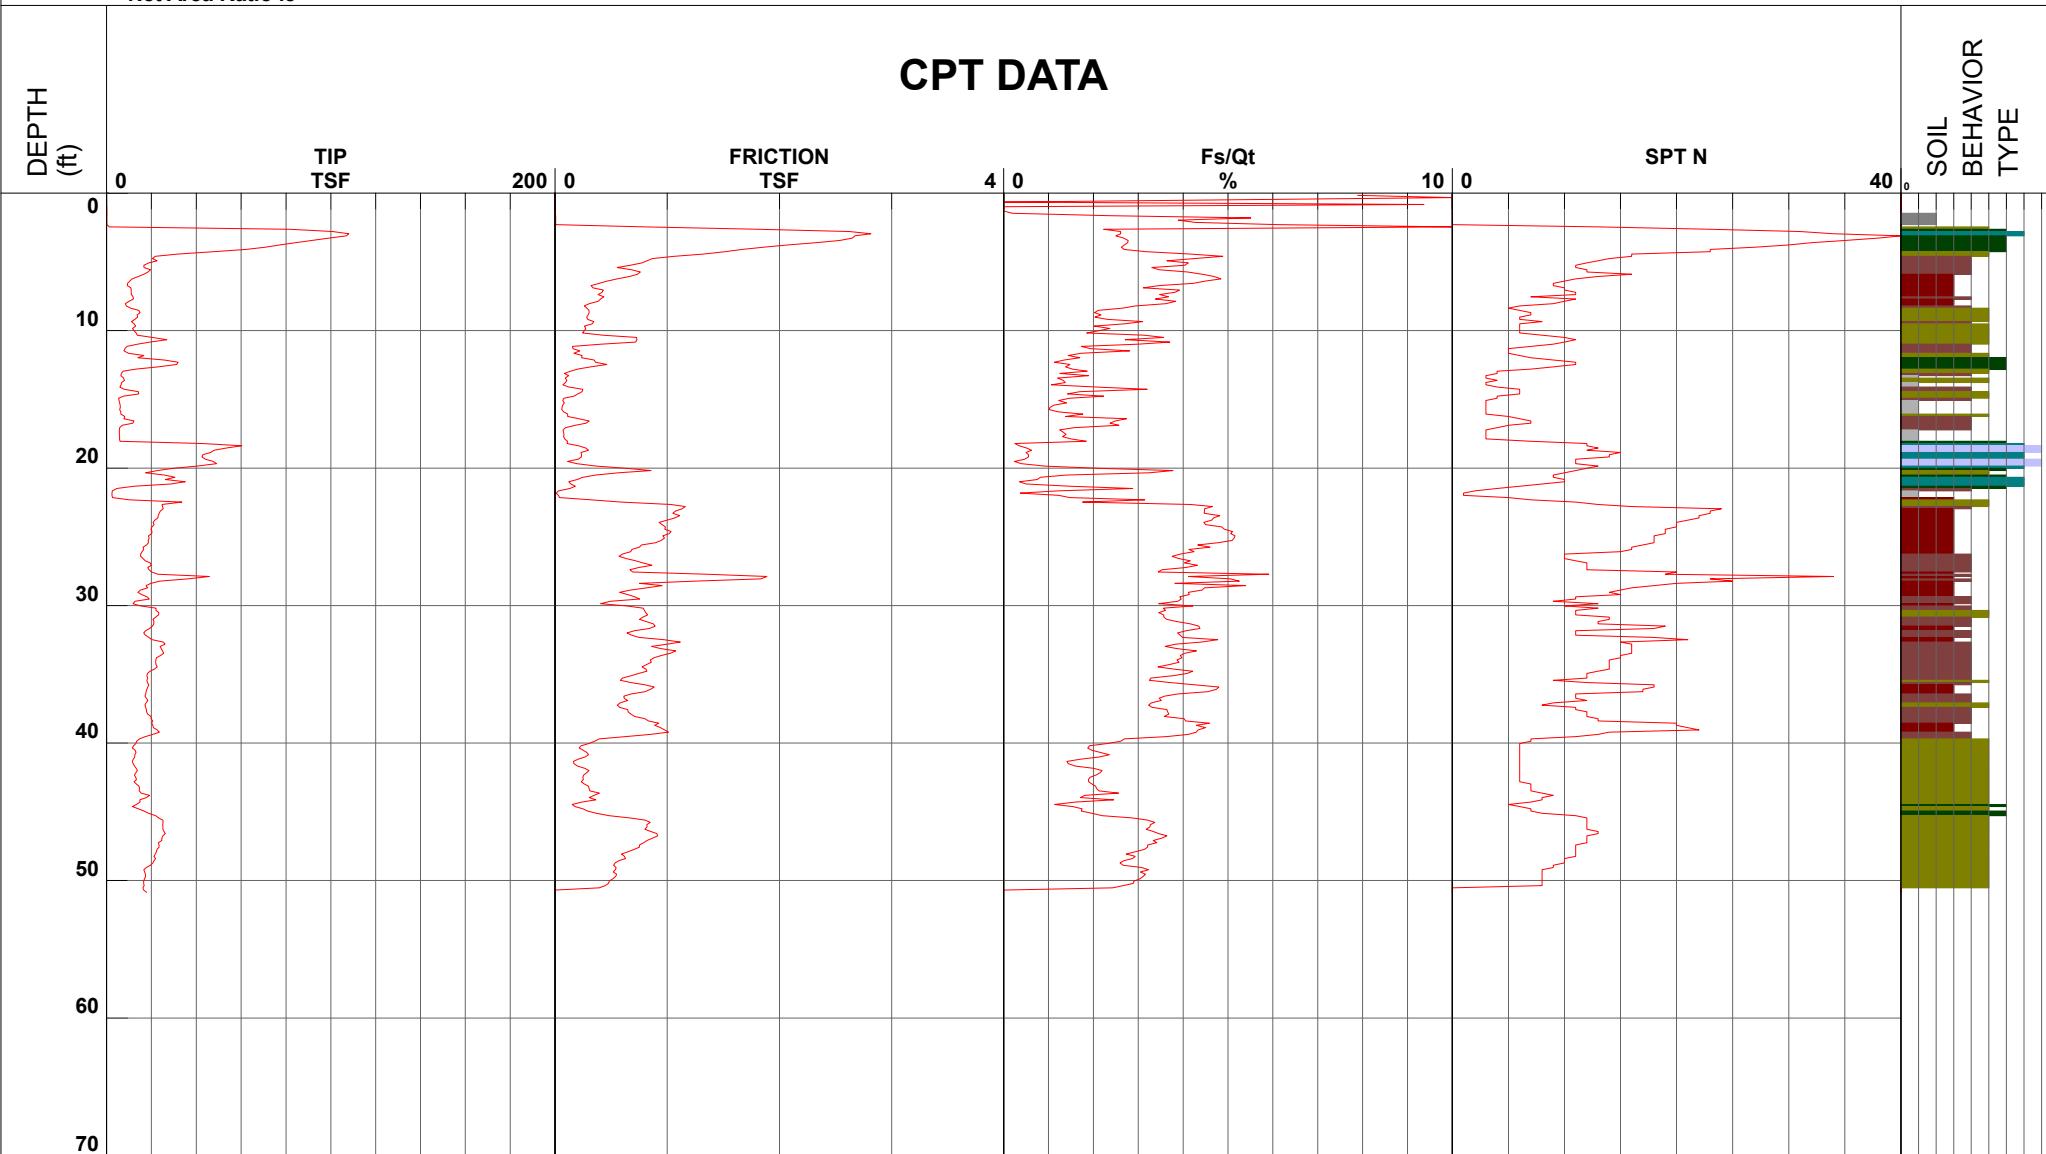
Project	Home 2 Suites 4-Story Hotel	Operator	JH-KK	Filename	SDF(052).cpt
Job Number	3464-1A	Cone Number	DDG1333	GPS	
Hole Number	CPT-03	Date and Time	9/9/2016 8:47:08 AM	Maximum Depth	
EST GW Depth During Test	10.00 ft				50.85 ft

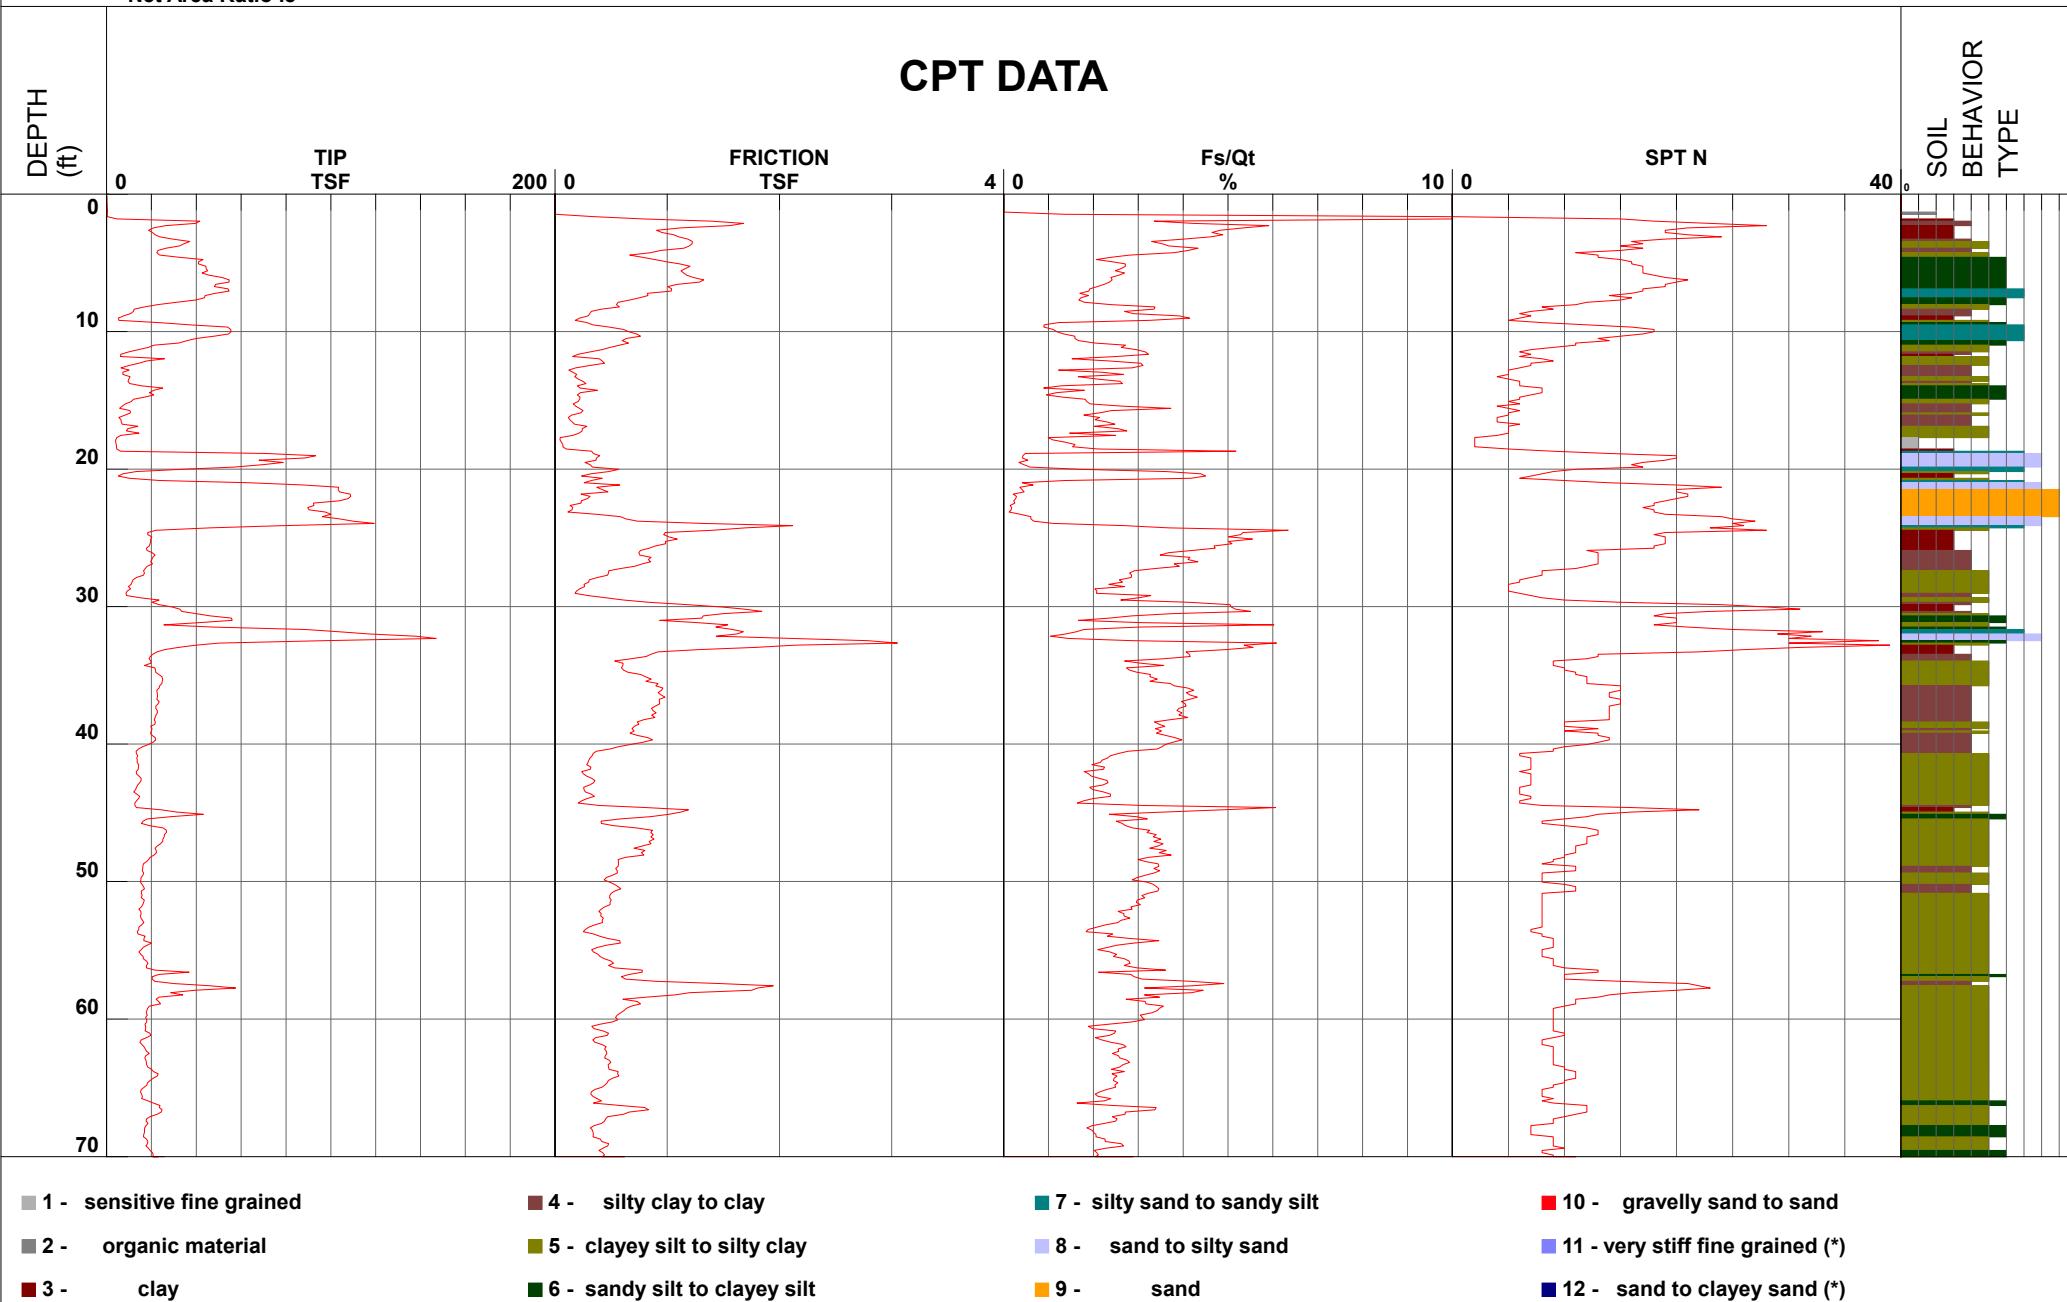
Project	Home 2 Suites 4-Story Hotel	Operator	JH-KK	Filename	SDF(051).cpt
Job Number	3464-1A	Cone Number	DDG1333	GPS	
Hole Number	CPT-04	Date and Time	9/9/2016 7:24:24 AM	Maximum Depth	
EST GW Depth During Test	10.00 ft				70.70 ft

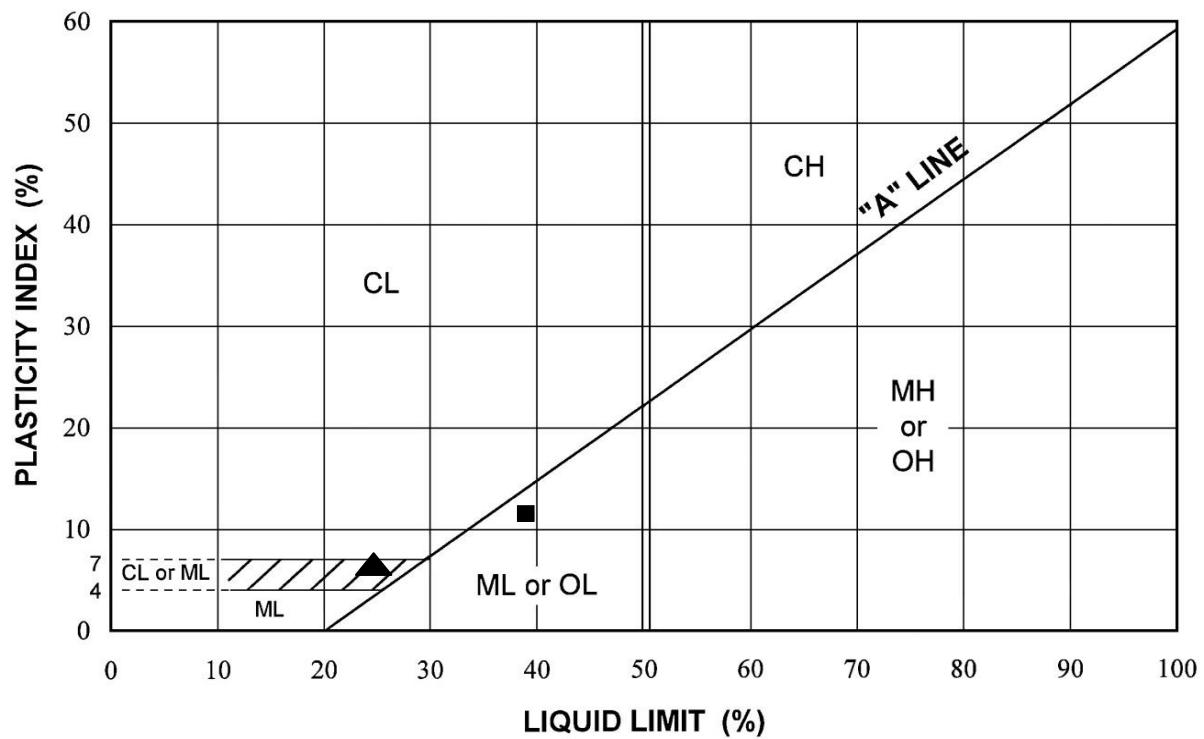
Chart Symbol	Boring Number	Sample Depth (feet)	Water Content (percent)	Liquid Limit (percent)	Plasticity Index (percent)	Liquidity Index (percent)	Passing No. 200 Sieve (percent)	USCS Soil Classification
■	EB-1	1-2.5	29	39	12			ML
▲	EB-2	29.5-30.5	24	25	5			CL/ML

**PLASTICITY CHART**  
 HOME 2 SUITES 4-STORY HOTEL  
 MILPITAS, CALIFORNIA

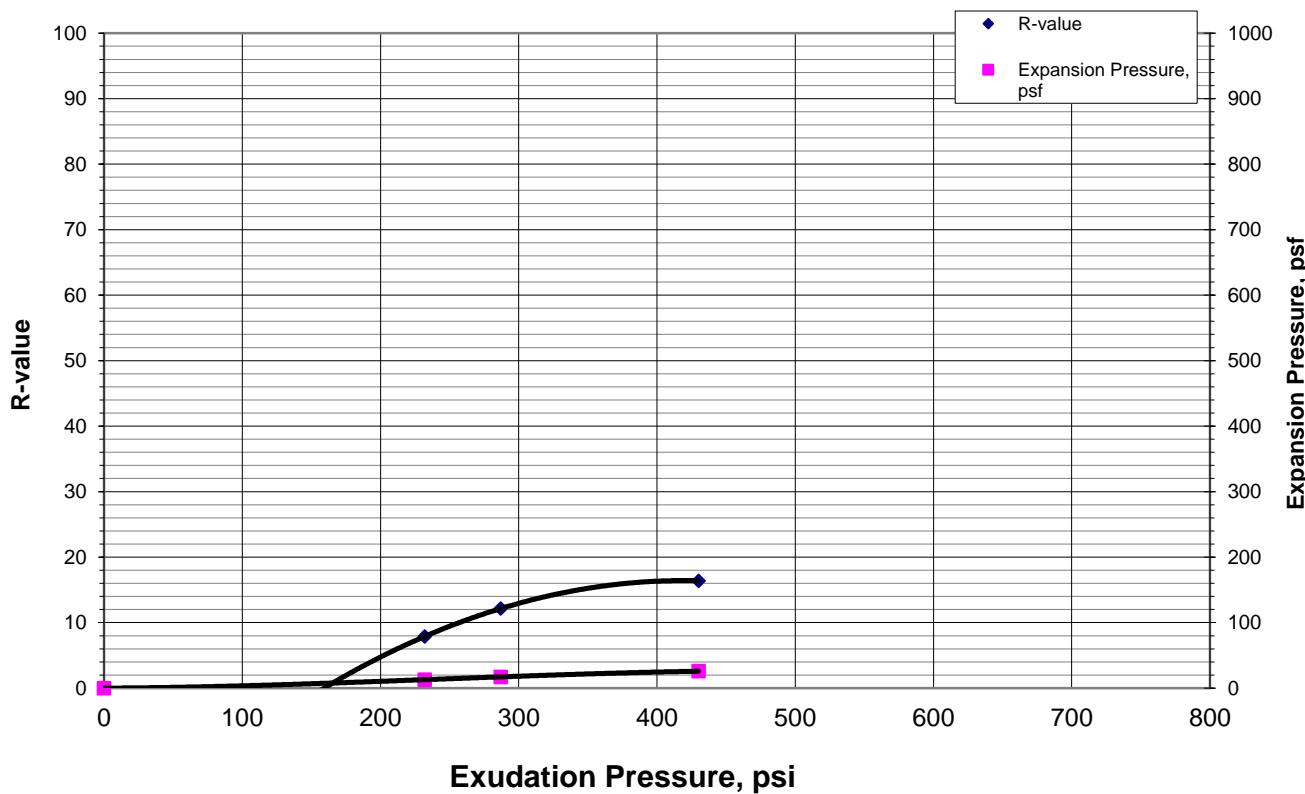
**FIGURE B-2**  
OCTOBER 2016  
PROJECT NO. 3464-1A

Job No.:	192-204	Date:	09/20/16	Initial Moisture,	12.4
Client:	Romig Engineers, Inc.	Tested	PJ	R-value	13
Project:	Home 2 Suites-Milpitas - 3464-1A	Reduced	RU	Expansion	
Sample	Bag Sample	Checked	DC	Pressure	20 psf
Soil Type:	Olive Brown CLAY w/ Sand				
Specimen Number	A	B	C	D	Remarks:
Exudation Pressure, psi	430	287	232		
Prepared Weight, grams	1200	1200	1200		
Final Water Added, grams/cc	32	44	60		
Weight of Soil & Mold, grams	3216	3171	3077		
Weight of Mold, grams	2102	2106	2097		
Height After Compaction, in.	2.54	2.45	2.34		
Moisture Content, %	15.4	16.5	18.0		
Dry Density, pcf	115.2	113.1	107.6		
Expansion Pressure, psf	26	17	13		
Stabilometer @ 1000					
Stabilometer @ 2000	132	136	144		
Turns Displacement	2.78	3.12	3.10		
R-value	16	12	8

**R-VALUE TEST RESULT**  
HOME 2 SUITES 4-STORY HOTEL  
MILPITAS, CALIFORNIA

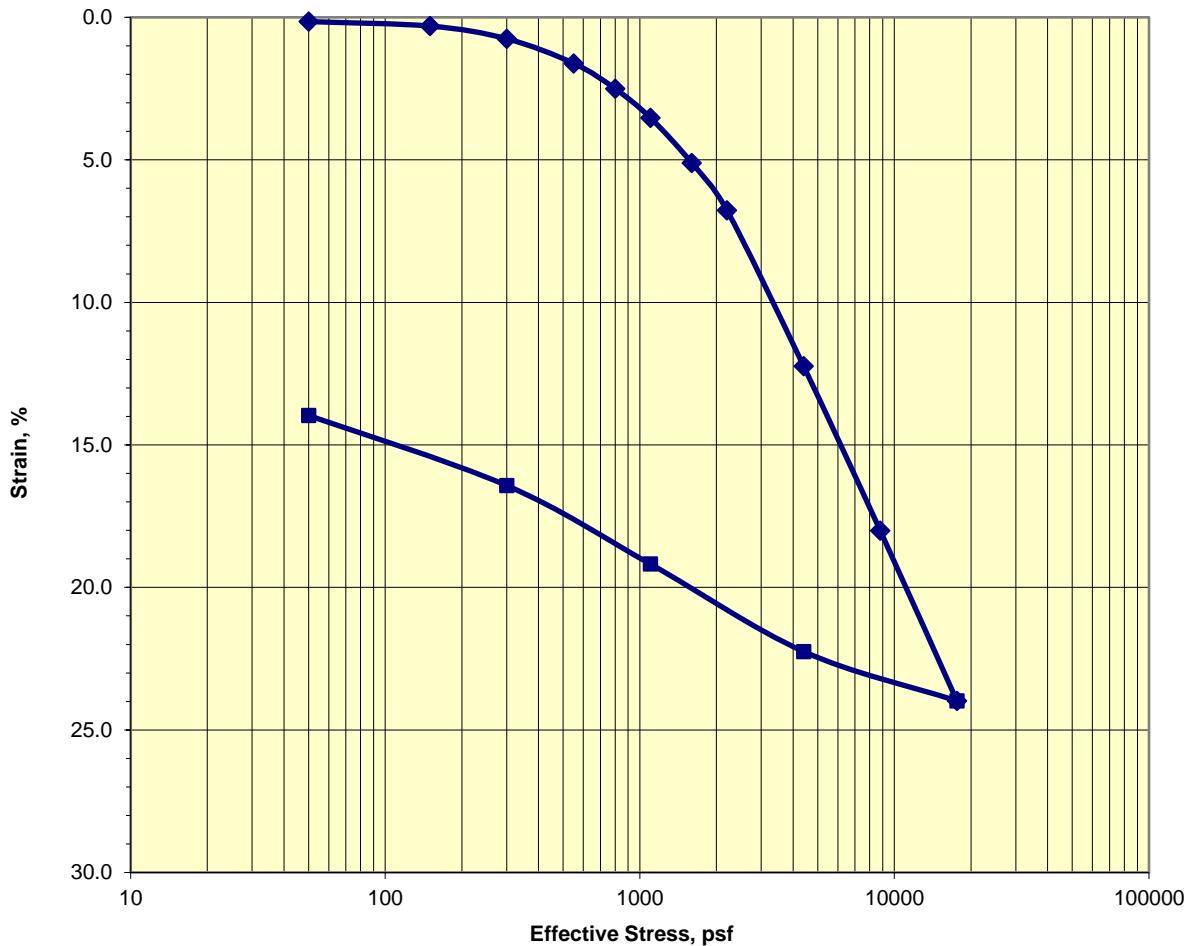
## Strain-Log-P Curve

Job No.: 192-204 Boring: EB-1 Run By: MD  
Client: Romig Engineers Inc. Sample: Reduced: PJ  
Project: Home 2 Suites-Milpitas - 3464-1A Depth, ft.: 15-17.5(Tip-3") Checked: PJ/DC  
Soil Type: Greenish Gray CLAY w/ Sand pockets (Bay Mud) Date: 10/3/2016

Assumed Gs	2.8	Initial	Final
Moisture %:		49.8	37.7
Dry Density, pcf:		73.0	85.0
Void Ratio:		1.396	1.055
% Saturation:		99.9	100.0

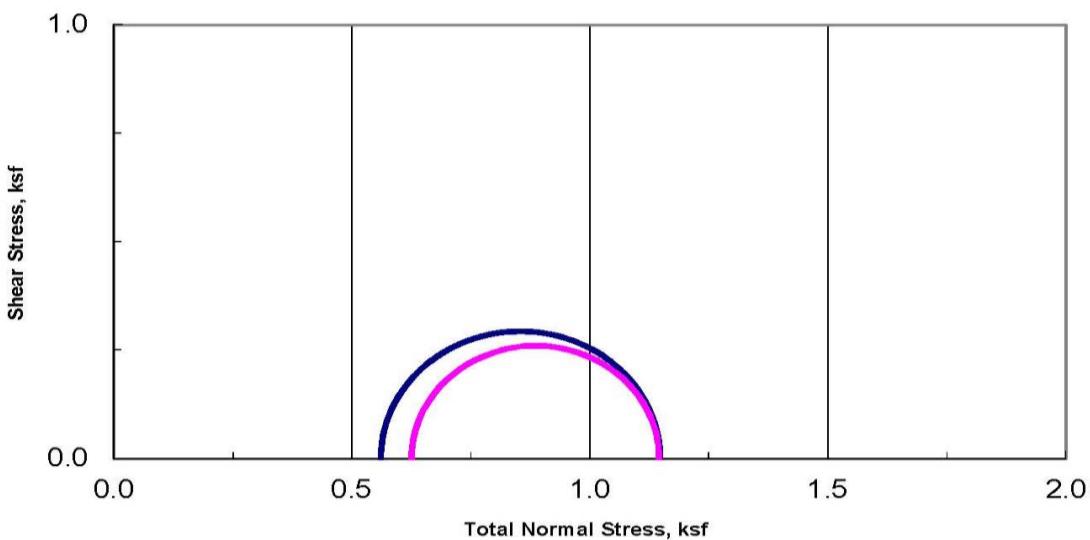
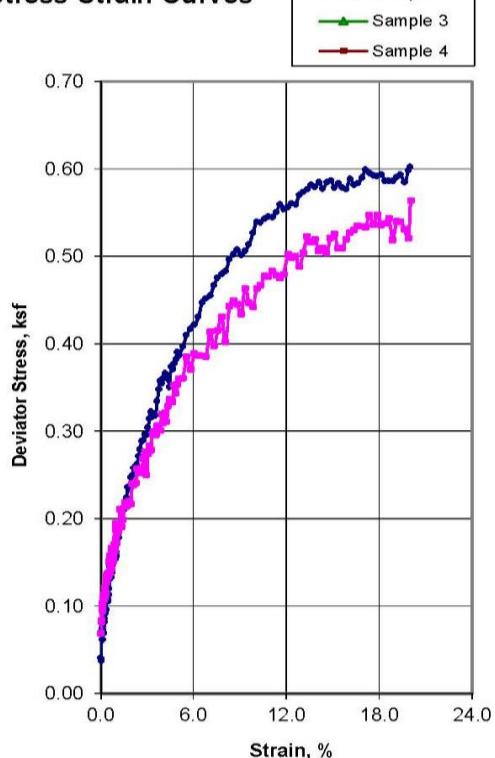
## Unconsolidated-Undrained Triaxial Test ASTM D2850

### Stress-Strain Curves

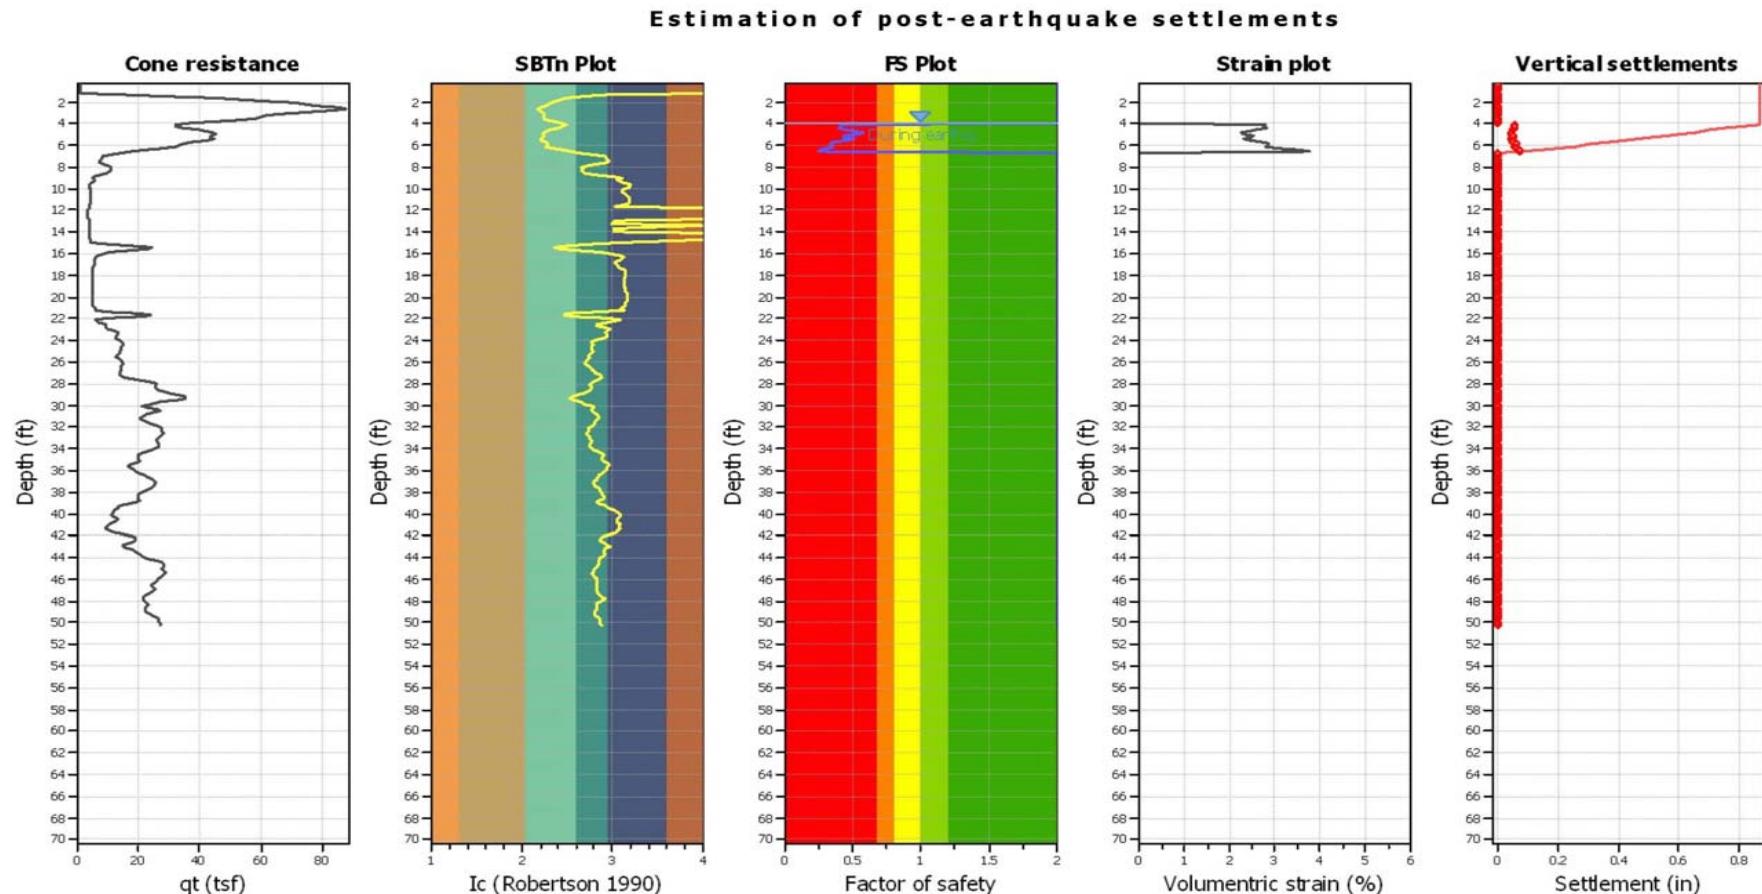
**FIGURE C-1**  
 OCTOBER 2016  
 PROJECT NO. 3464-1A

q: Total cone resistance (cone resistance  $q_c$  corrected for pore water effects)  
 I<sub>c</sub>: Soil Behaviour Type Index  
 FS: Calculated Factor of Safety against liquefaction  
 Volumetric strain: Post-liquefaction volumetric strain

**LIQUEFACTION ANALYSIS FOR CPT-1**  
 PATEL HOME 2 SUITES  
 MILPITAS, CALIFORNIA

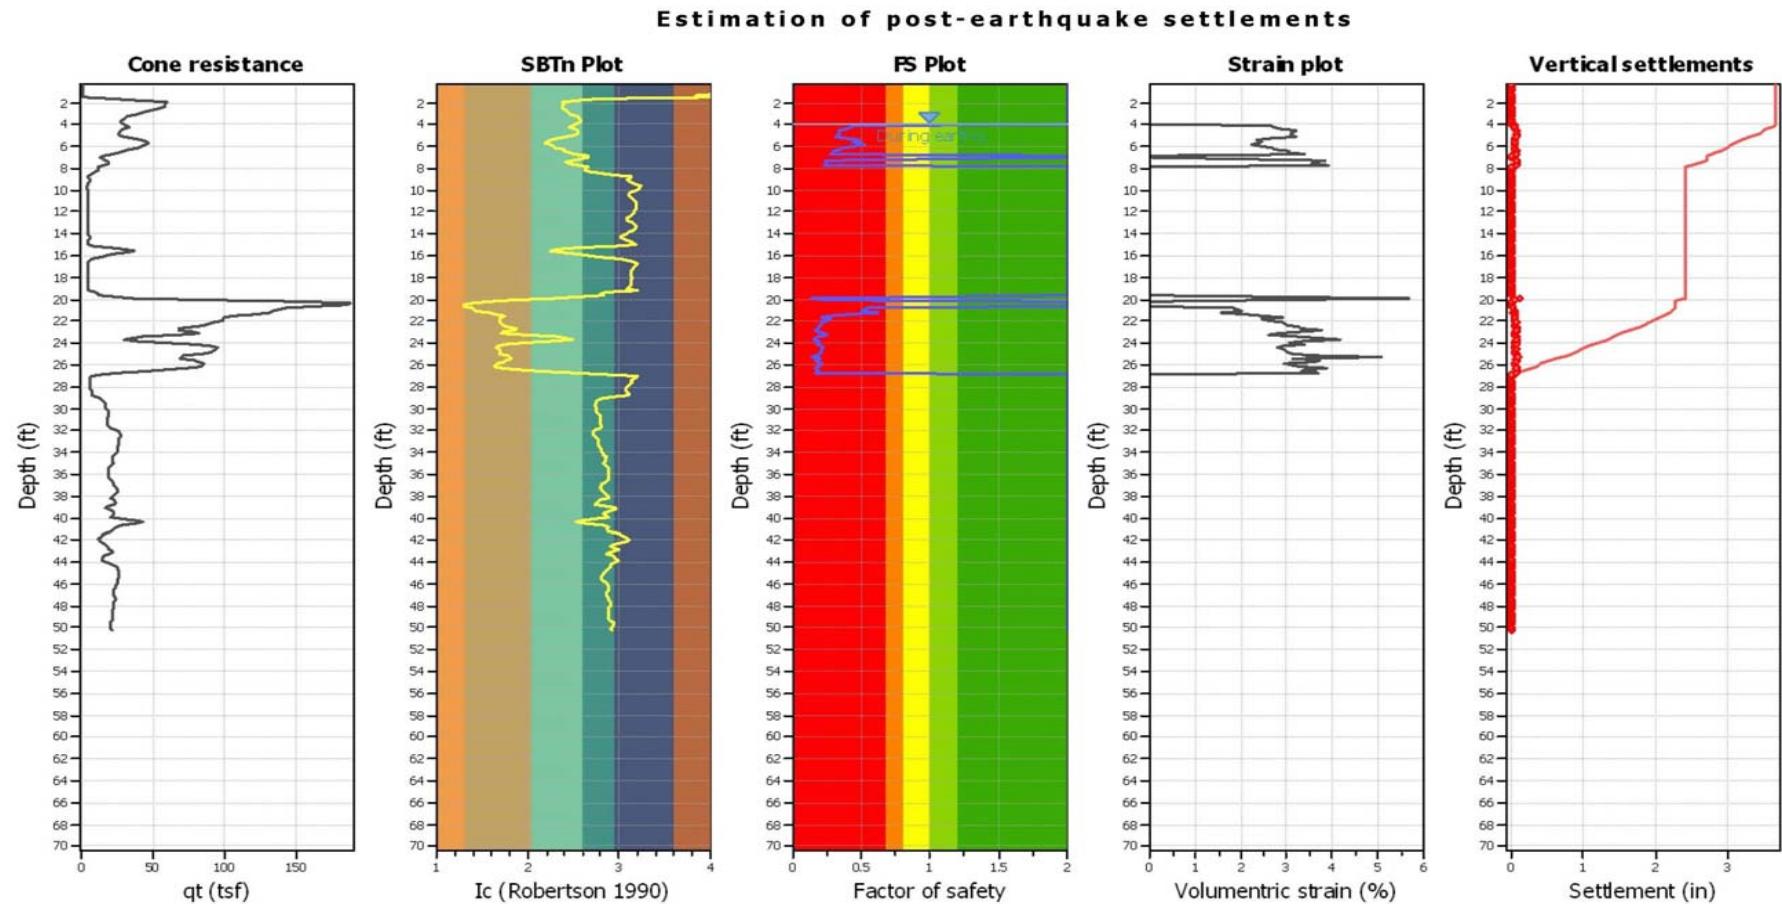
**FIGURE C-2**  
 OCTOBER 2016  
 PROJECT NO. 3464-1A

q: Total cone resistance (cone resistance  $q_c$  corrected for pore water effects)  
 I<sub>c</sub>: Soil Behaviour Type Index  
 FS: Calculated Factor of Safety against liquefaction  
 Volumetric strain: Post-liquefaction volumetric strain

**LIQUEFACTION ANALYSIS FOR CPT-2**  
 PATEL HOME 2 SUITES  
 MILPITAS, CALIFORNIA

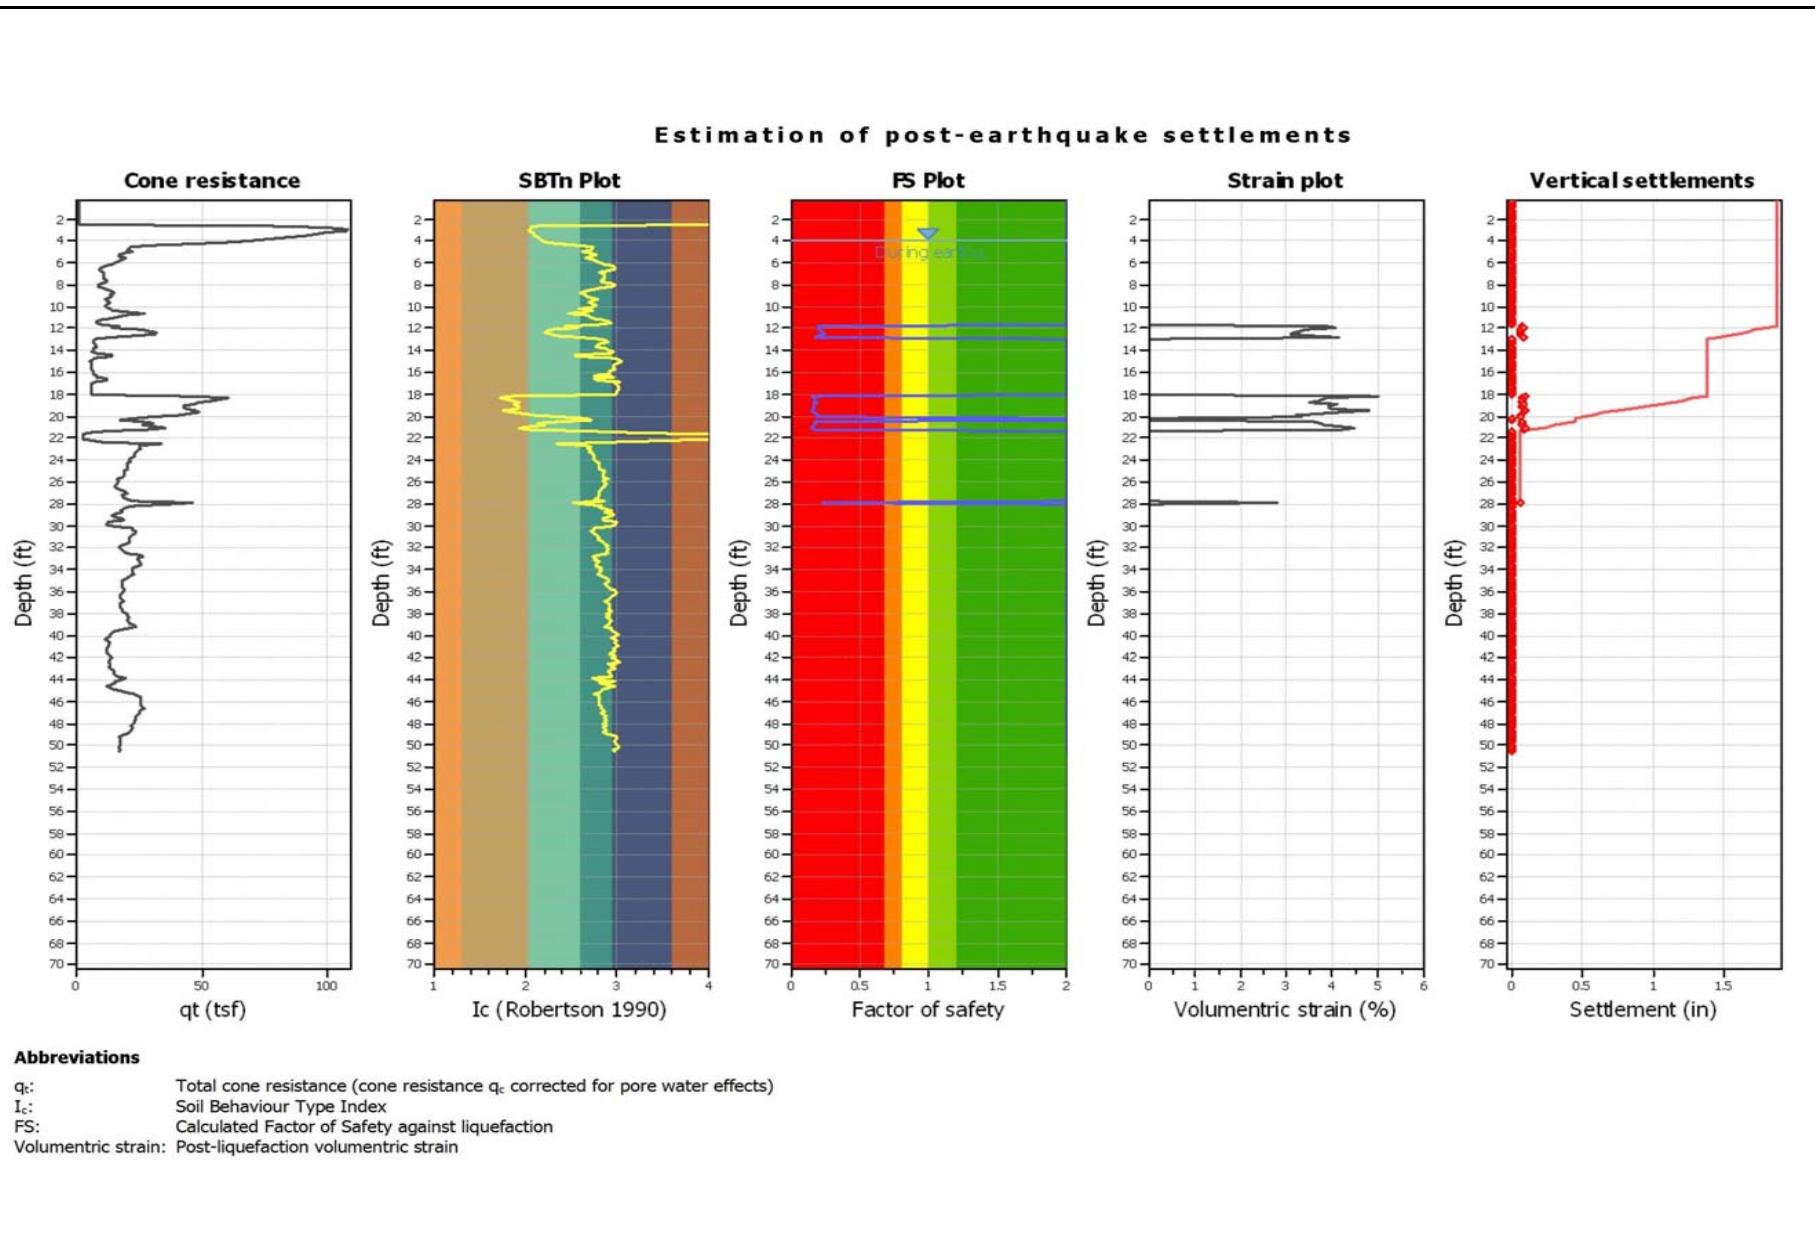
**FIGURE C-3**  
 OCTOBER 2016  
 PROJECT NO. 3464-1A

**LIQUEFACTION ANALYSIS FOR CPT-3**  
 PATEL HOME 2 SUITES  
 MILPITAS, CALIFORNIA
