# HOME2 SUITES MILPITAS, CA

## ARBORIST REPORT AND TREE INVENTORY

**GEOTECHNICAL INVESTIGATION  
HOME 2 SUITES 4-STORY HOTEL  
1301 CALIFORNIA CIRCLE  
MILPITAS, CALIFORNIA 95035**

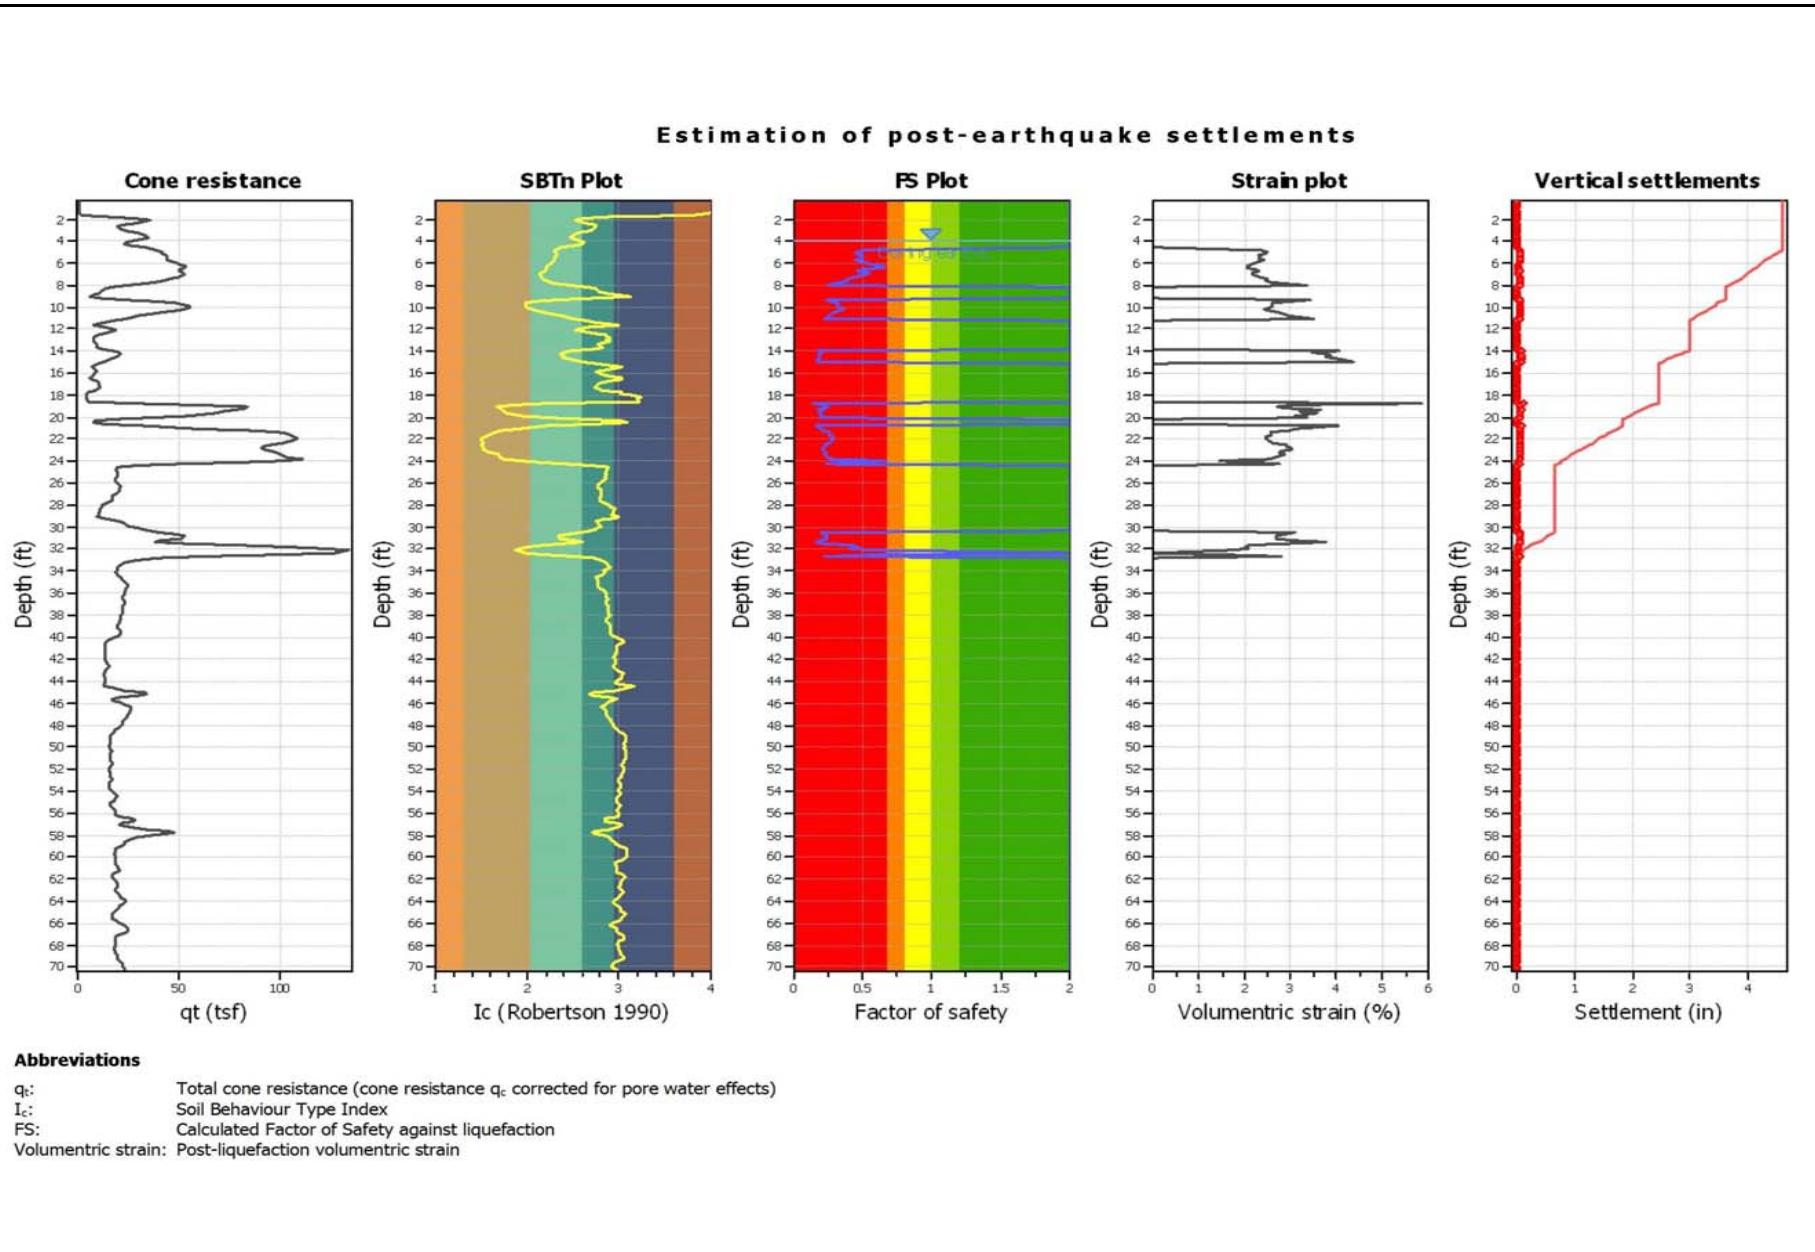
**FIGURE C-4**  
 OCTOBER 2016  
 PROJECT NO. 3464-1A

**LIQUEFACTION ANALYSIS FOR CPT-4**  
 PATEL HOME 2 SUITES  
 MILPITAS, CALIFORNIA

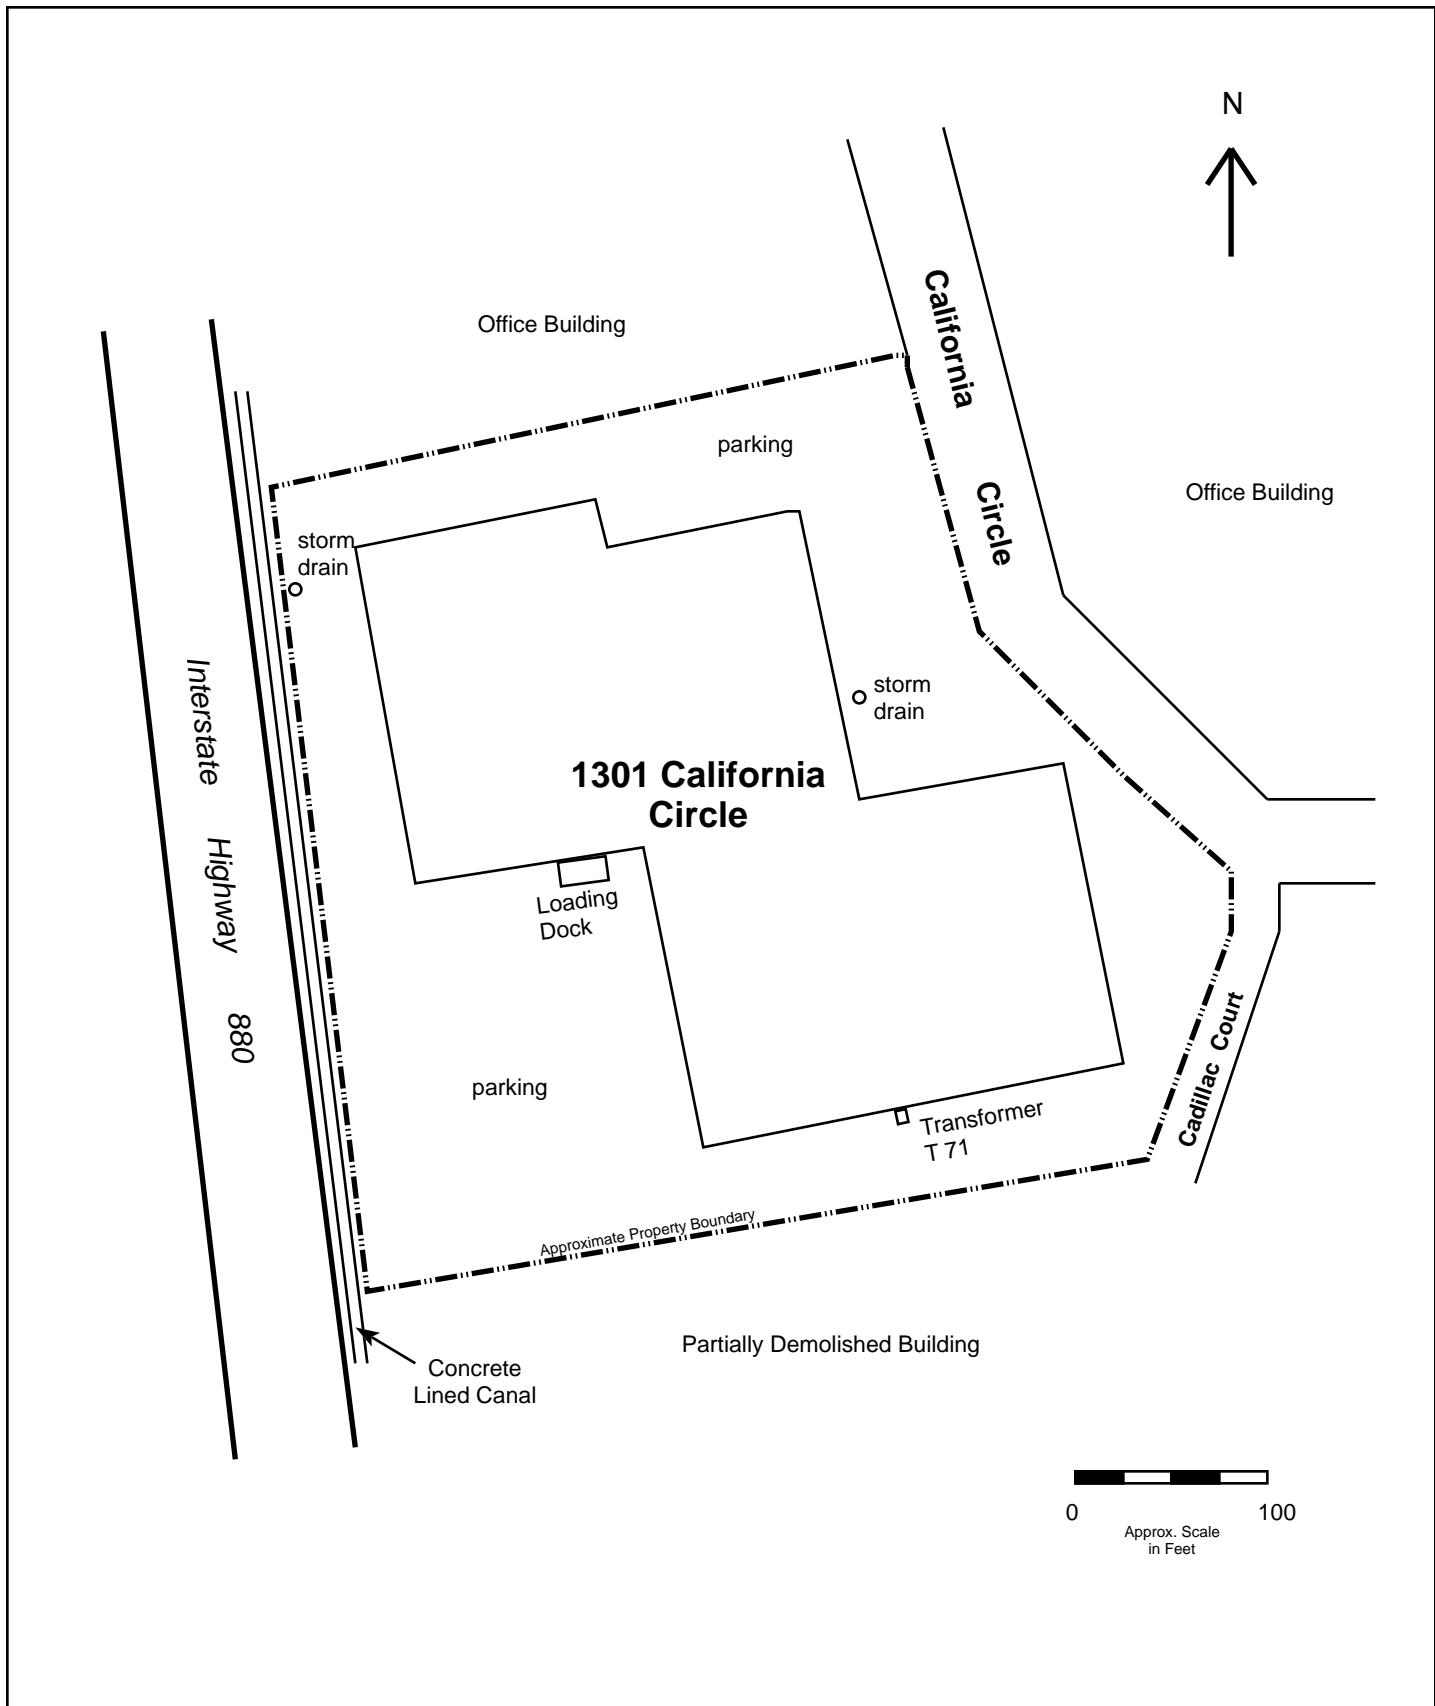
**FIGURE 2**  
JUNE 2013  
PROJ. NO. 3464-1

**SITE SKETCH MAP**  
1301 CALIFORNIA CIRCLE  
MILPITAS, SANTA CLARA COUNTY, CA

We are pleased to present this Phase I Environmental Site Assessment (ESA) for the referenced property in Milpitas, California. The site is located at 1301 California Drive in Milpitas, California (APN 022-38-002), as shown on the Vicinity Map, Figure 1 and Site Sketch Map, Figure 2.

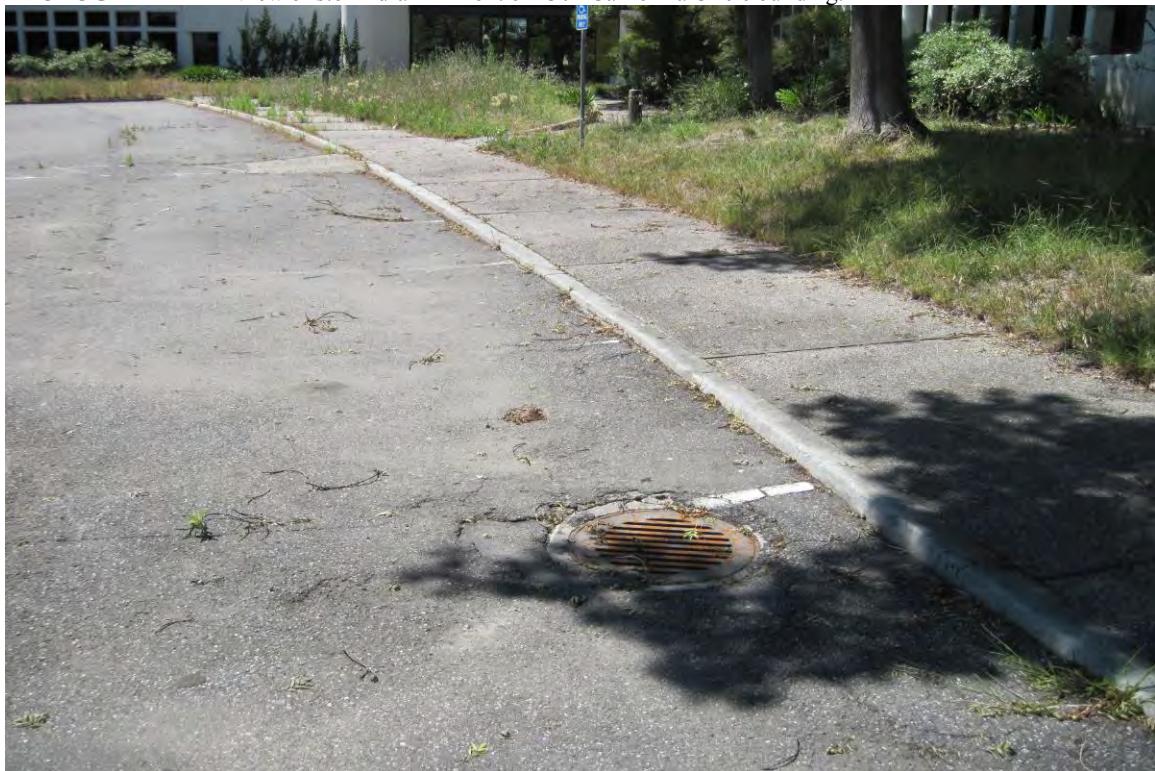
**PHOTOGRAPH #2** – View of storm drain in front of 1301 California Circle building.

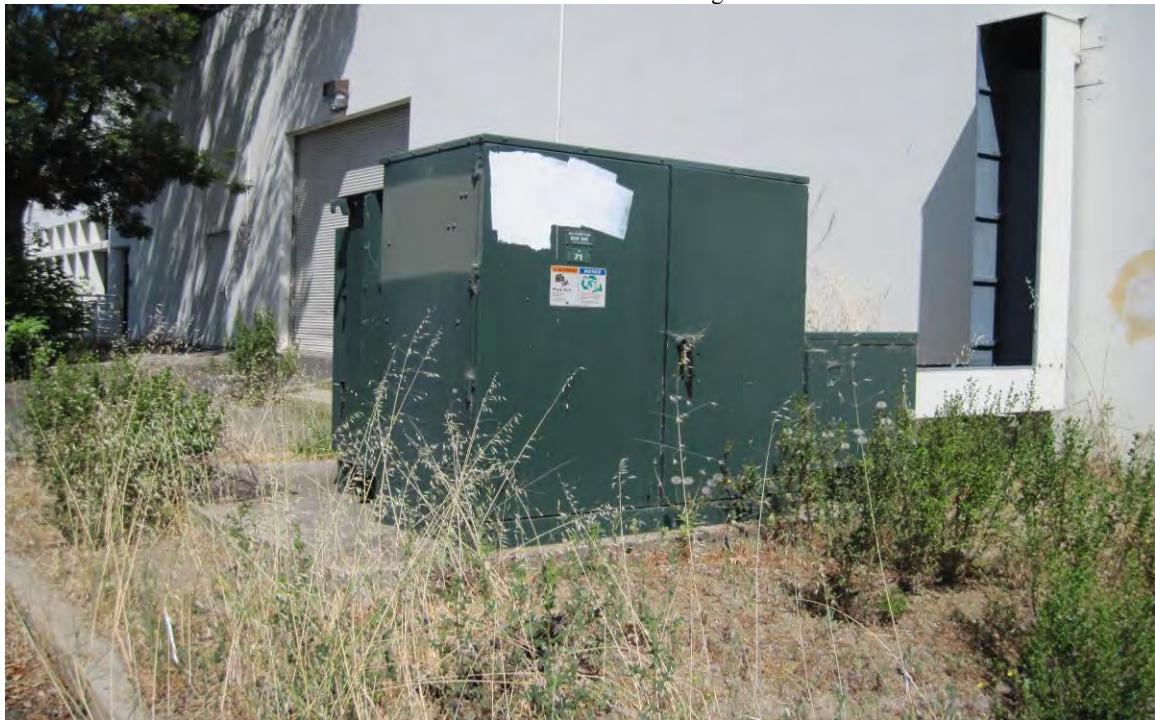
**PHOTOGRAPH #5** – View of transformer T 71 on south side of building.

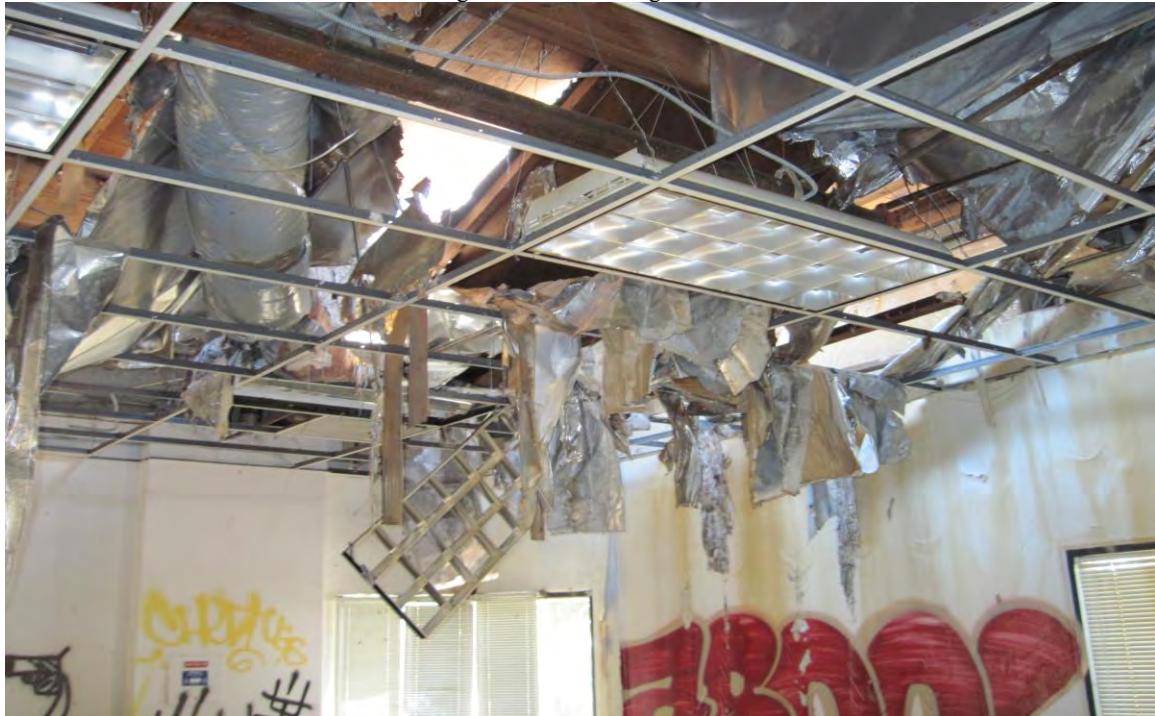
**PHOTOGRAPH #7** – View of wrecked ceiling and hole cut through roof.

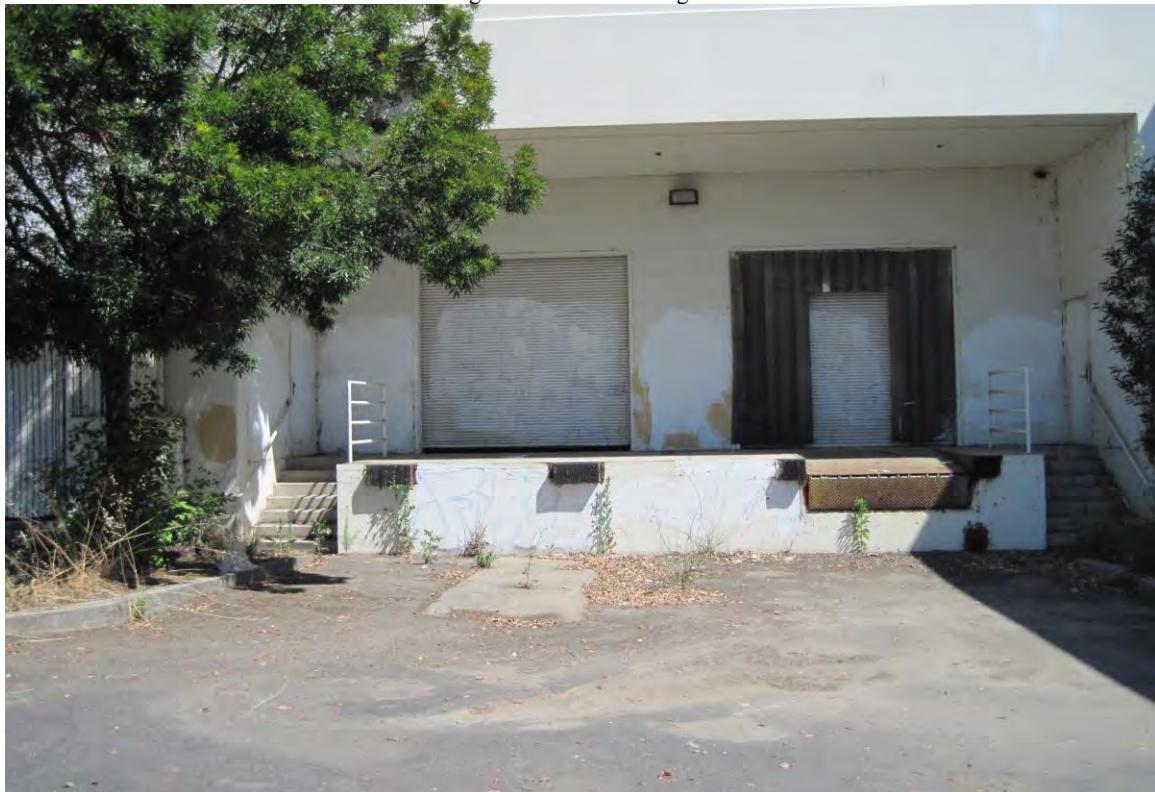
**PHOTOGRAPH #12** – View of exterior loading dock rear of building.

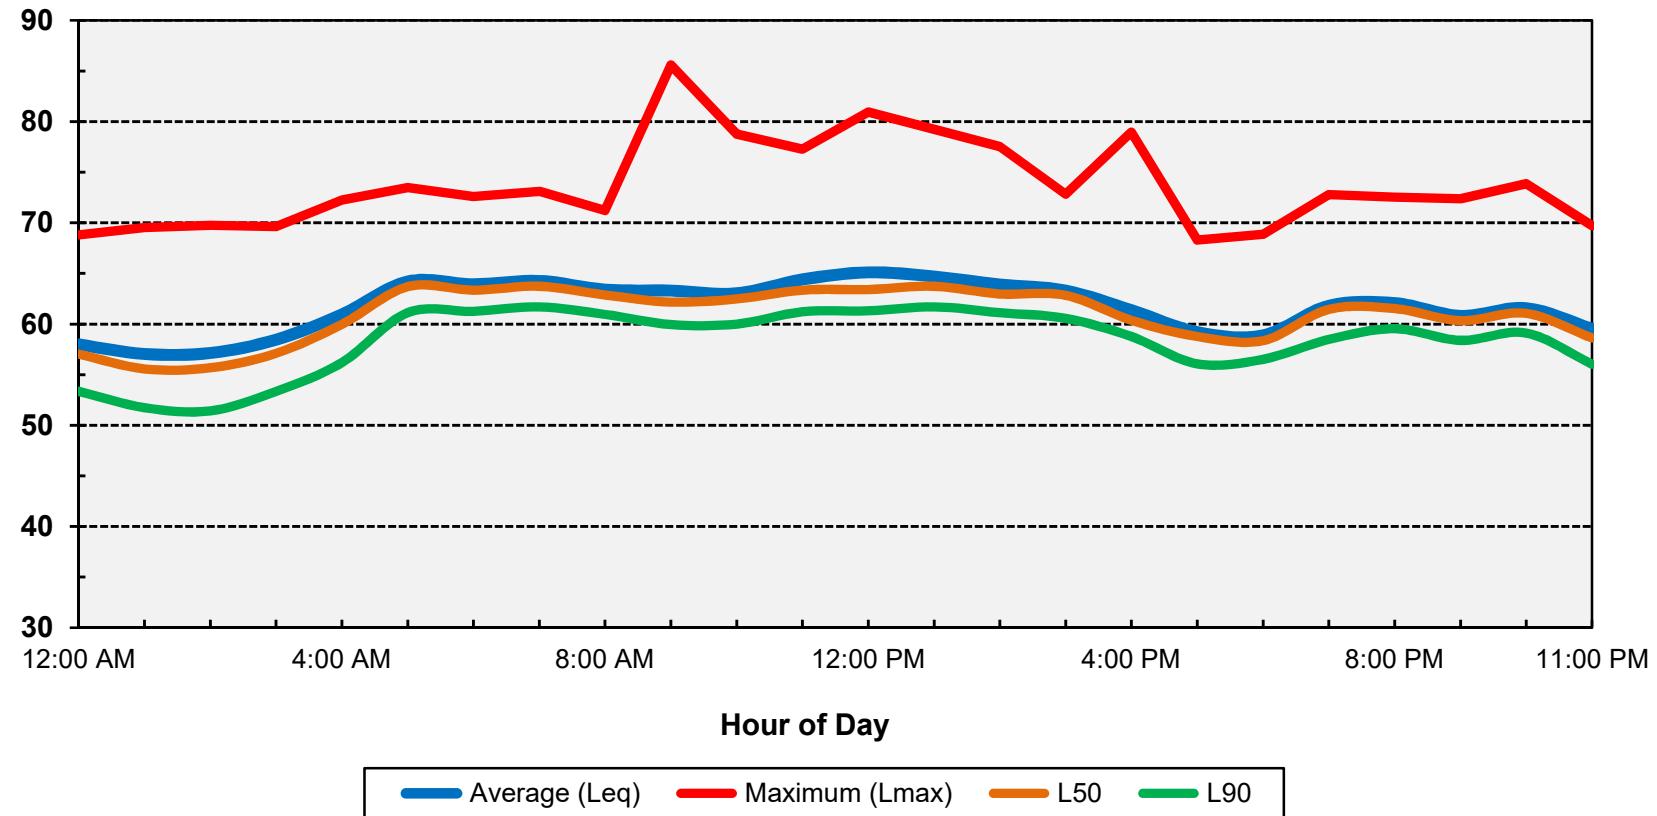
**Appendix C**  
**Home 2 Suites Hilton Milpitas**  
**Ambient Noise Monitoring Results - Site A**  
**Tuesday, December 20, 2016**

**Sound Level, dBA**

**Ldn: 68 dB**

The exterior noise environment at the project site is defined primarily by traffic on Interstate 880. To quantify existing noise levels at the project site, BAC conducted short-term (15-minute) and long-term (24-hour) noise level surveys on the project site on December 20, 2016. The measurement sites are shown on Figure 1. The purpose of the continuous noise level survey was to determine existing traffic noise exposure on the project site in terms of the day/night average level ( $L_{dn}$ ), and to determine the typical changes in noise environment which occur at the project site over a 24-hour period.

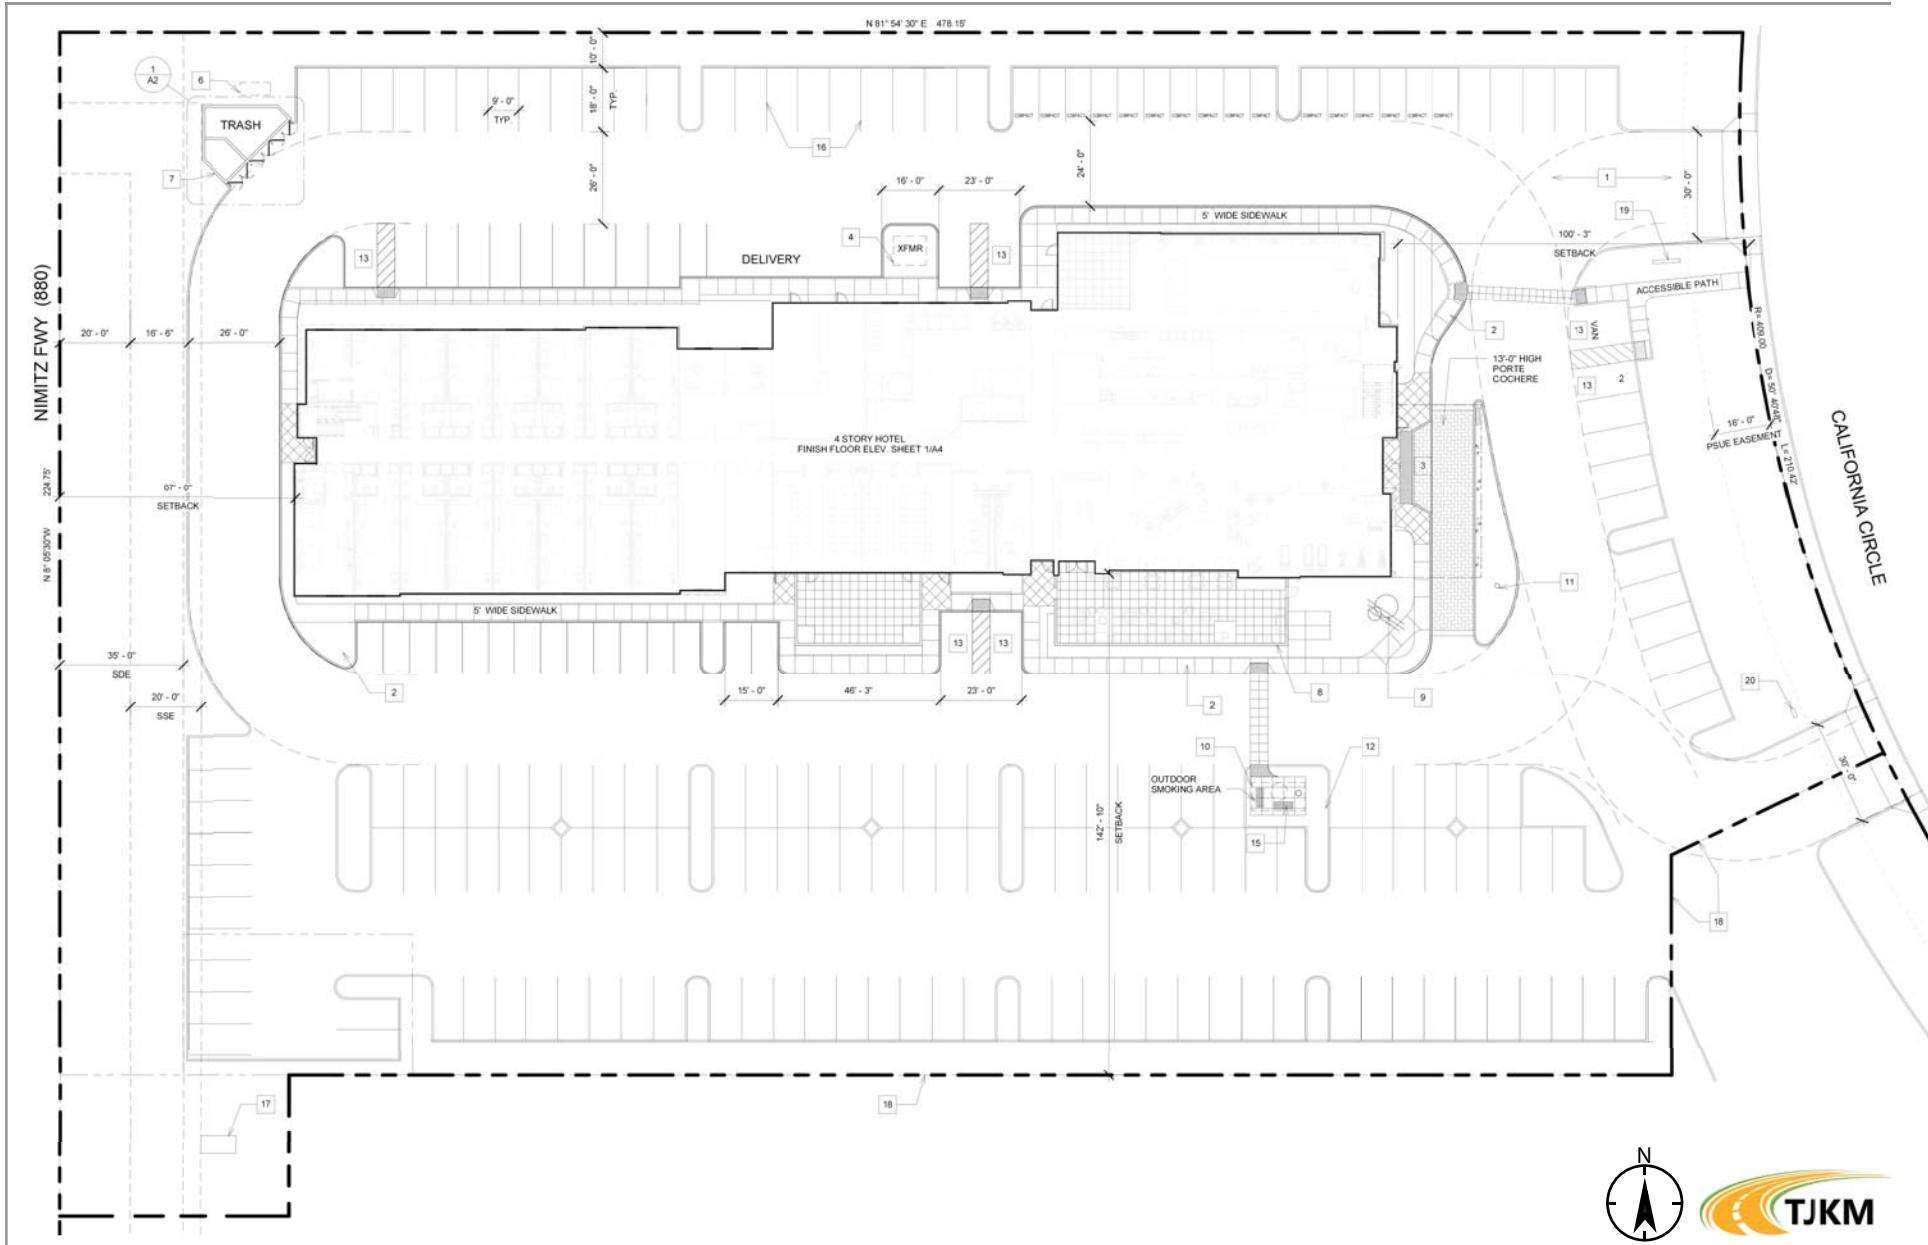
## Site Plan

Source: RYS Architects
